# **SEISMIC FRAGILITY ASSESSMENT OF UNREINFORCED MASONRY CHURCHES OF CENTRAL CHILE**

**NURIA CHIARA PALAZZI**

Thesis submitted to Pontificia Universidad Católica de Chile and University of Florence in partial fulfillment of the requirements for the Degree of Doctor in Engineering Sciences and Doctor in Architecture

Santiago of Chile, October, 2019

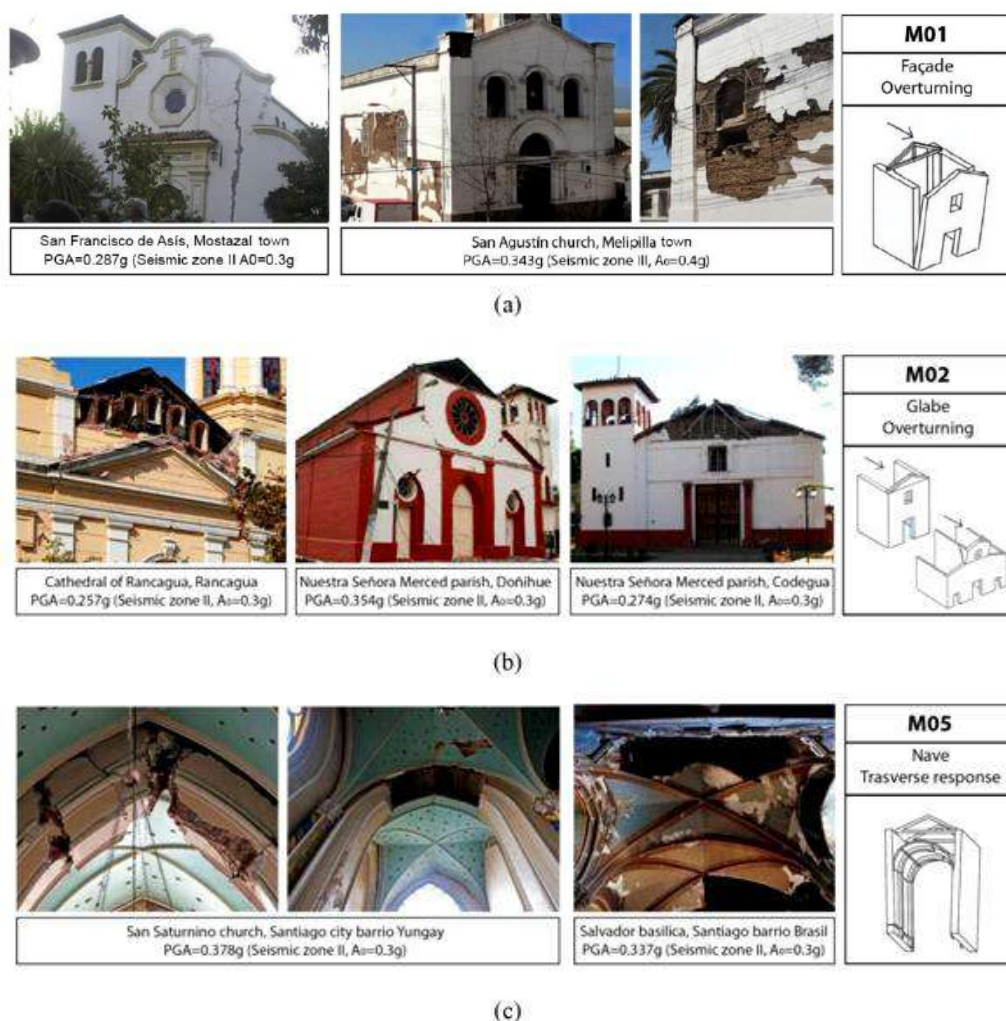
A typical out-of-plane mechanism of the central part of façade was observed in the San Francisco de Mostazal's church (PGA=0.287g) in the municipality of Rancagua built in 1858. Deep vertical cracks were observed due to the lack of connection between the façade, the longitudinal nave walls, and the bell-tower (Fig. 4.5a). In the San Agustín's church (PGA=0.343g), located in the town of Melipilla and built in 1744, triggering of the first mode mechanism of the façade was detected. Different materials in the façade (brick masonry) and the side walls (adobe) were a critical link between structural elements. Maule's shaking produced detachment of the entire façade with 7m wide and 1.5m height extension (Fig.4.5a) and the collapsed stucco, (Lira&Arévalo, 2010). The presence of good quality connections between the façade and lateral walls of the side aisles limited the collapse of the façade macro-element at the upper part (i.e. gable). In several Colonial churches, the collapse of tympanums was observed. Its reconstruction with wooden elements and brick (*tabiquería*), and the lack of a good connection between the roof and façade represent an important discontinuity and weakness to present an overturning of the wall.

**Figure 4.5 -** (a) Out-of-plane mechanisms of the façade due to poor connections at the corners: in the San Francisco de Mostazal the simple overturning involved the central part of façade, and in the San Agustín church the complete façade; (b) gable overturning effect of inadequate connection between roof structure and masonry wall of the upper part of façade on Cathedral of Rancagua, Doñihue's parish, and Codegua's church; and (c) observed collapses on the haunch of the transverse arches of side aisles

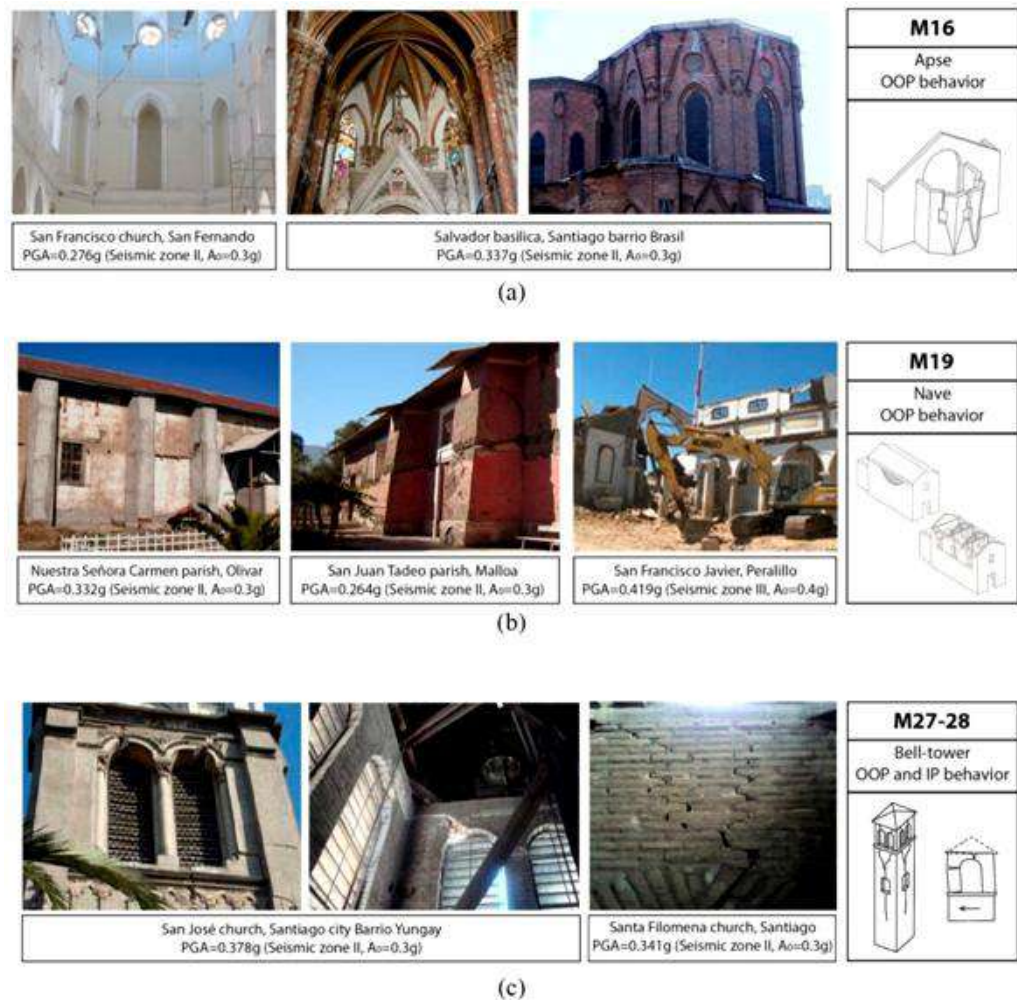
deep horizontal cracks and partial collapse in parishes Nuestra Señora del Carmen in Olivar, in San Juan Tadeo in Malloa (PGA=0.264g) and in San Francisco Javier of Peralillo (PGA=0.419g), which west nave completely collapsed (Fig.4.6b).

**Figure 4.6-** (a)Vertical cracks in windows due to the hammering roof covering; (b) deep horizontal cracks windows and buttresses, and total collapse of the lateral wall due to the hammering roof and connection between the wooden trusses and the masonry walls; and (c)diagonal cracks on bell-tower walls.

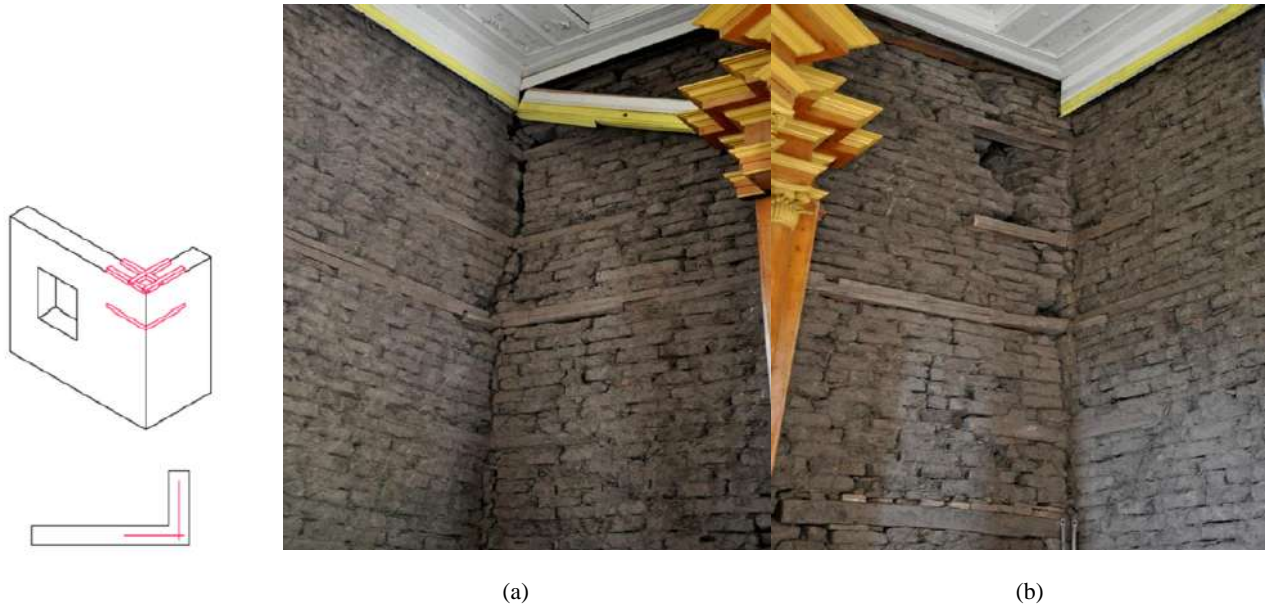
This traditional strengthening solution induces walls working together even when the bonds between perpendicular walls crack during an earthquake (Ortega et al., 2017), as can be seen in the 2010 post-earthquake photos of the rear wall of central nave (Fig.5.1.3 a-b).

**Figure 5.1.3** – (a) (b) Corner keys between rear and lateral walls.

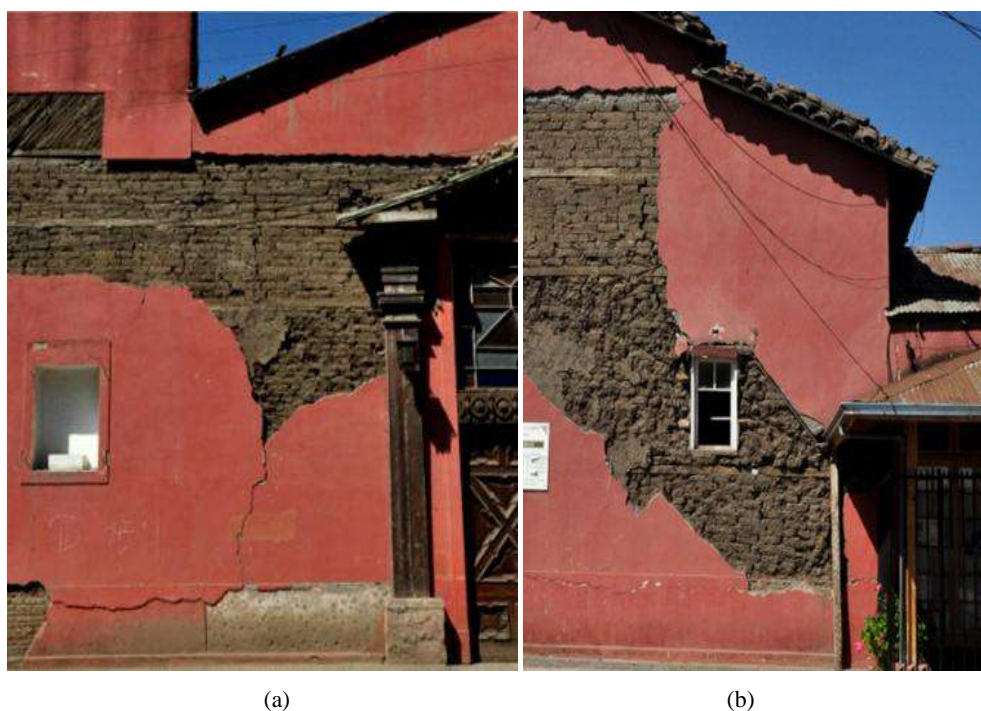
**Figure 5.1.7** – Deep vertical cracks in the main façade (Surtierra, 2011).

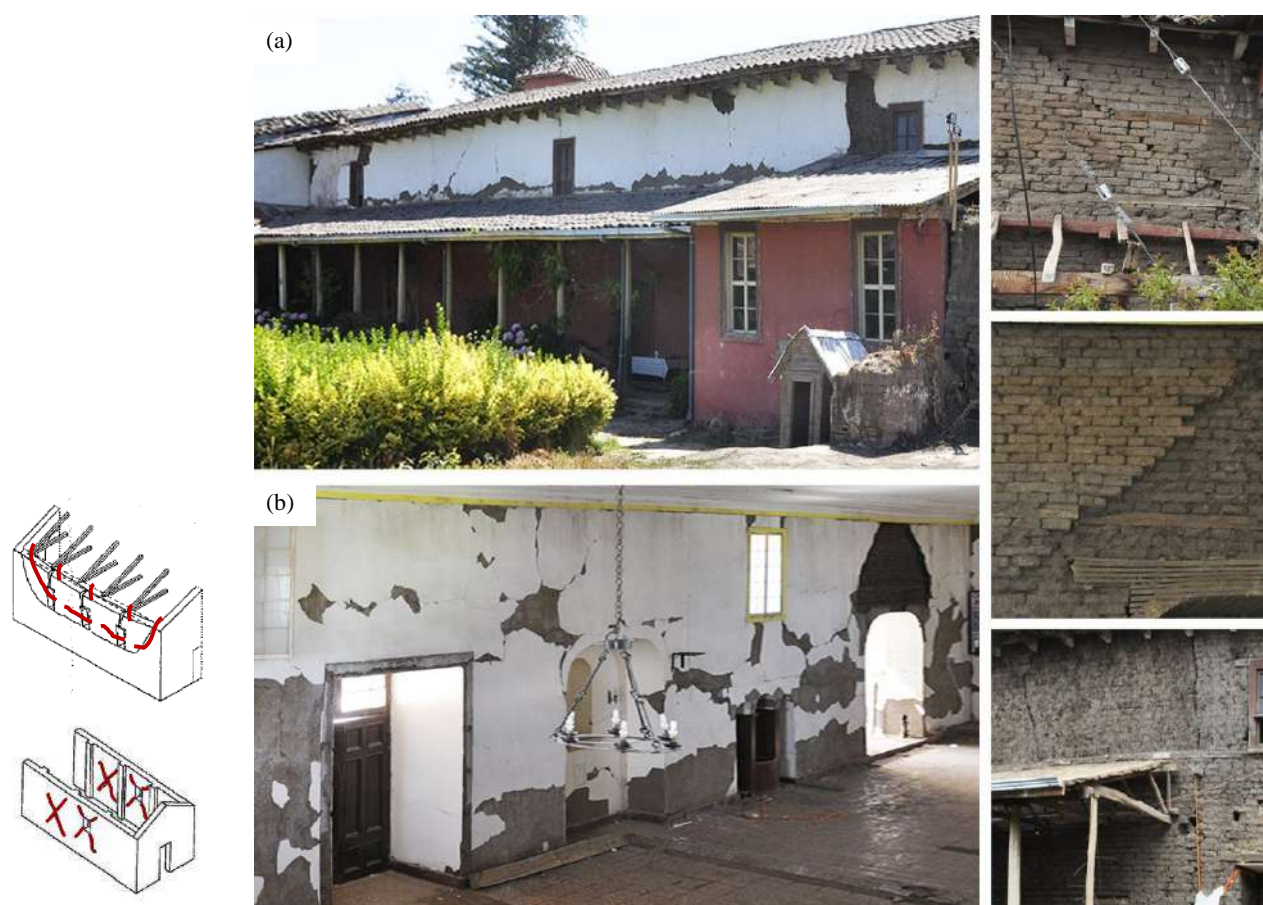
**Figure 5.1.8** – Deep vertical cracks observable in the (a) internal and (b) external elevations of side walls (Surtierra, 2011).

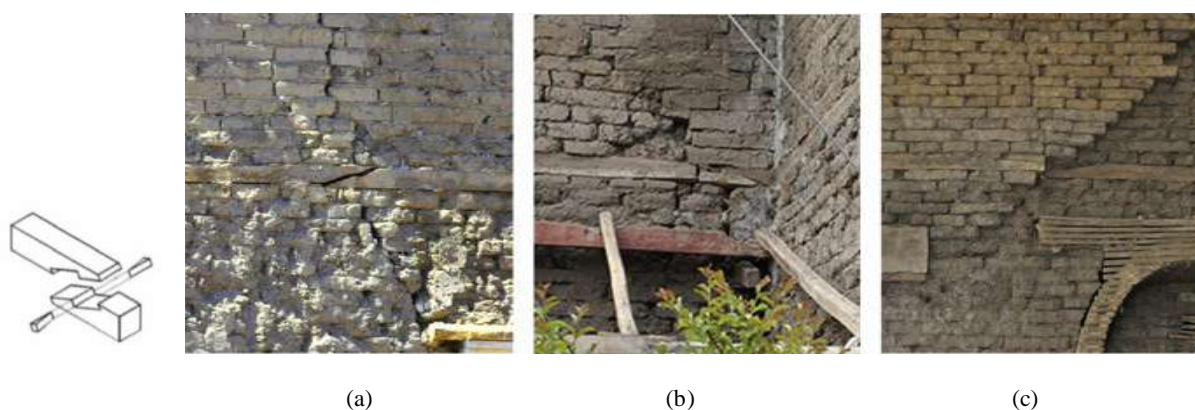
**Figure 5.1.9** - Failure modes of hooked scarf joints after 2010 Maule earthquake in the ring-beam.

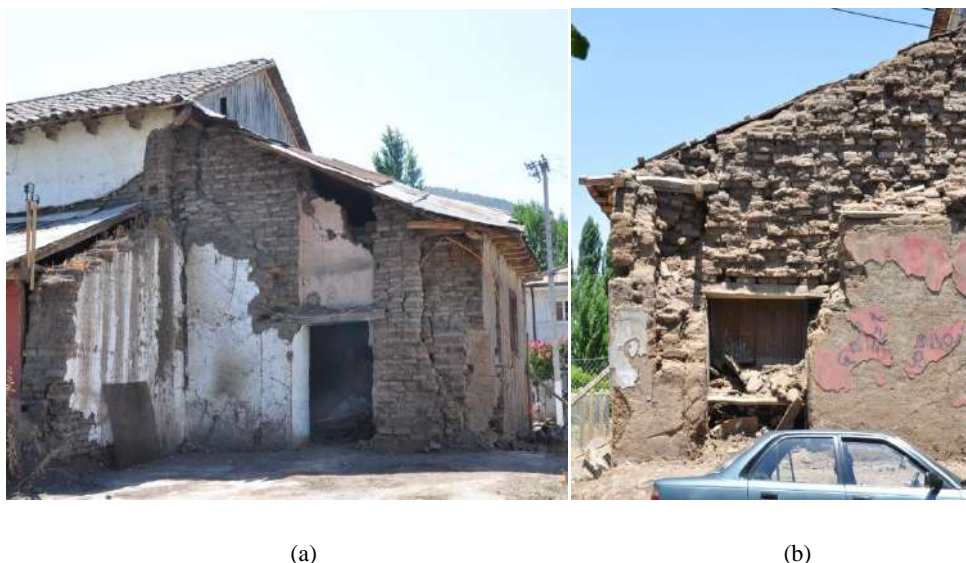
**Figure 5.1.10** - Local collapses of Sacristy (Surtierra, 2011).

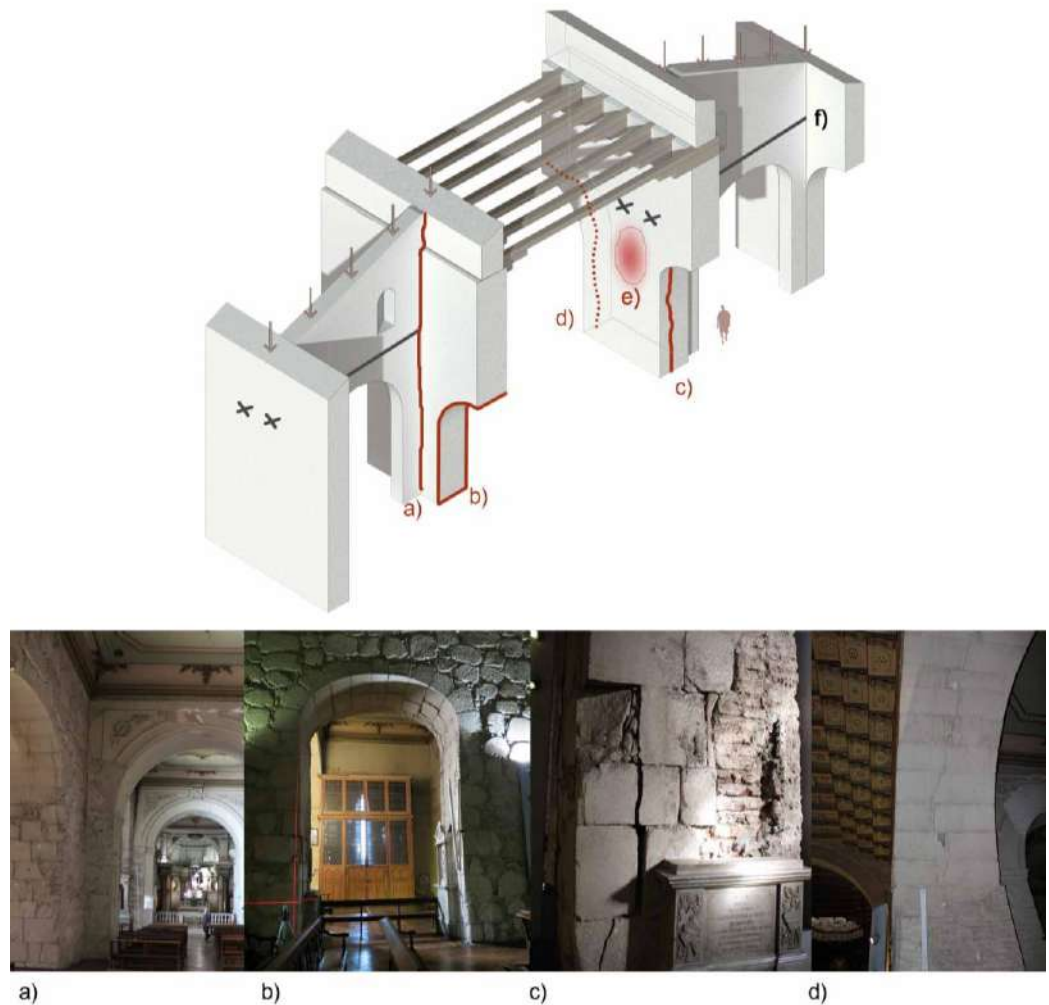
**Figure 5.2.9-** Cracks in transverse arches(Jorquera et al., 2017).

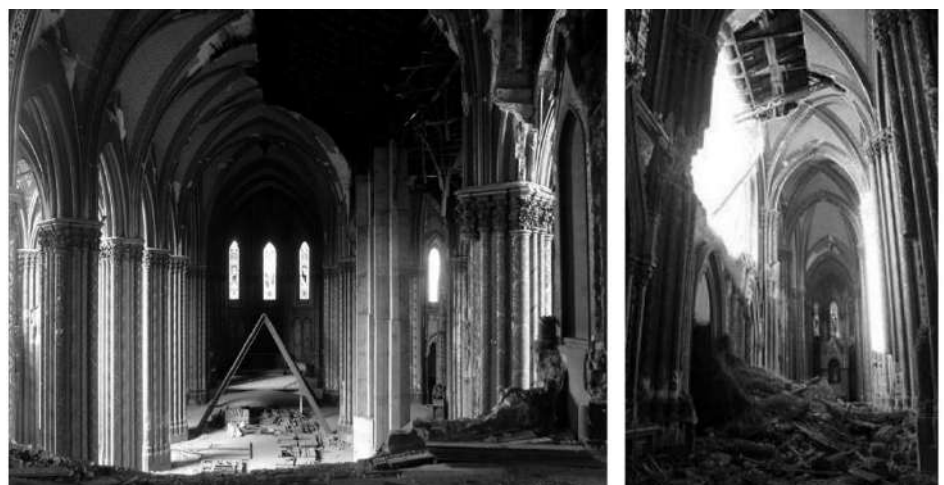
**Figure 5.3.4** - Photo (a) and (b): worrying crack pattern and local failures of east side aisle wall, central arch of narthex, arcades of the external gallery and columns of the central nave. (Ministry of Public Works).

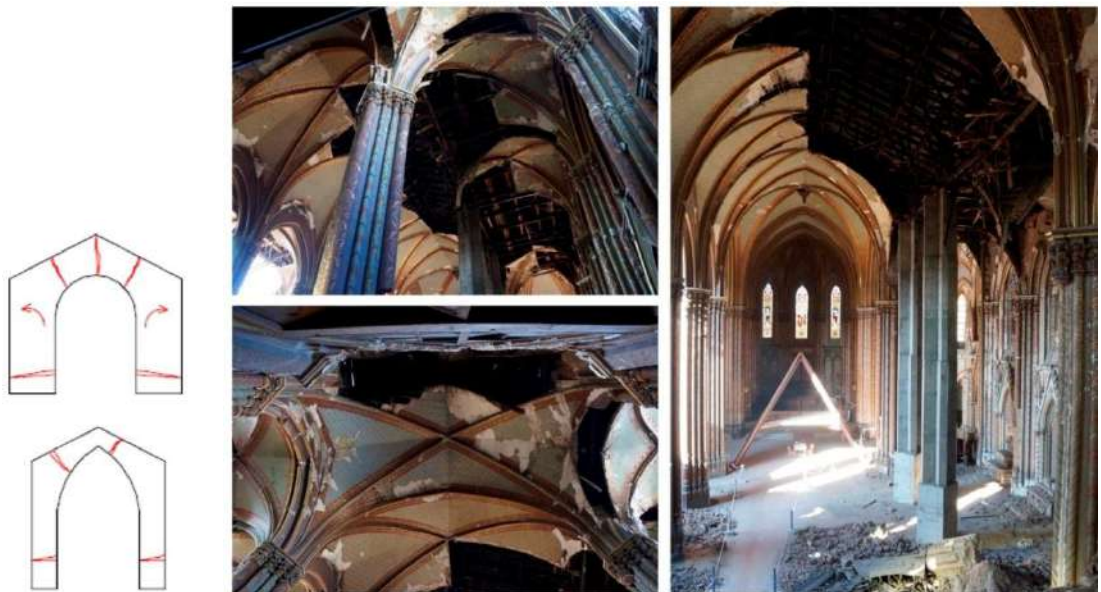
**Figure 5.3.11** -Collapses of the transverse arches and arches of the longitudinal west wall.

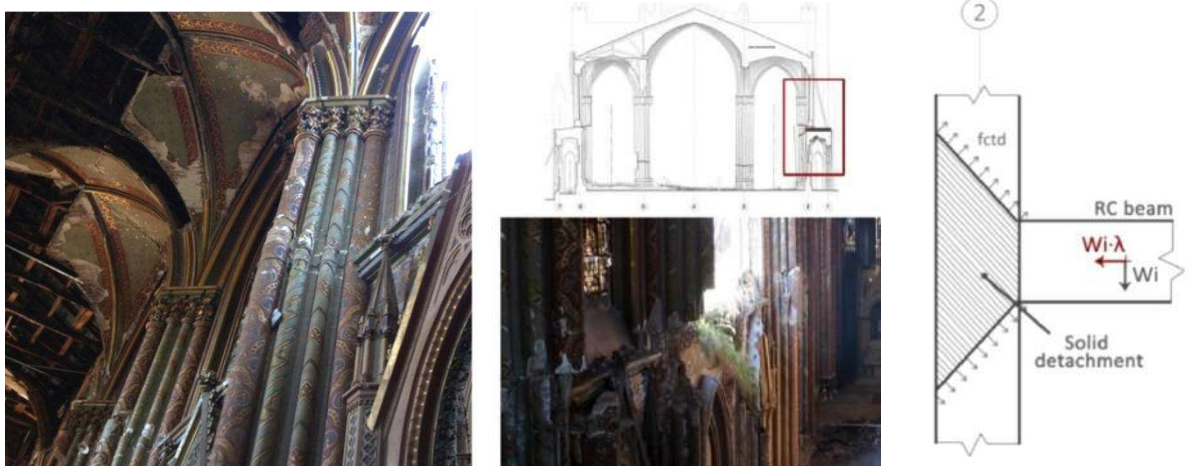
*Figure 5.3.12 –Punching mechanism in the east aisle generate by RC beams*

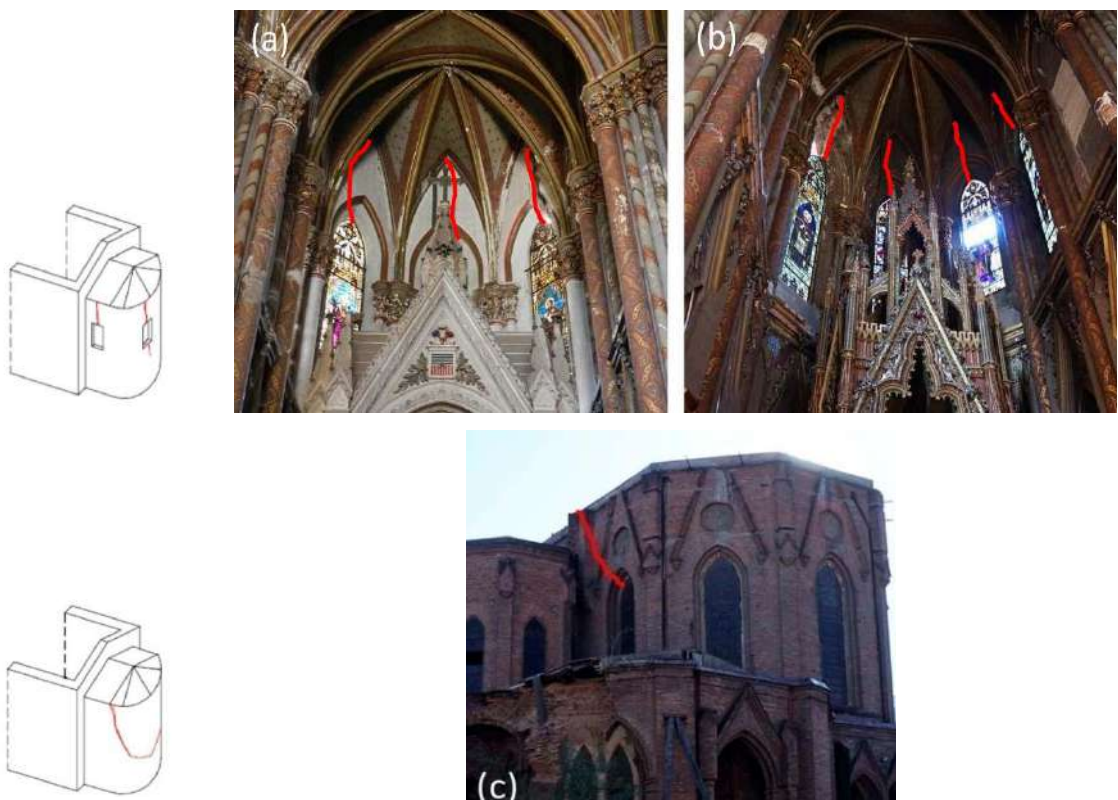
**Figure 5.3.13** - Deep cracks in the lateral apses (a) and (b), and in the central apse (c).

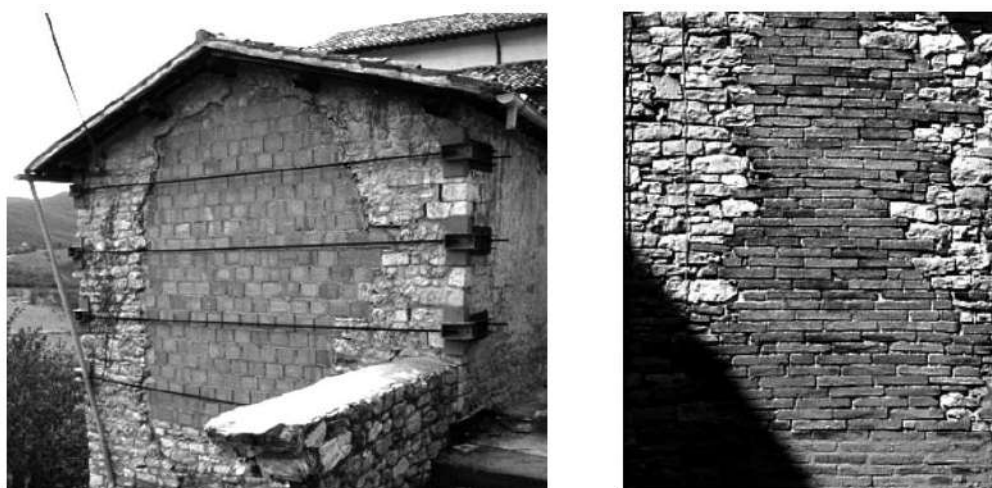
**Figure 6.12** - Masonry replacement intervention. The repairs are ineffective due to the lack of compatibility between the masonry portions (Frumento et al., 2006).

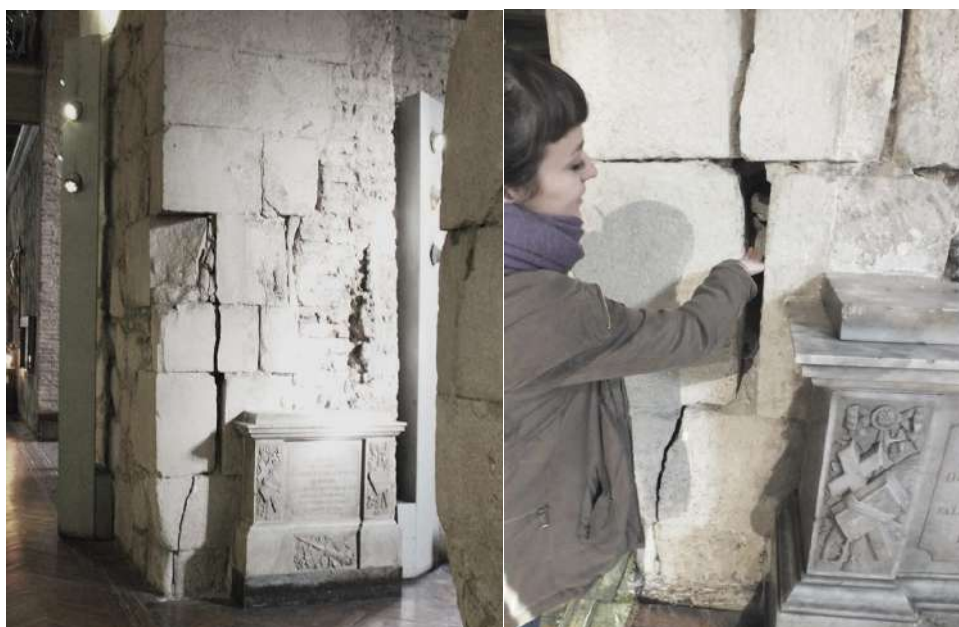
**Figure 6.19** - Worrying deep vertical crack in arch piers of central nave pillar axis F.
