PART I: RESPONSE OF REINFORCED CONCRETE BUILDINGS IN CONCEPCION DURING THE MAULE EARTHQUAKE

Thesis submitted to the Office of Research and Graduate Studies in partial fulfillment of the requirements for the Degree of Master of Science in Engineering

Santiago de Chile, (December, 2011)

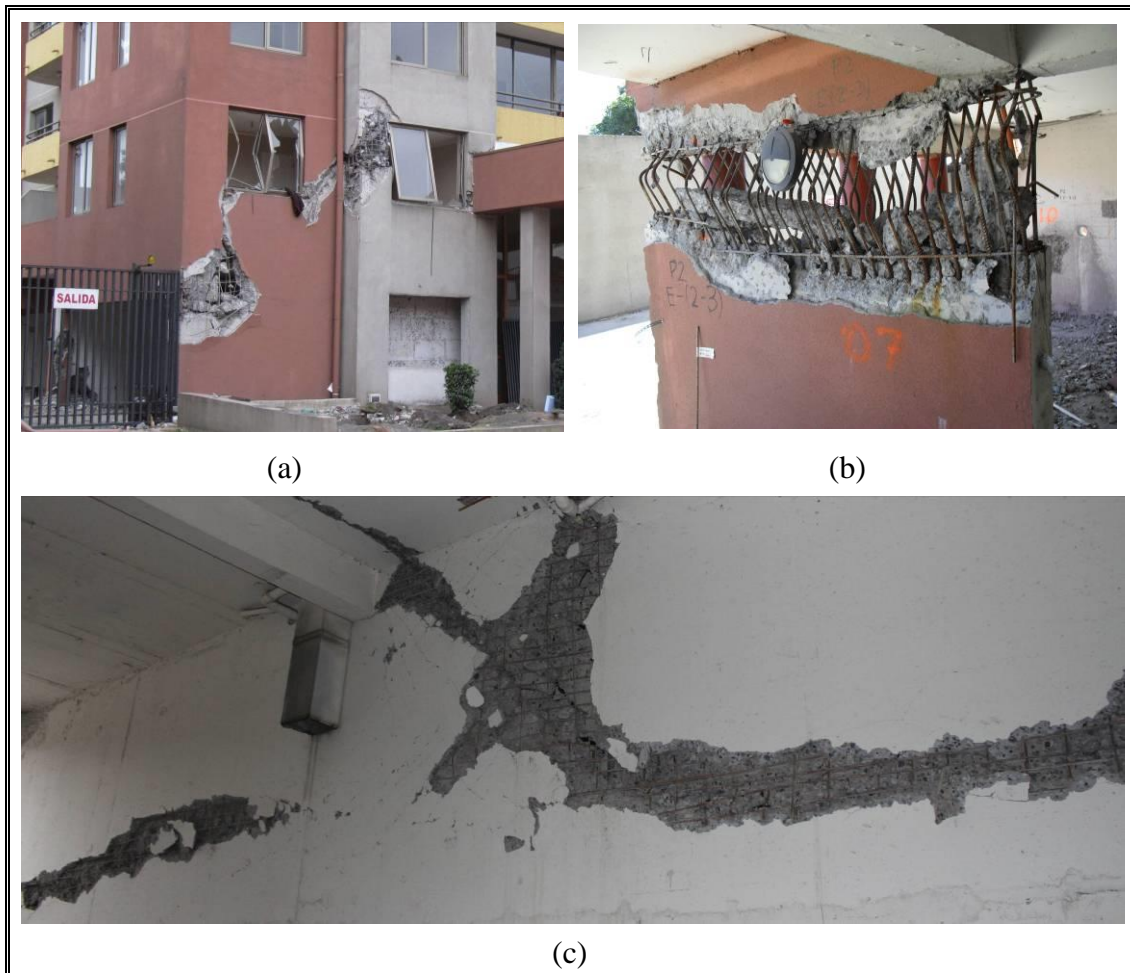
CM-3 sustained failures in multiple EW-oriented walls in the first two elevated stories and the subterranean levels. Apparent failures involved shear failure through multiple piers separated by openings (a), compression or flexural compression failures (b), and shearing failures of horizontal wall segments at the bottom of a series of vertically aligned door openings (c). These cases are shown in Figure 6-3.

Figure 6-3: Examples of wall damage in building CM-3

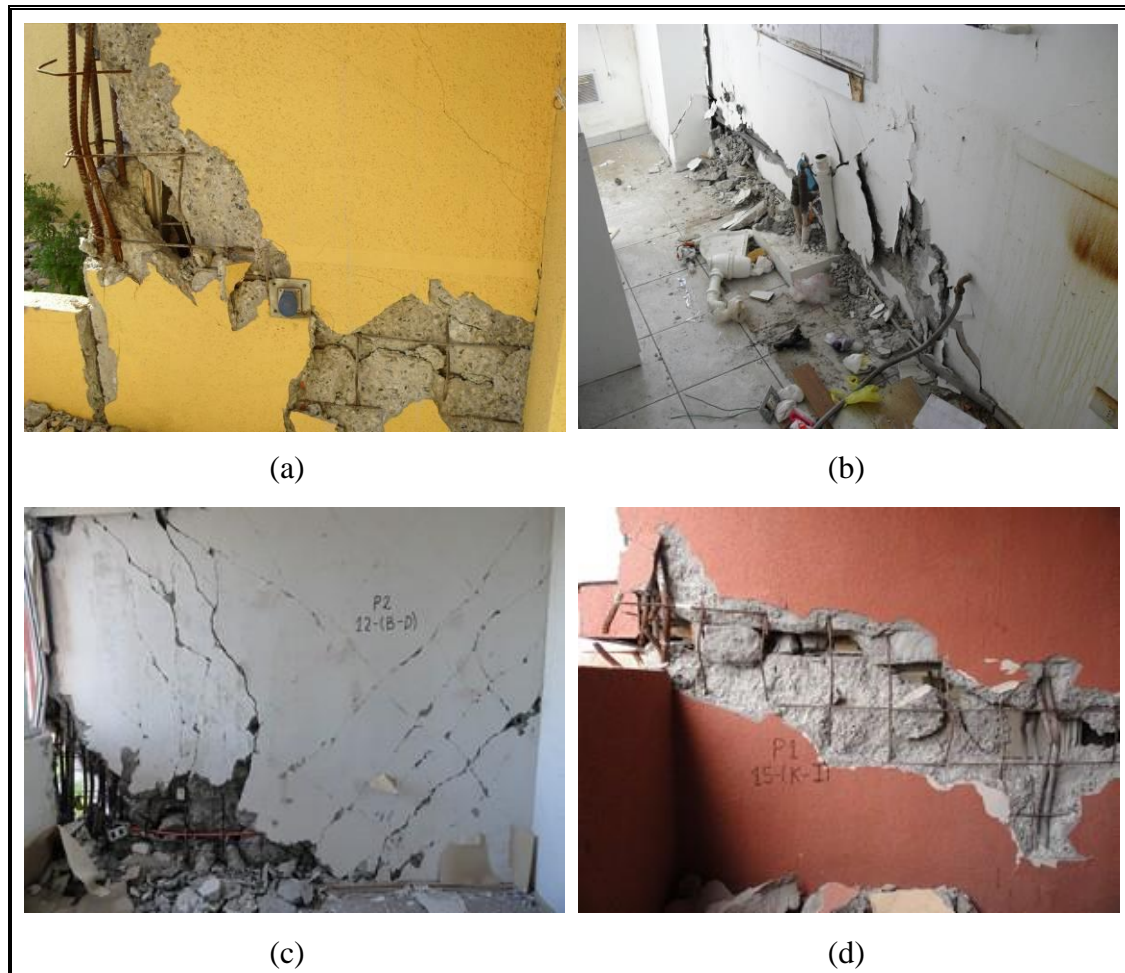
These similar, adjacent buildings sustained similar damage, concentrated in first-story EW-oriented walls (Figure 2-4m). Figure 6-7 shows damage characteristic of the most severe damage for these buildings. Building RT-8 was clearly more damaged than PP-7.

Figure 6-7: Examples of wall damage in buildings (a), (b) PP-7; (c), (d) RT-8

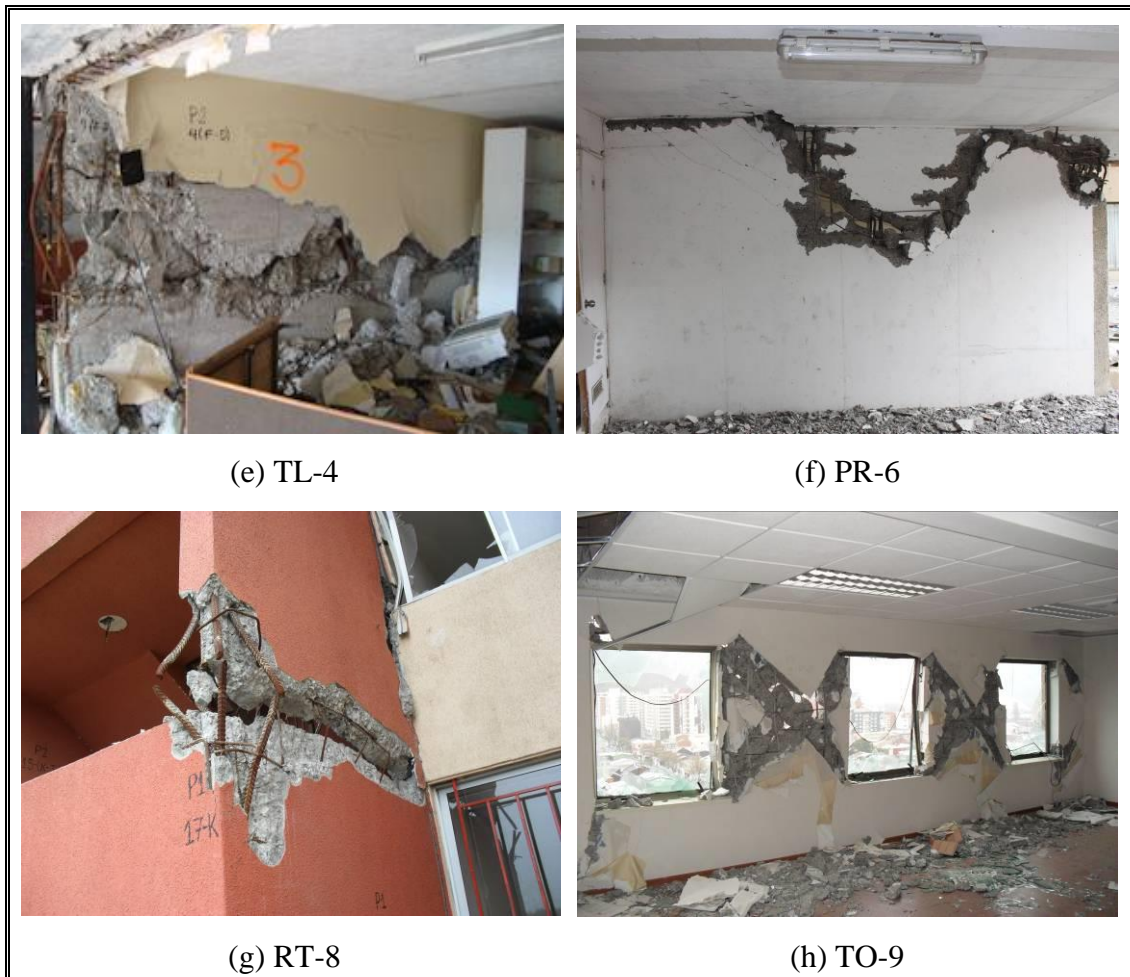
Figure 7-6: Examples of severe wall damage

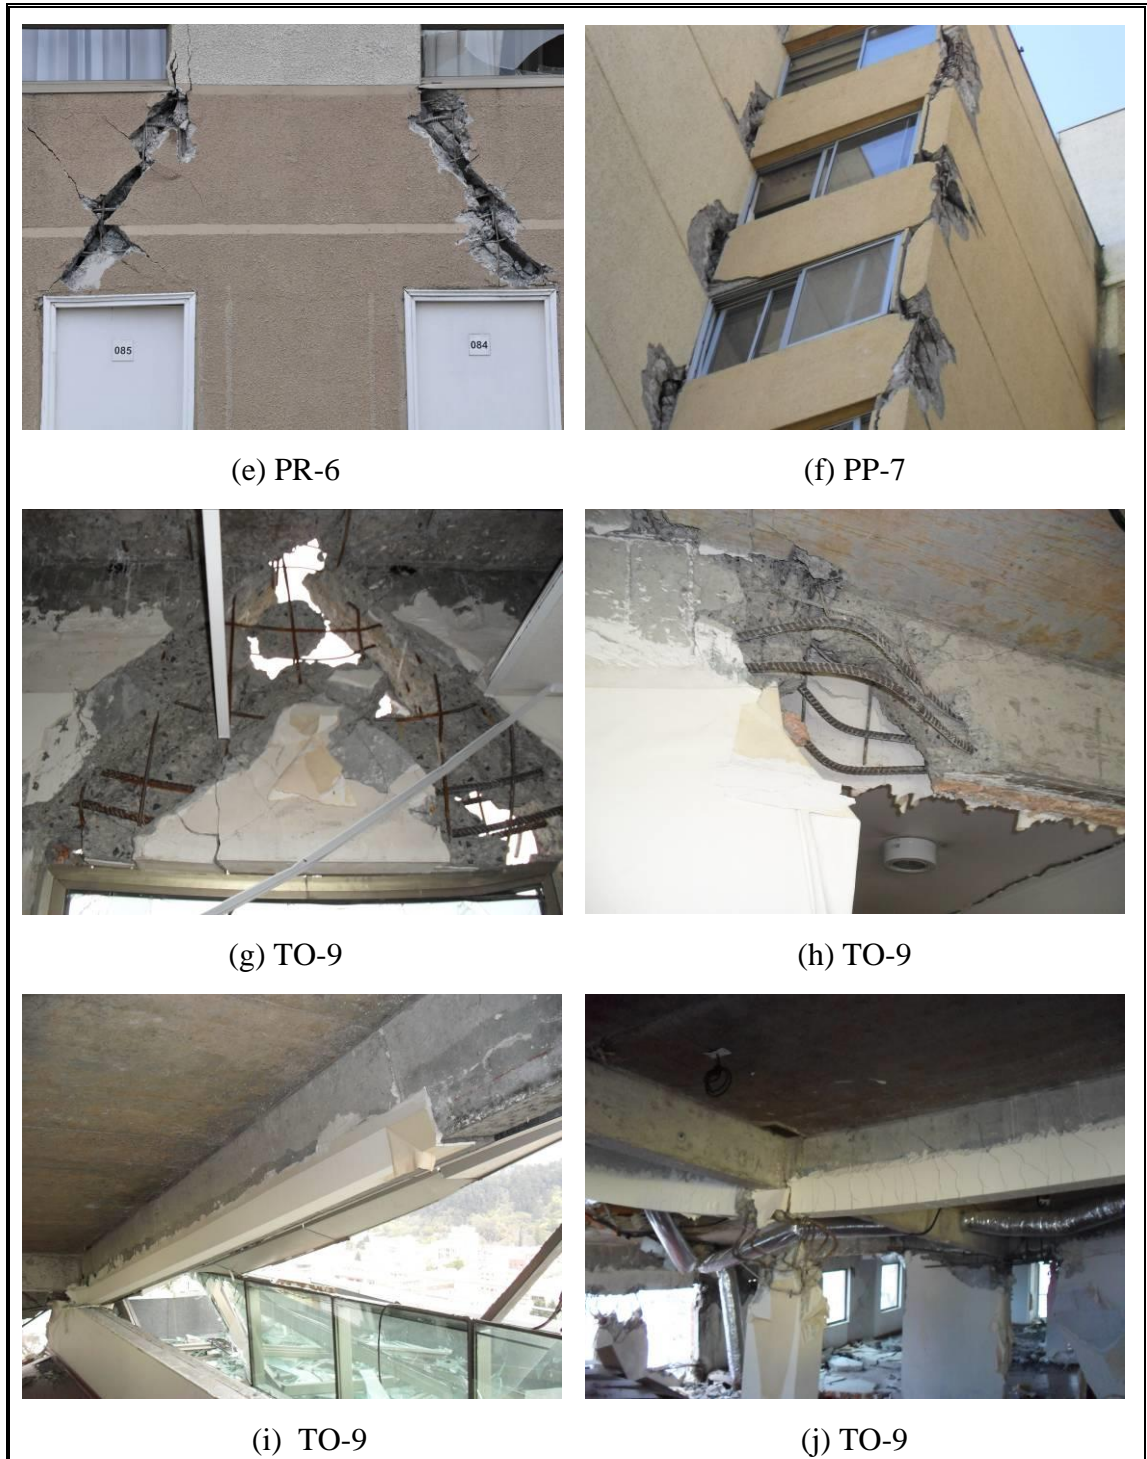
Figure 7-11: Examples of severe beam damage

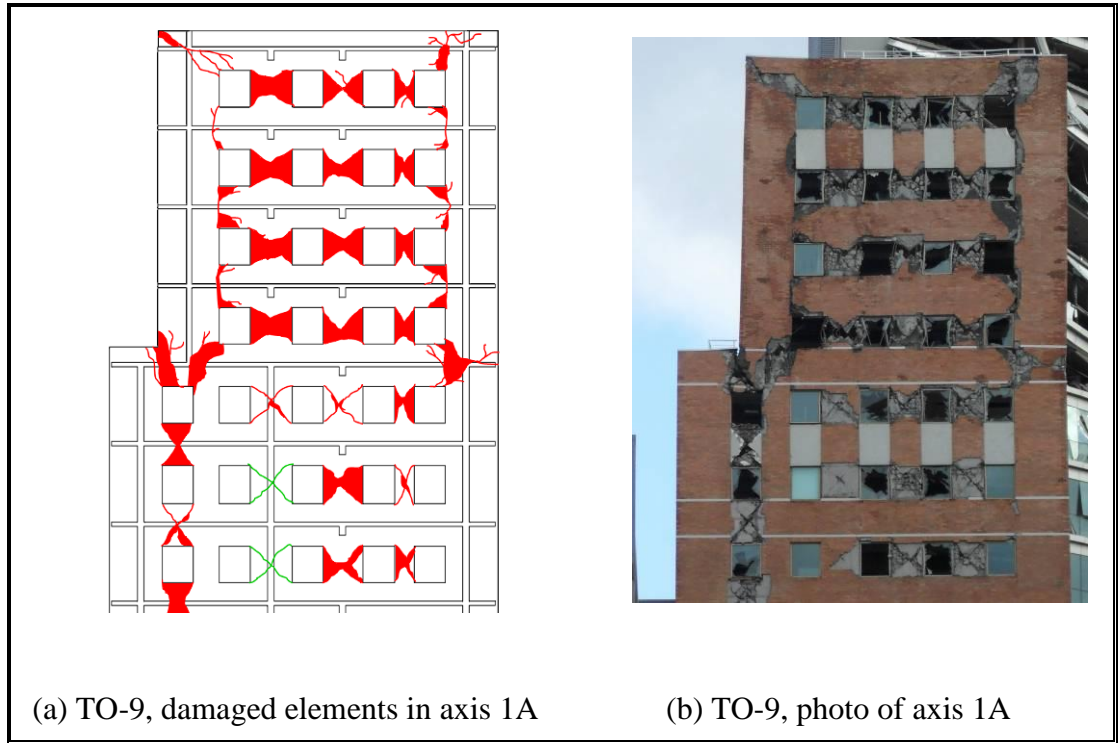
A comparison between damage recorded in structural drawings with real damage is observed in Figure 9-2 for axis 1A of building TO-9.

Figure 9-2: Comparison between recorded and actual damage for axis 1A of TO-9

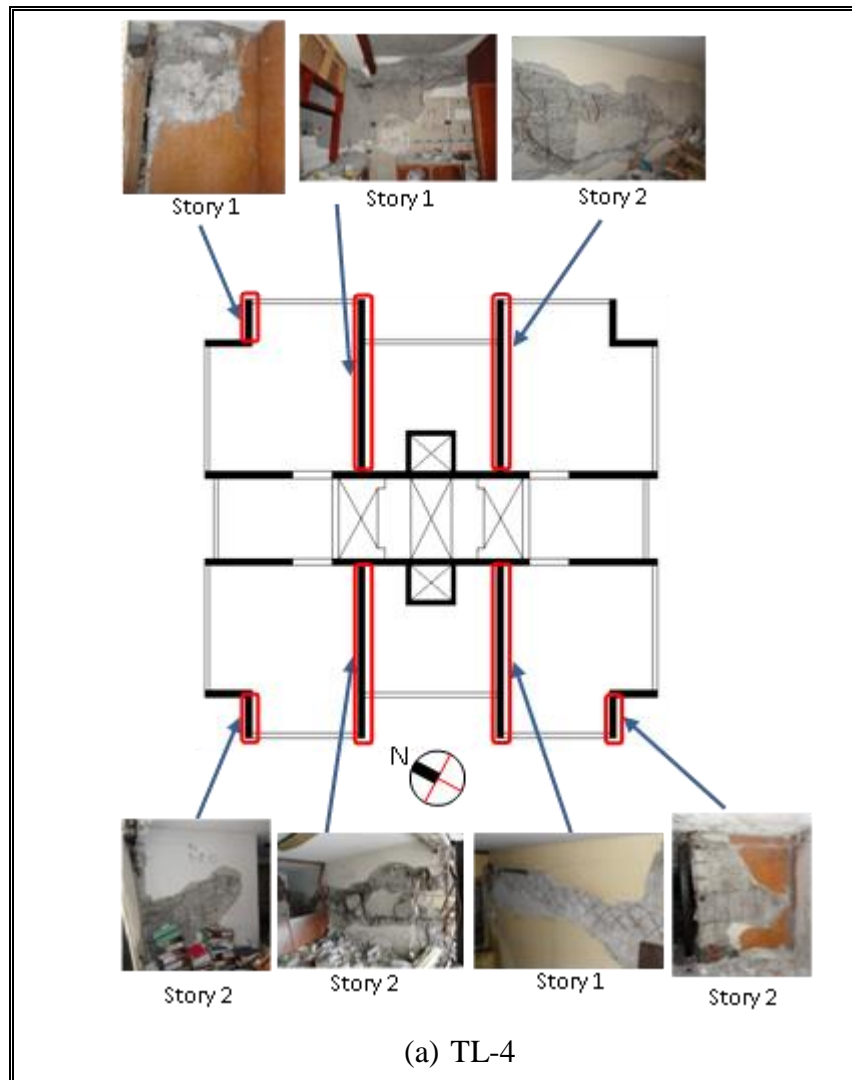
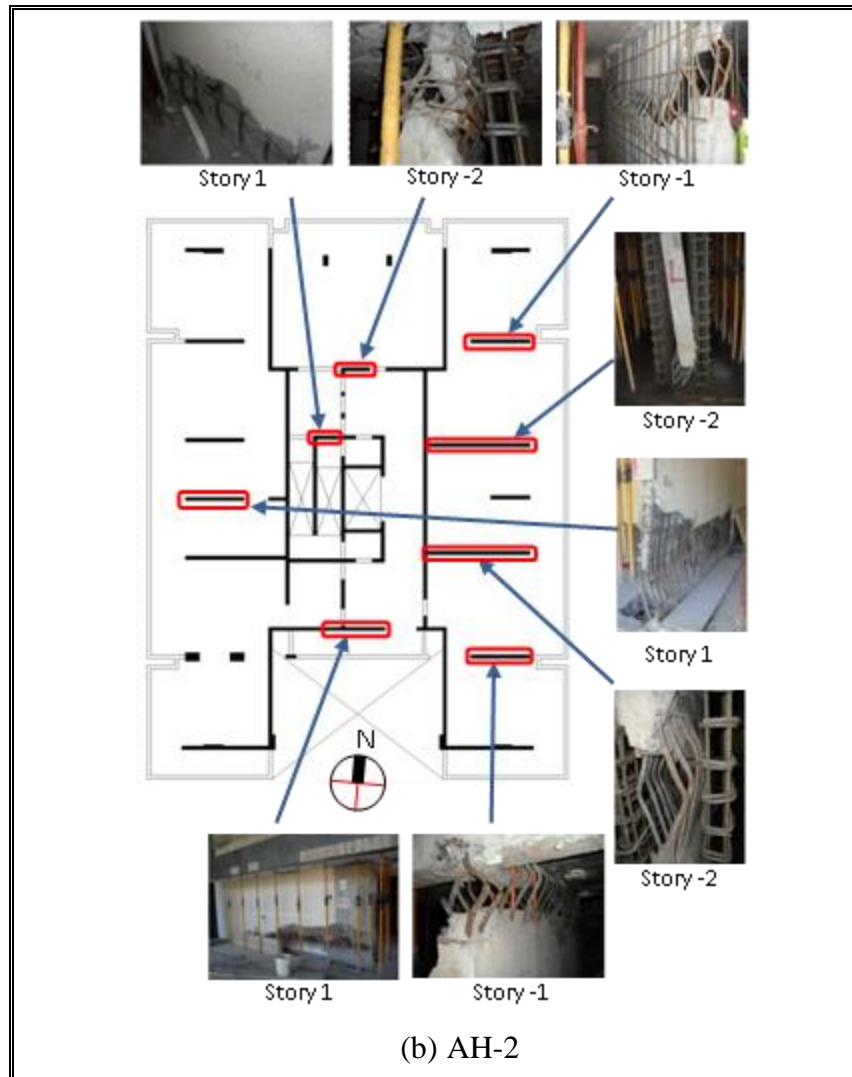
discussed later. Just as an example of this effect, shown in Figure 10-1 is a summary of the severely damaged walls affecting the stability of two of the structures, AH-2 and TL-4.

Figure 10-1: Severely damaged walls at buildings (a) TL-4, (b) AH-2

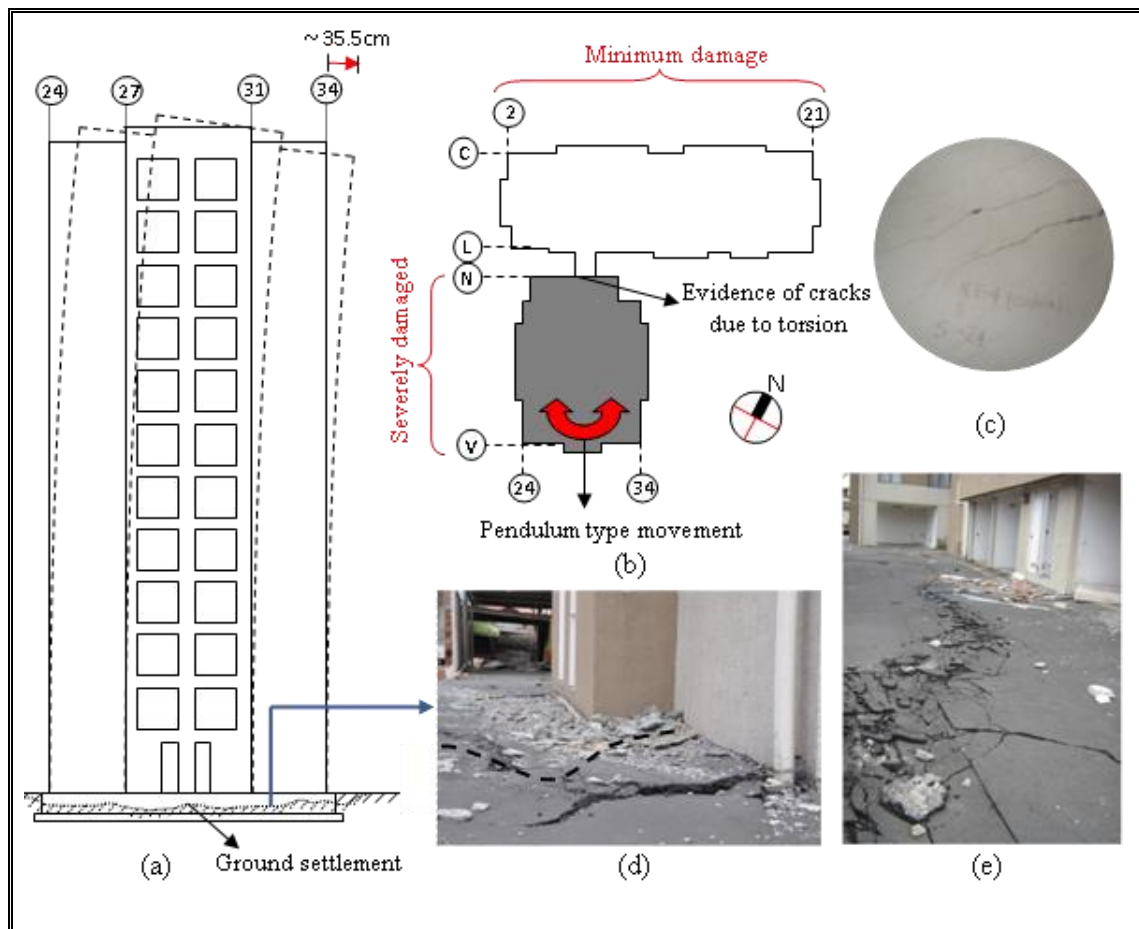
ended up balancing about the longitudinal corridor with indication of tension of the walls at one side of the corridor and compression driven failures at the other. The clearest example on how directionality may affect the behavior of the buildings is PR-6. This building is actually two structures perpendicularly oriented in plan, forming an “L-shaped” footprint (Figure 10-2).

Figure 10-2: Building PR-6; (a) Schematic elevation V-W, (b) Story plan and damaged area, (c) Torsion in axis N, (d) Ground settlement near axis V, (e) Settlement in PR-6

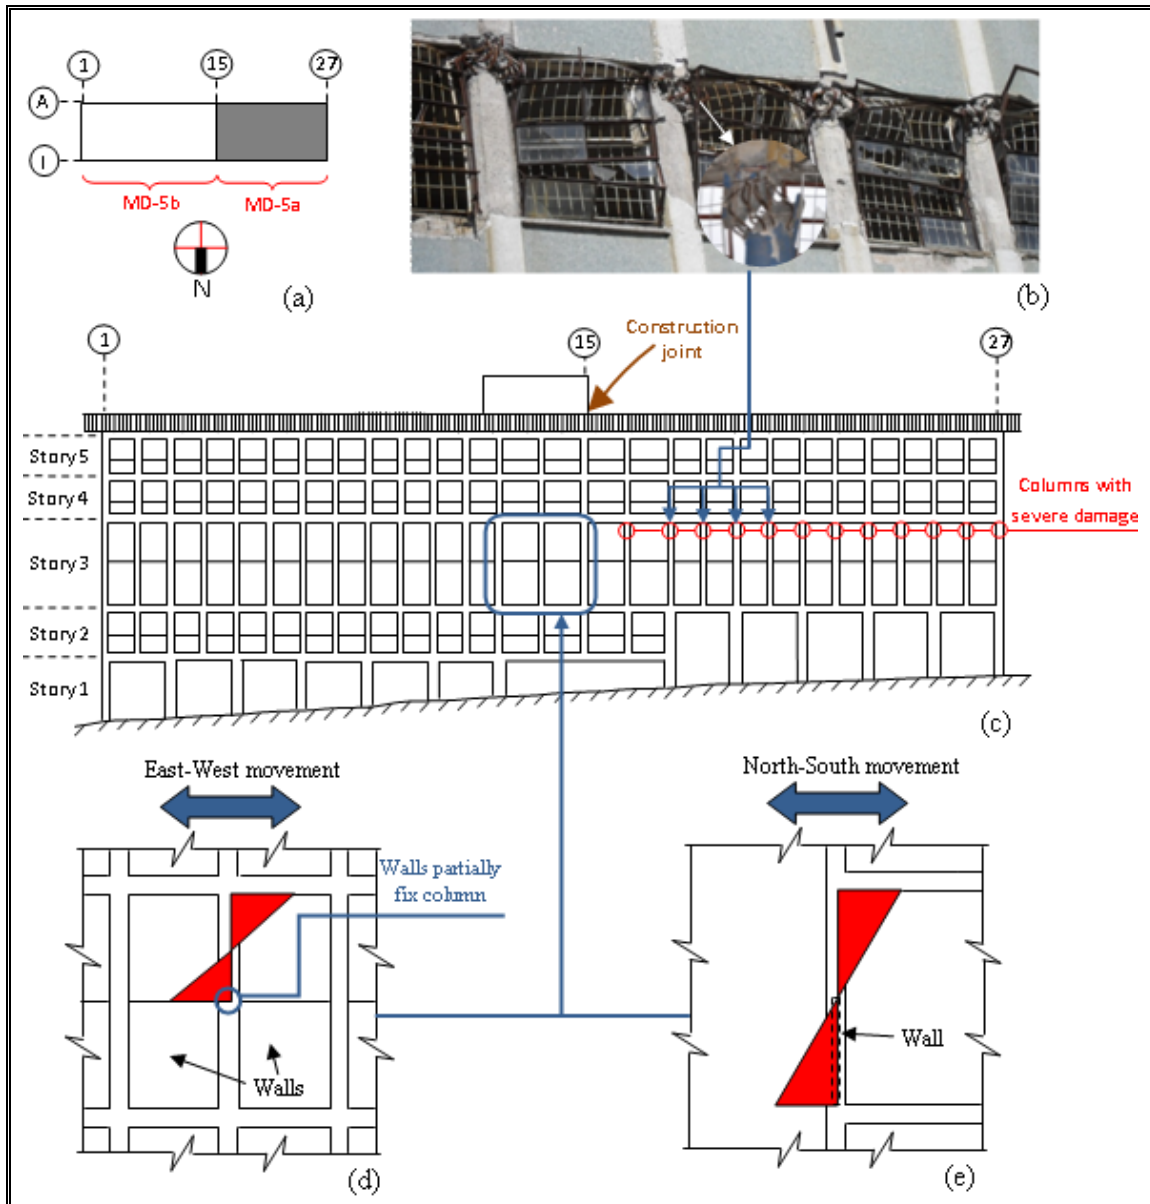
Moment diagrams for collapsed columns in each direction are shown in Figures 10-3d and 10-3e. Along the E-W direction, walls constrain columns at mid height. It is simple to prove that because of the constraint, simultaneous motion in both directions would result in higher bending moments at the top of the columns, exactly where hinges were formed. Although a combination of seismic excitation in both directions explains the observed damage in MD-5, the larger E-W damage intensity is still present and collapsed stories are clearly displaced in this direction (Figure 10-3b). Despite its age, this is a case where the designer must be aware of the 3D behavior of a structure, regardless of the code analysis which neglects the simultaneous action of two horizontal components for a regular structure.

Figure 10-3: Building MD-5: (a) schematic plan; (b) collapsed columns; (c) elevation I; bending moment diagram in collapsed columns for (d) E-W, and (e) N-S

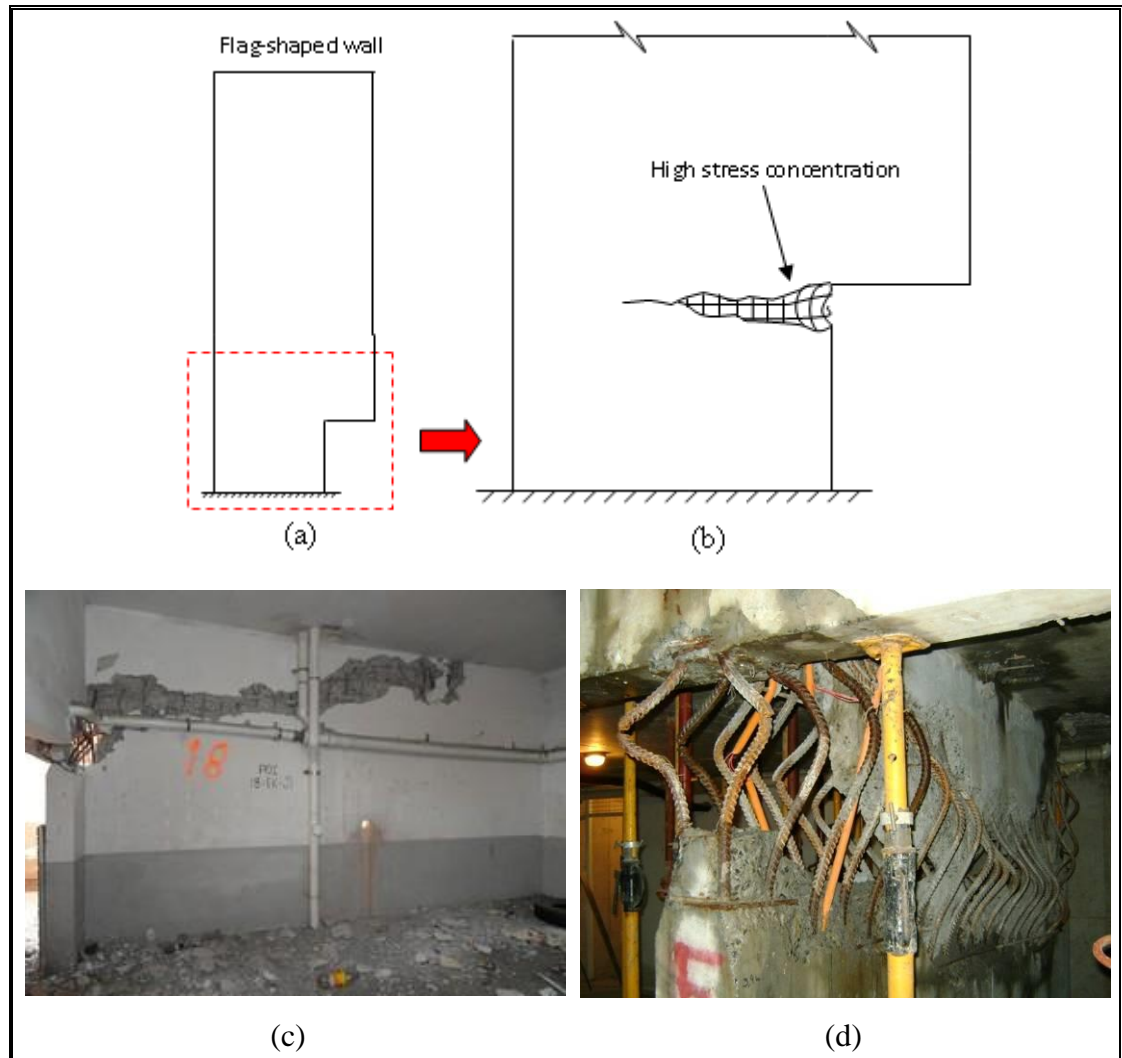
A very common irregularity observed in most damaged buildings is the so called flag-shaped pattern. In that case, shear walls reduce in length due to architectural and functional constraints in the first stories (open spaces at the lobby) and parking levels (ramp and circulation requirements). A schematic view of observed damage is shown in Figure 10-5b, where large stress concentrations occur at the contraction region of the wall. It became evident that the usual design assumption that the floor slab would be capable of distributing locally such concentration does not work. Typical examples of wall damage are shown in Figures 10-5c and 10-5d. It can be shown that refining the meshes of the usual finite element models of the buildings clearly shows this concentration effect, but more important than that is to be sure in design not only how the usual transfer of shear forces occurs through the slab, but how a smoother transition of the combined axial and bending capacity is achieved since moments are similar above and below the slab, but the axial stresses below are considerably larger.

Figure 10-5: (a) Typical flag-shaped wall; (b) damage observed in flag shaped walls;
Examples at buildings (c) AA-1 and (d) AH-2

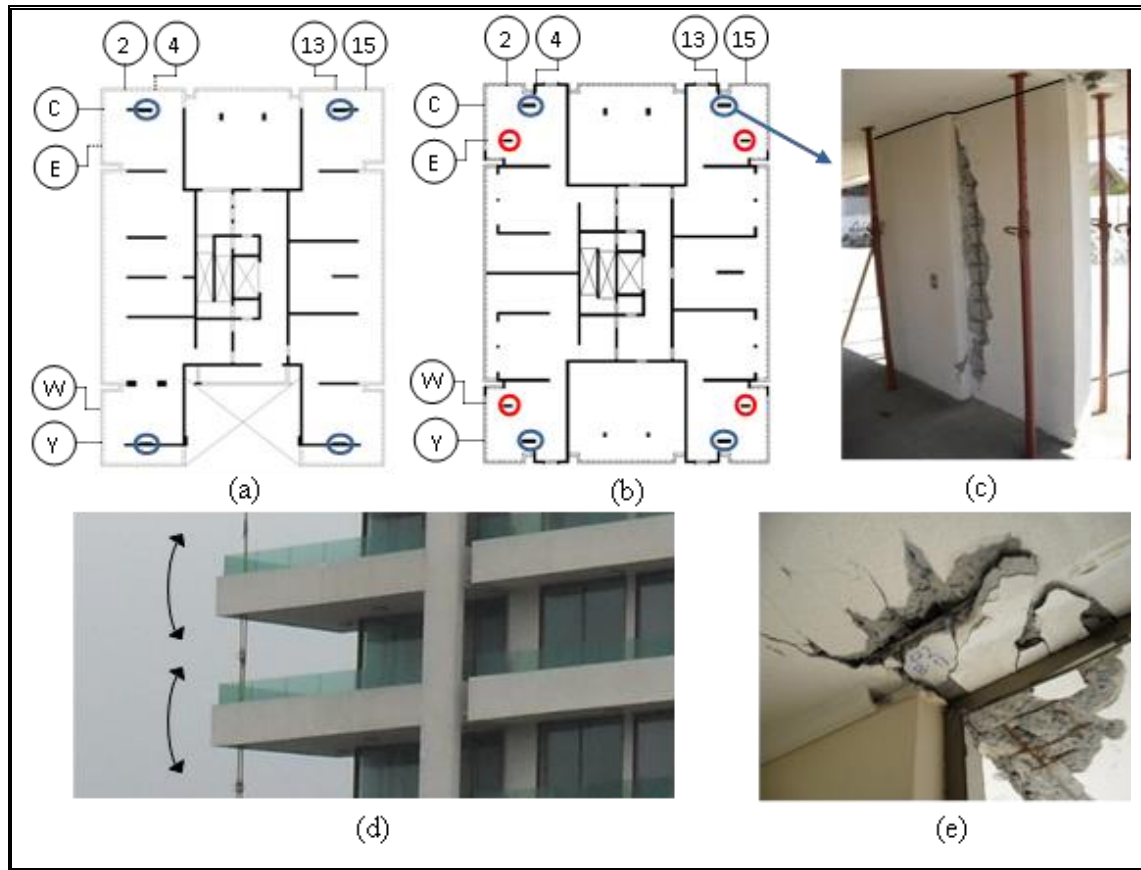
Configuration issues in building AH-2 also caused unseen damage patterns. Firstly, shear failure in walls with variable thickness was observed. Shown in Figures 10-7a and 10-7b are structural drawings of stories 1 and 2, and highlighted in blue is a wall of thickness 30cm that in lower stories has at its edges walls of thickness 20cm. As shown in Figure 10-7c there is almost a perfect shear failure between the two walls of different thickness, mainly due to their relative displacement. Secondly, inspection of higher stories showed that there was slab damage at the four edges of the building, with wall punching and notorious permanent slab deformations. Apart from having the corners of the building a considerable slab area in cantilever, walls marked in red go from stories 2 through 15 and do not reach story 1 (Figure 10-7b). Slabs flapped up and down freely with the help of these discontinuous elements, punching walls nearby and leaving permanent deformation at all stories above 2. Although this damage due to the configuration is localized and completely avoidable, reparation costs are high and the building will probably be demolished, at least in part, because of the settlement of floors.

Figure 10-7: Building AH-2. (a) Story 1 of AH-2, (b) story 2 of AH-2, (c) shear damage in first story wall, (d) slab movement and (e) punching of walls through slabs

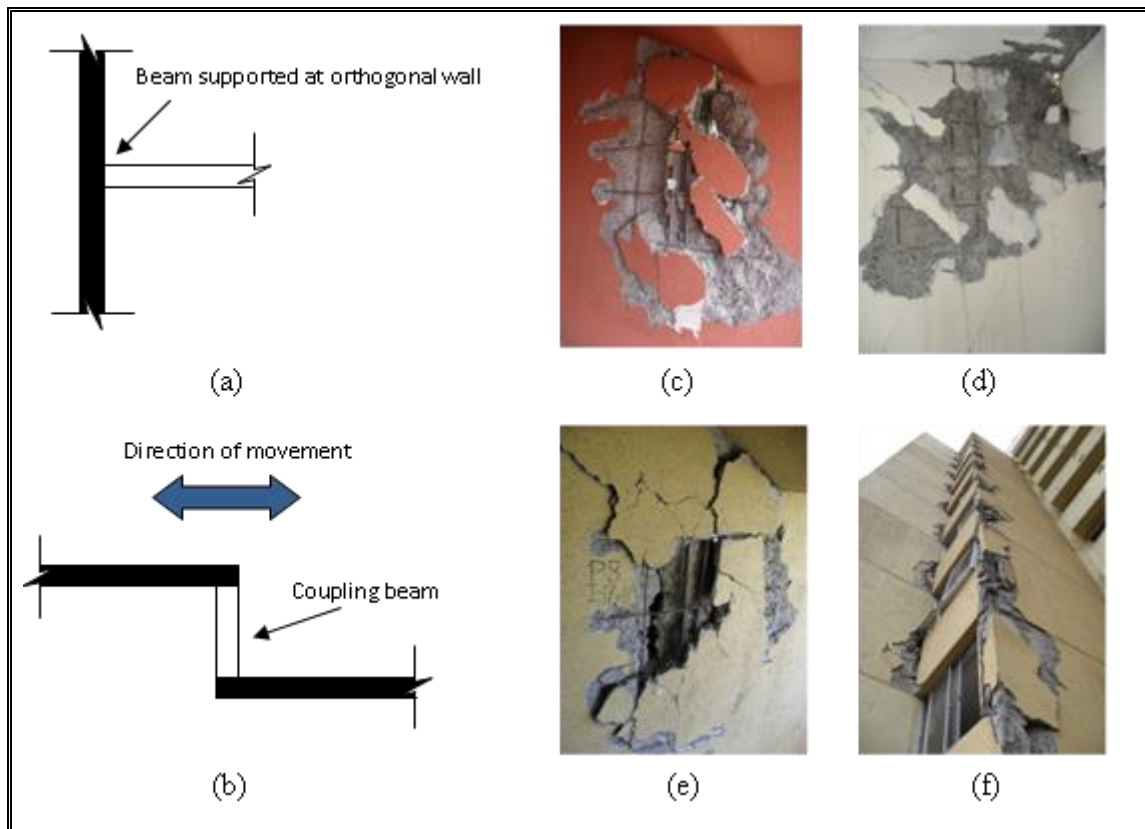
In several buildings, damage due to the configuration issues and support of beams was also observed. Because beams carry sometimes considerable gravitational load, this effect may compromise the stability of the structure. One remarkable example is beams supported by orthogonal walls. Cyclic motion in these buildings made beams to pull out and punch the walls as shown in Figure 10-8. Another case is perimeter spandrel beams coupled with transverse shear walls. Damage in this case occurred due to the direction of motion, mainly at buildings PP-7 and RT-8 (Figure 10-8f). It is clear that modeling of these deep beams as frame elements in a structural model would not capture the real state of stress in the connection.

Figure 10-8: (a) Beams supported at orthogonal walls and (b) beams coupled with transverse shear walls. Beam punching at (c) RT-8, (d) TO-9, (e) PP-7. (f) Damage in coupling beams of PP-7

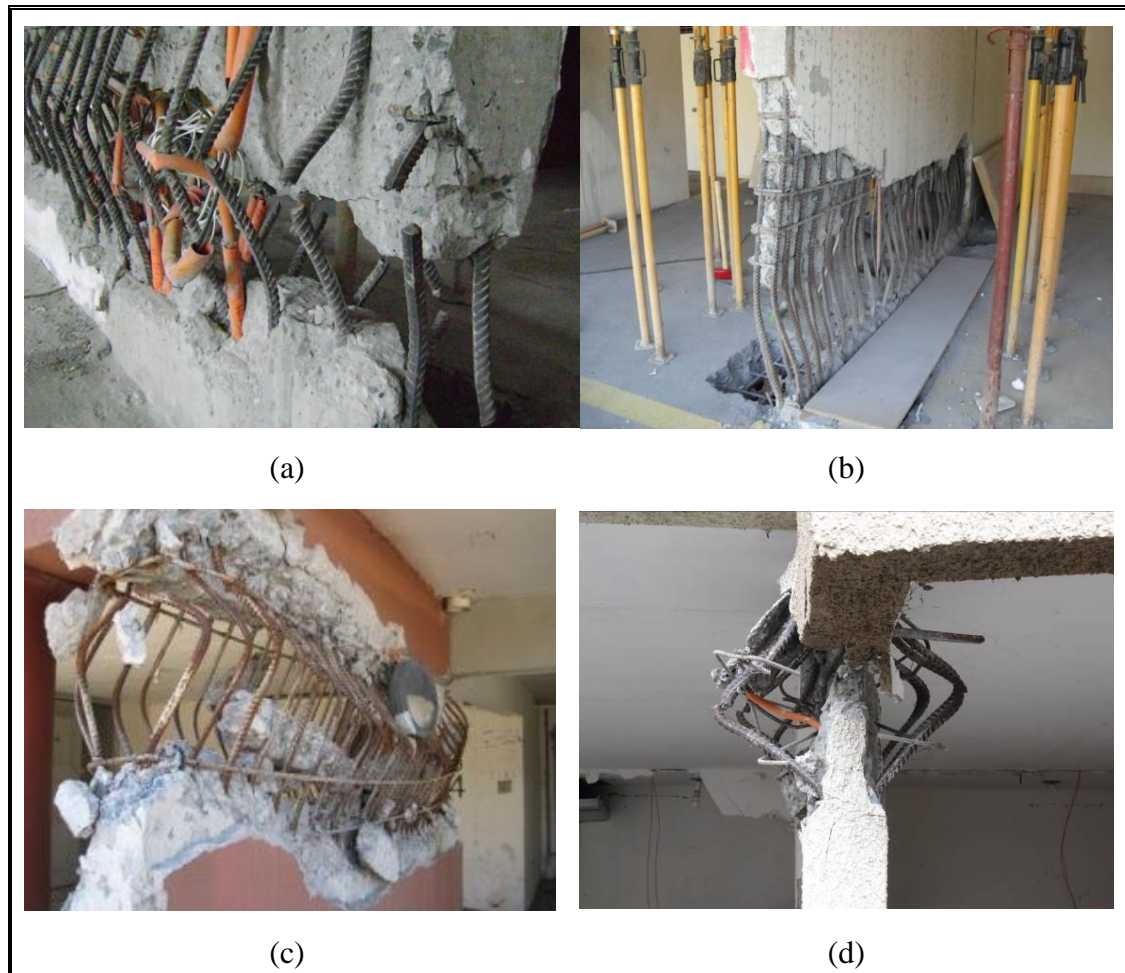
As bending occurs, the boundaries of the wall are subjected to very high axial stresses due to the combination of axial and flexural demand. Small areas of the walls were partially confined—and most of times not confined because the Chilean seismic code (NCh 433Of.96, 1996) excluded the ACI confinement requirements. Thus, at boundaries cover concrete spalls-off and longitudinal boundary reinforcement buckles due to the large stirrup spacing and poor detailing. Consequently, the wall loses considerable flexural capacity while keeping the axial load. As the wall cycles, it is the web reinforcement the one that pretends to carry the bending moment, but the demand exceeds the bending capacity of the wall, the wall lateral cover spalls-of, the web reinforcement yields and fractures, and the wall cuts in the tension part of becomes unstable in compression. There is evidence also that this occurs in a brittle manner, which is consistent with the high axial loads, and that the “unzipping” crack quickly propagates throughout the length of the wall. Due to the localized nature of the failure, the building is not capable to develop large ductility or energy dissipation making the assumption of the R-factor used in design unwarranted. Naturally, if the wall has a large flange in compression as a result of a perpendicular longitudinal wall, no damage occurs at that side, which also demonstrates that compression stresses played an important role in the failure pattern. Shown in Figures 10-9a through 10-9d are examples of “unzipping” wall damage for the buildings considered.

Figure 10-9: Typical thin wall failure. Buildings (a), (b): AH-2, (c) CM-3 and (d) PR-6.

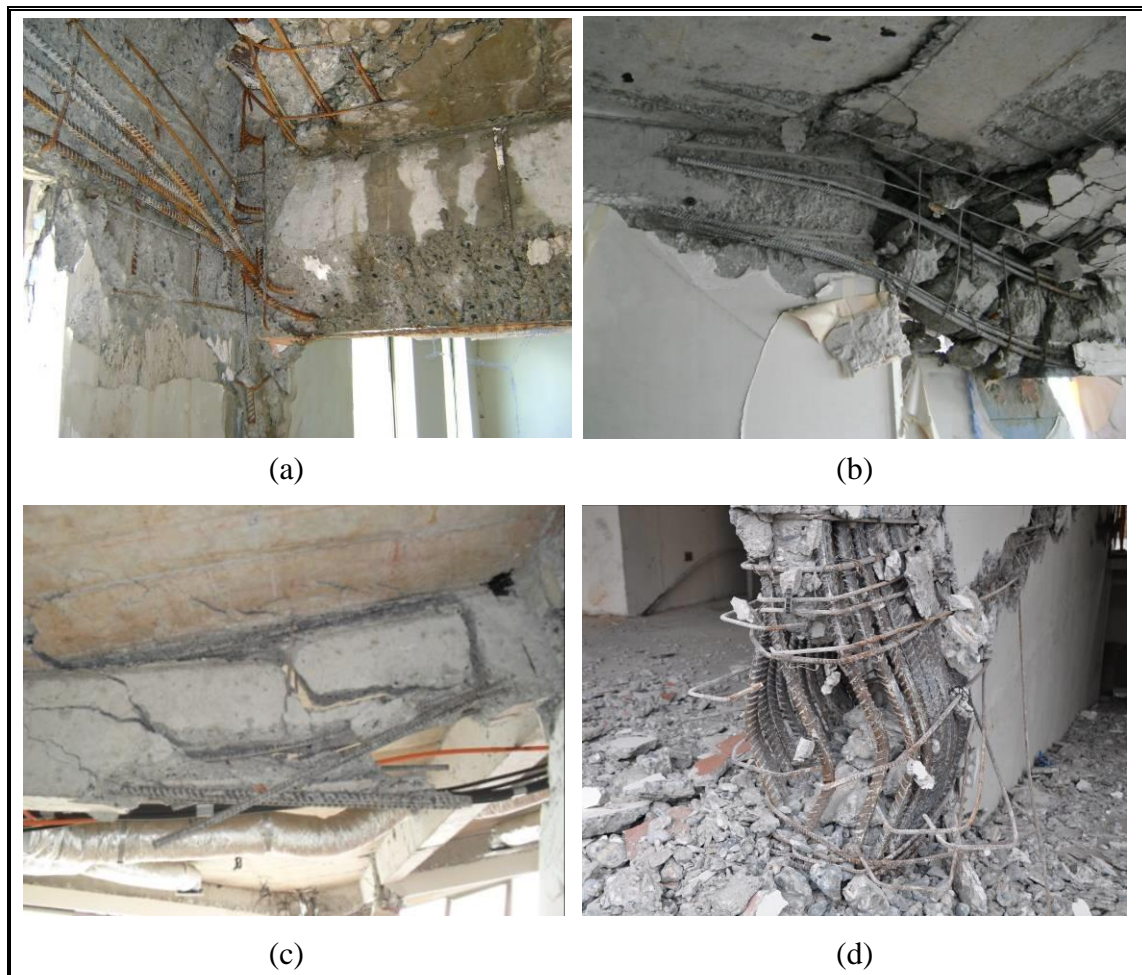
The typical detailing in boundaries of walls considers the mesh with legs bent in 90° but without hooks around the longitudinal bars. This confinement proved to be highly insufficient; other examples of poor detailing and construction are shown in Figure 10-10.

Figure 10-10: (a) Inadequate anchorage of beam-wall connection, (b) reinforcement outside of the confined area, (c) unconfined longitudinal reinforcement and lack of stirrups, (d) typical observed hooks.

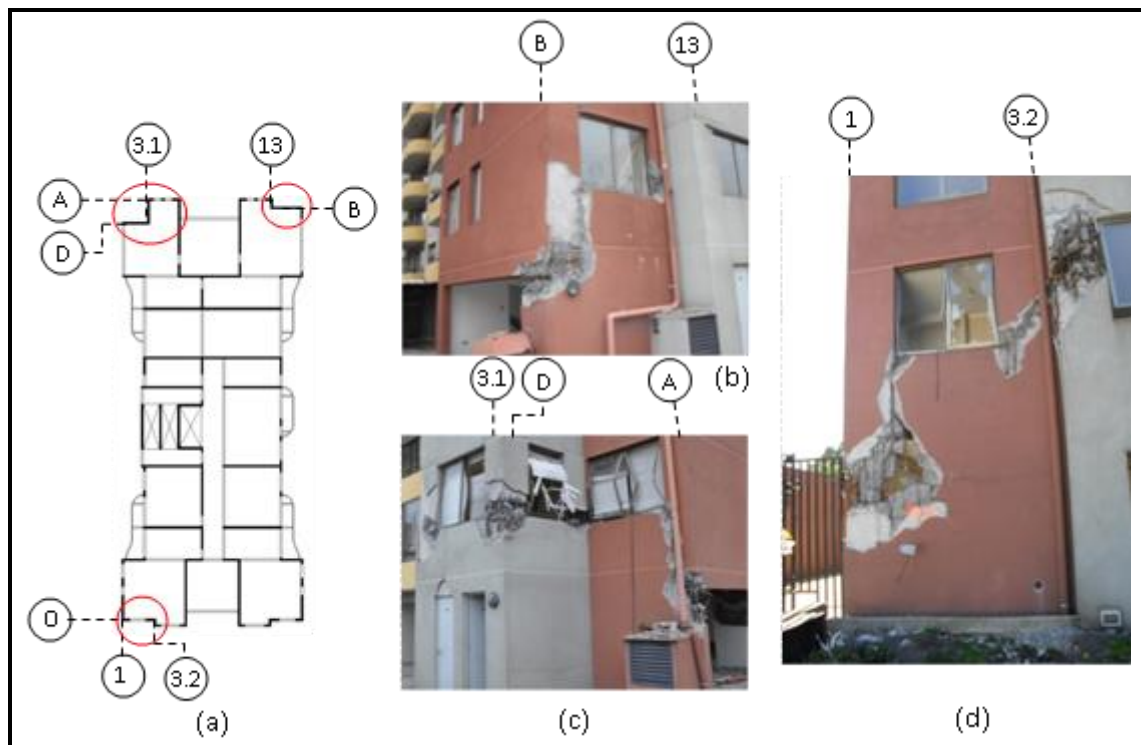
In some cases, building damage involved more than one story. This is somewhat difficult to capture in design because structural models treat building elements as units in each story. However, it is evident that fracture will occur in the simplest and least demanding way to the structure. We have denoted this phenomenon as multistory damage. Shown in Figure 10-11 is the case of CM-3 where three of the four corners of the building experienced this behavior. Buildings should be analyzed and designed as 3D systems, considering all possible failure mechanisms crossing stories and connecting weak elements in neighbor stories.

Figure 10-11: Multistory damage at CM-3. (a) Structural plan of story 2, (b) N-E corner, (c) N-W corner and (d) S-W corner.

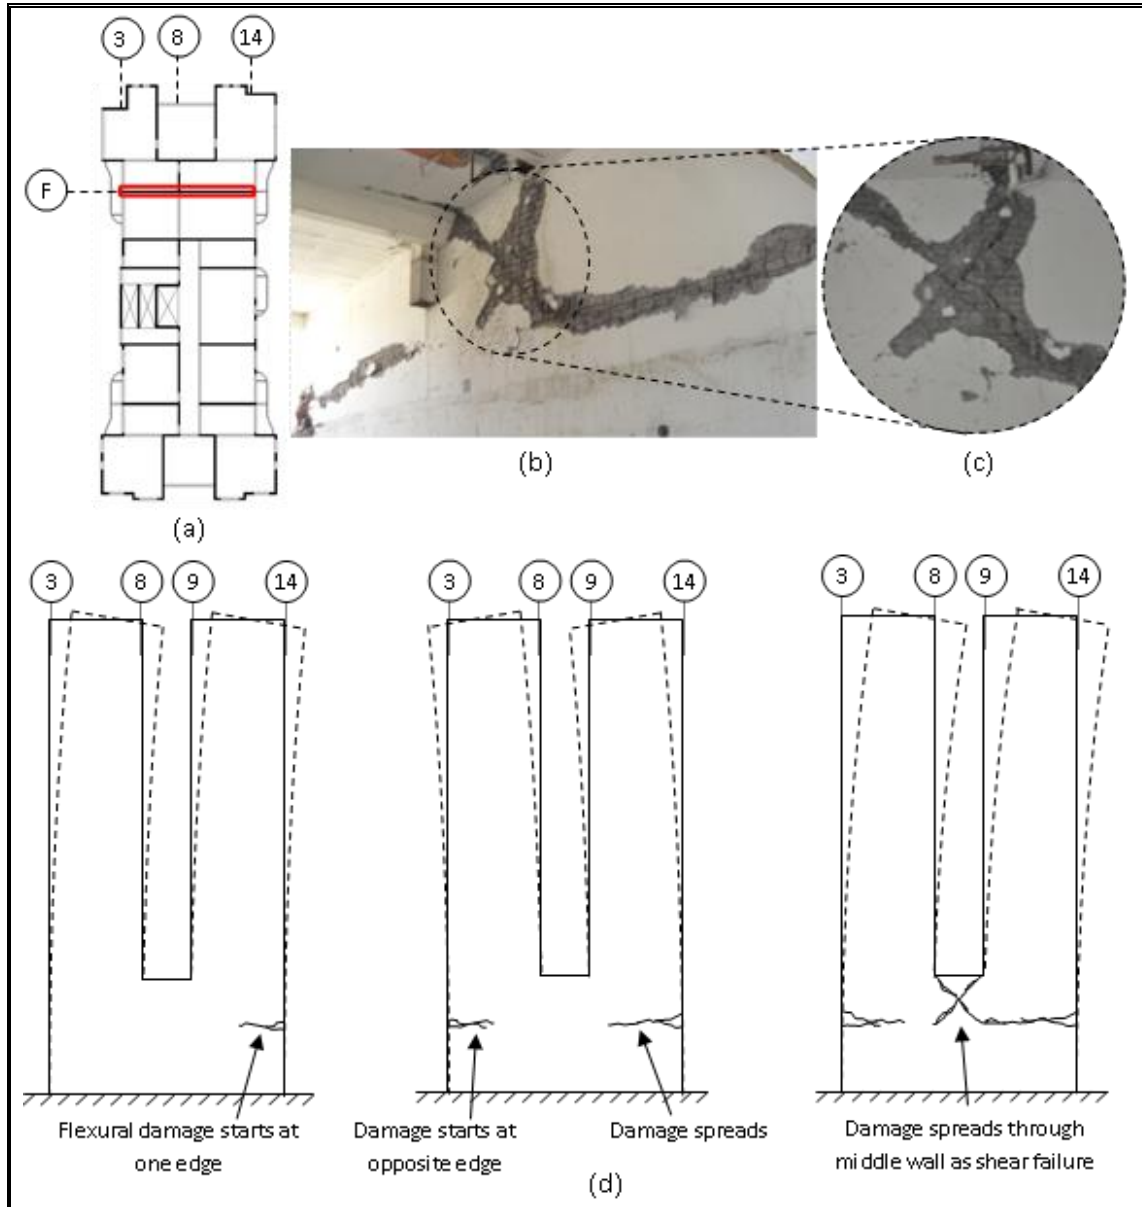
Moreover, damage propagated not only between stories, but also along elements of the same story. An example is shown in Figure 10-12, where flexural damage at the external walls caused shear damage in the central portion of the wall of building CM-3. Figure 10-12d shows the flexural damage at one of these edges.

Figure 10-12: (a) Location of walls in plan CM-3, (b) observed damage, (c) shear failure at central wall and (d) induced damage in elevation F.

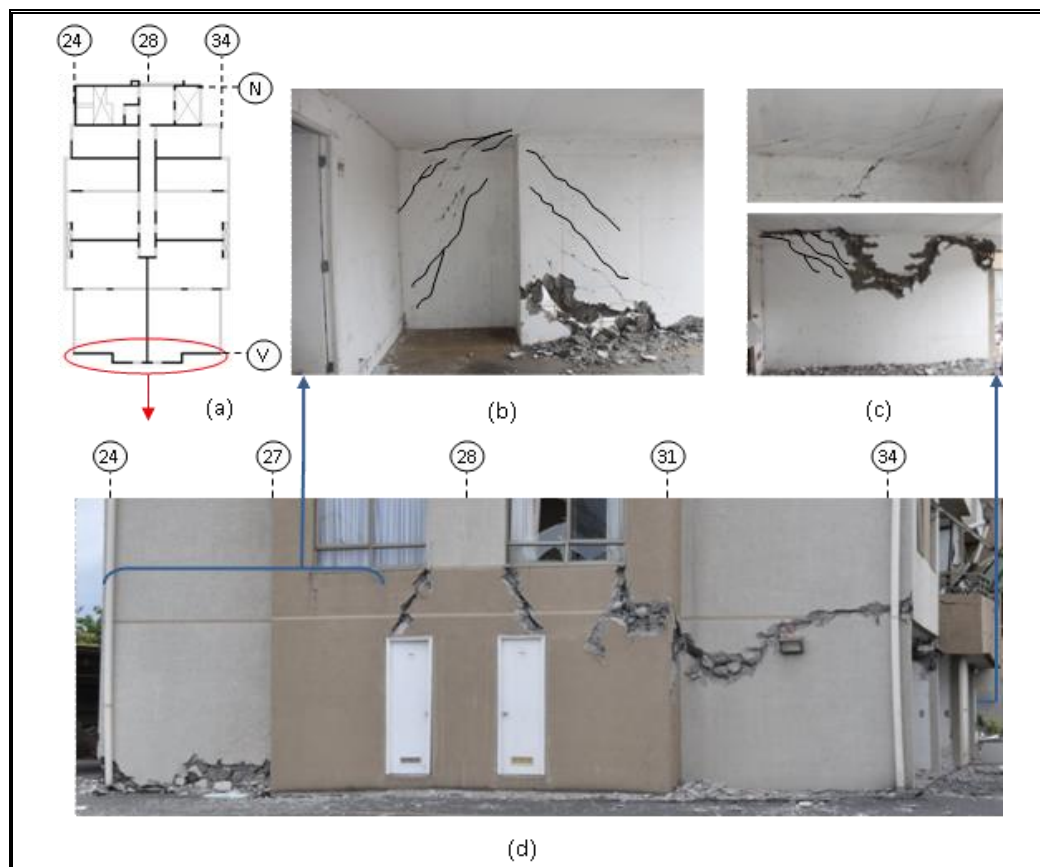
Figure 10-13: Building PR-6. (a) Structural plan of 1st story, (b) shear damage propagation through the slab, (c) zoom of damaged slab and superimposed flexural and shear stress cracking. (d) Multistory damage.

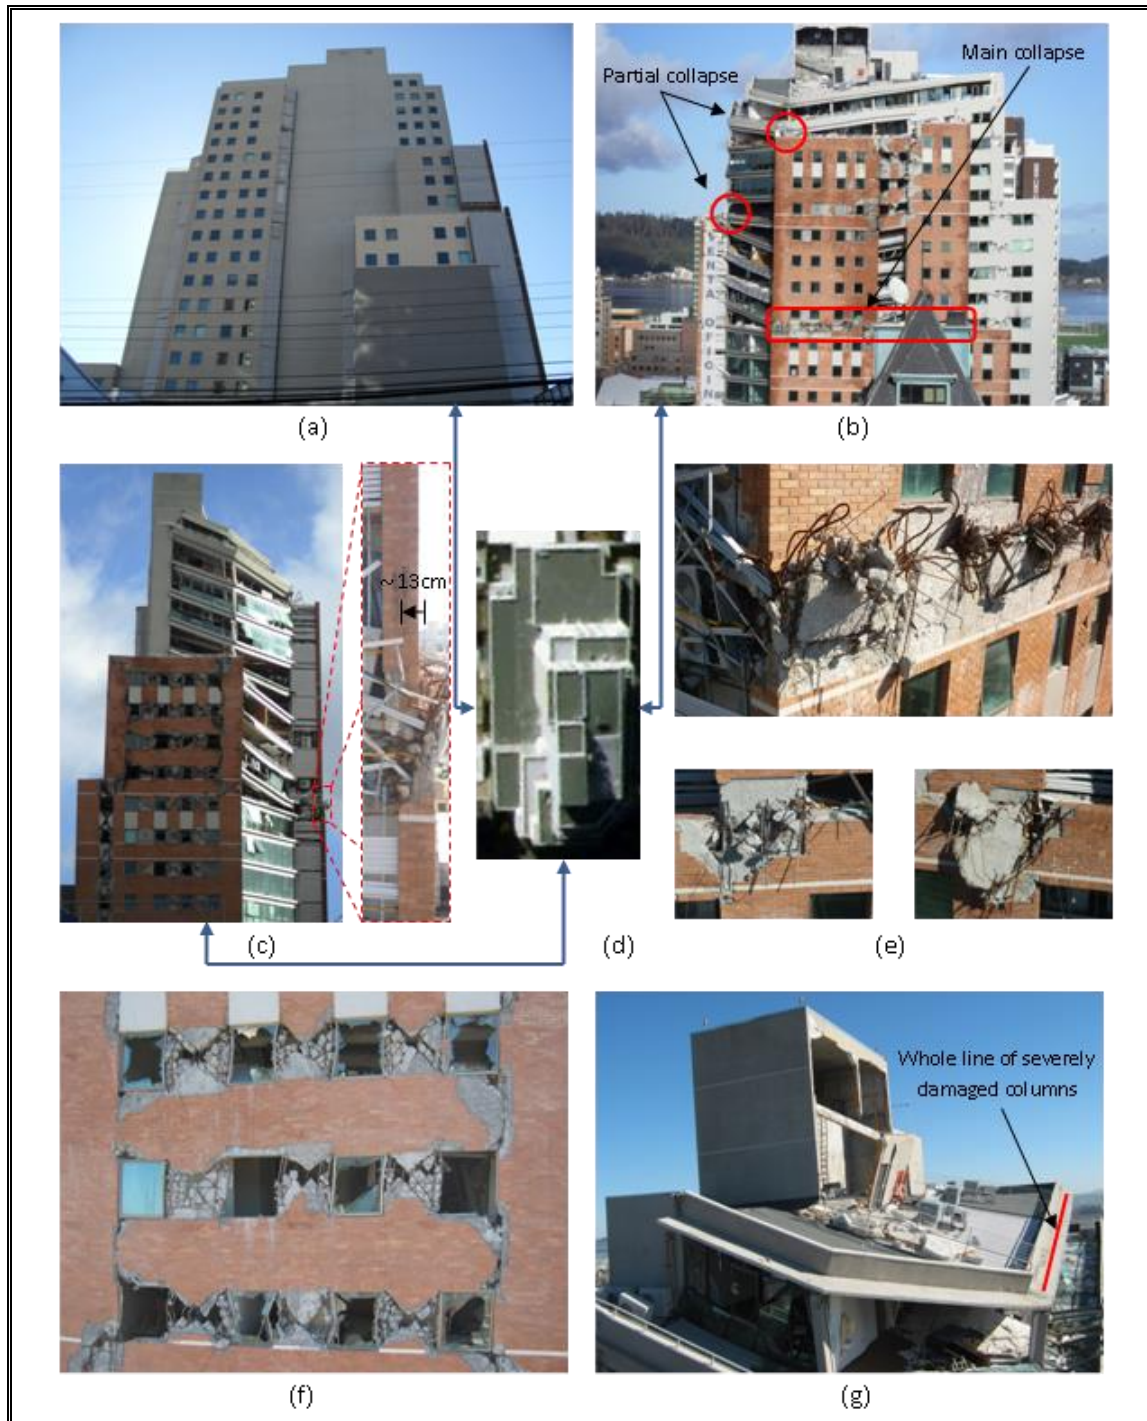
Figure 11-1: Building TO-9. (a) West view, (b) East view, (c) South view and deformed axis J, (d) top view, (e) main collapse at story 12, (f) short column damage along axis 1A and (g) condition of 21st story.
