PART I: RESPONSE OF REINFORCED CONCRETE BUILDINGS IN CONCEPCION DURING THE MAULE EARTHQUAKE

Thesis submitted to the Office of Research and Graduate Studies in partial fulfillment of the requirements for the Degree of Master of Science in Engineering

Santiago de Chile, (December, 2011)

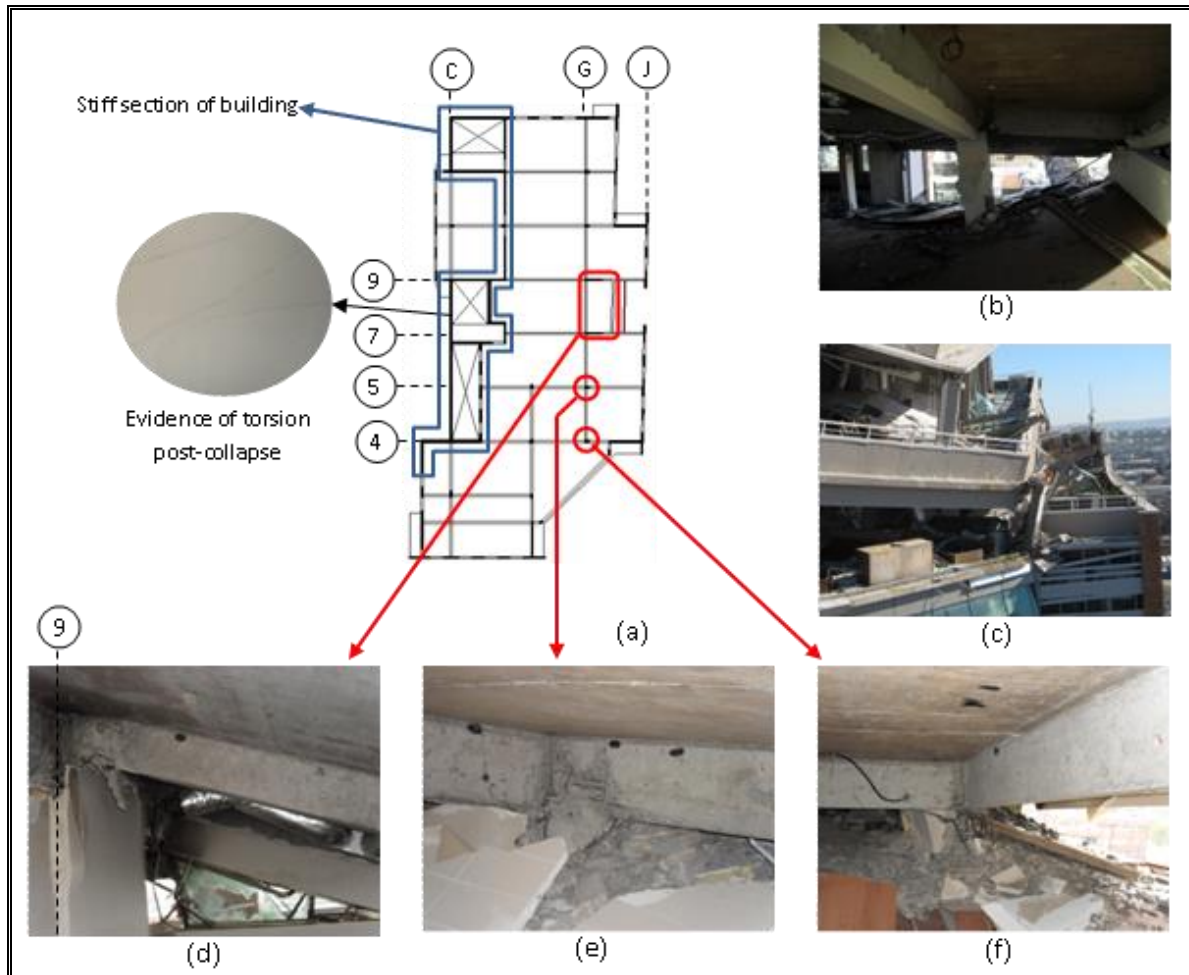
Figure 11-2: Building TO-9. (a) Structural plan of 12th story, (b) partial collapse of the 16th story, (c) partial collapse of the 20th story, (d) beams at 12th story, (e) column in axes G-5 of 12th story and (f) column in axes G-4.

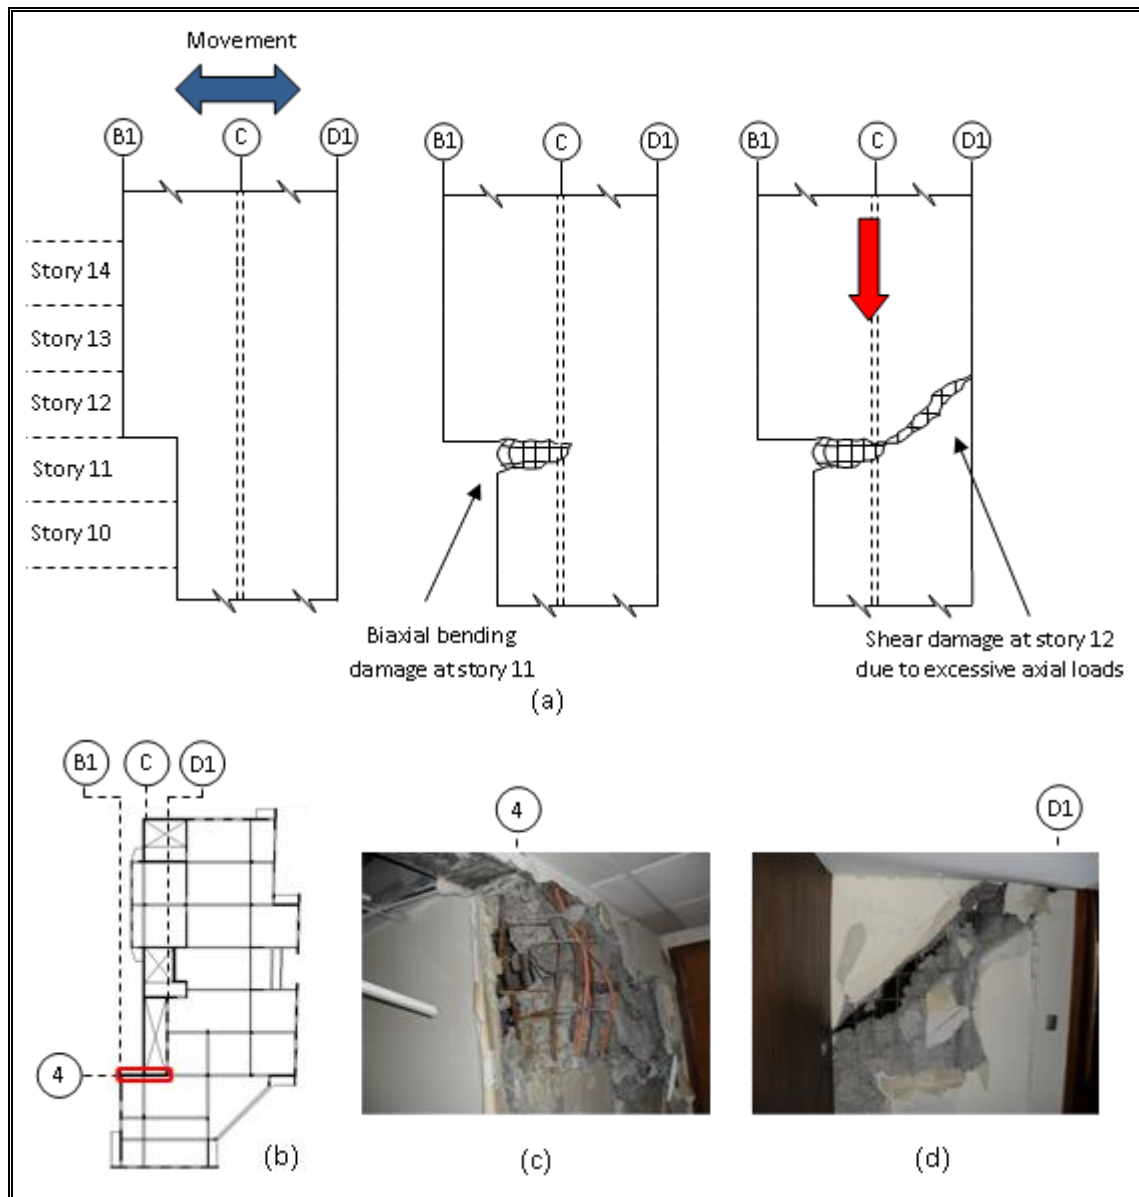
Figure 11-4: Important damage at core. (a) Explanation of observed behavior, (b) location of wall in story 12, (c) flexure-axial damage in story 11, (d) shear induced damage in story 12.
