PONTIFICIA UNIVERSIDAD CATOLICA DE CHILE

INFLUENCE OF AXIAL LOAD IN THE SEISMIC BEHAVIOR OF REINFORCED CONCRETE WALLS WITH NONSEISMIC DETAILING

Thesis submitted to the Office of Research and Graduate Studies in partial fulfillment of the requirements for the Degree of Master of Science in Engineering

Santiago de Chile, (August, 2013)

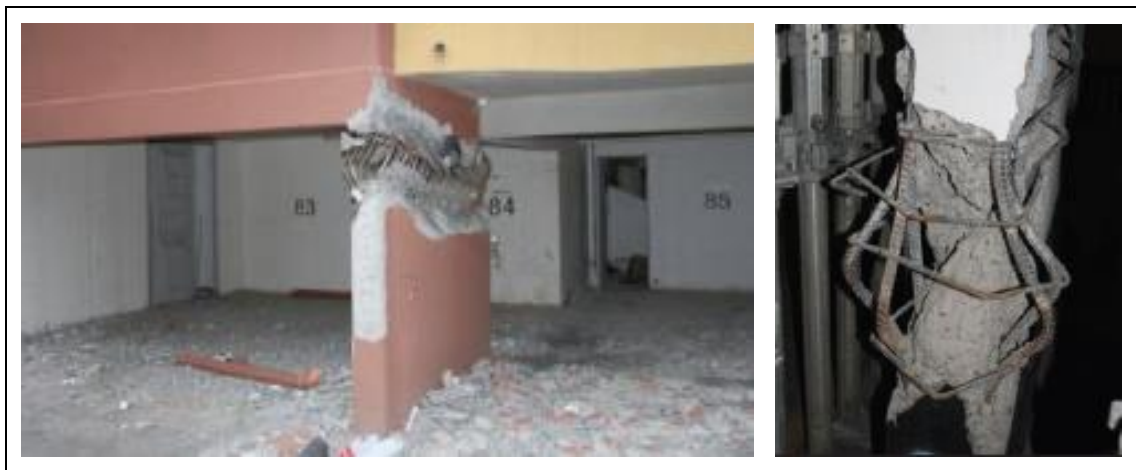
Figure 1.1. Flexural-compressive failure in damaged Chilean walls

new structures constructed after year 2000 and that high axial load was a relevant factor that may have triggered the observed damage. According to Zhang and Wang (2000), and Su and Wong (2007), high axial loads reduce the wall ductility significantly. However, these conclusions were obtained by testing RC walls with transverse boundary reinforcement, which provides concrete confinement and which was not required by Chilean design codes. During a compressive failure of a well confined RC wall, the axial strength is not reduced after cover concrete spalling; the concrete core becomes stronger due to confinement, and the plasticity is distributed along the wall height. However, if confinement is poor, damage concentrates in a reduced region of the wall causing a brittle flexural-compressive failure which is induced by crushing of concrete and buckling of vertical reinforcement bars, as was observed in some walls of damaged Chilean buildings (Figure 1.1).

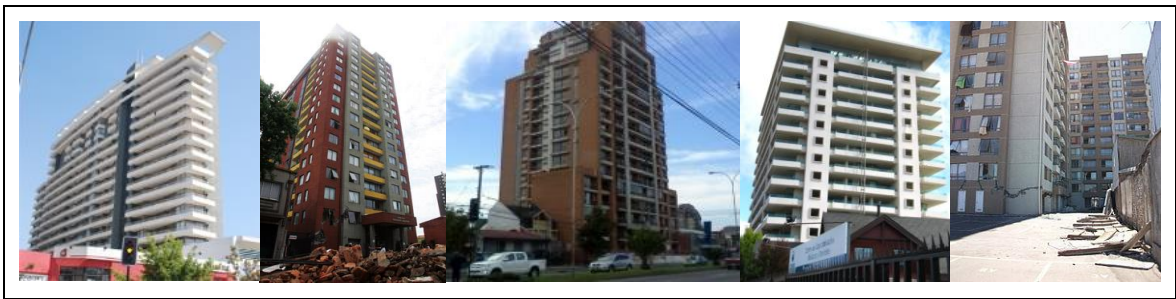
Figure 3.1. Damaged buildings surveyed

Five damaged buildings (Figure 3.1) were considered in this survey in order to study the relevant characteristics of their RC walls. Four of these buildings are located in Concepción (CM, AH, PR and AA) and one in Santiago (EM). All these buildings can be considered high-rise buildings because they have between 12 and 20 stories (Table 3.1). The specified concrete strength is $f'_c = 20$ MPa for PR and EM buildings and $f'_c = 25$ MPa for CM, AH and AA buildings. The characteristics of the buildings located in Concepción were obtained from the survey performed by Westenenk et al. (2012).

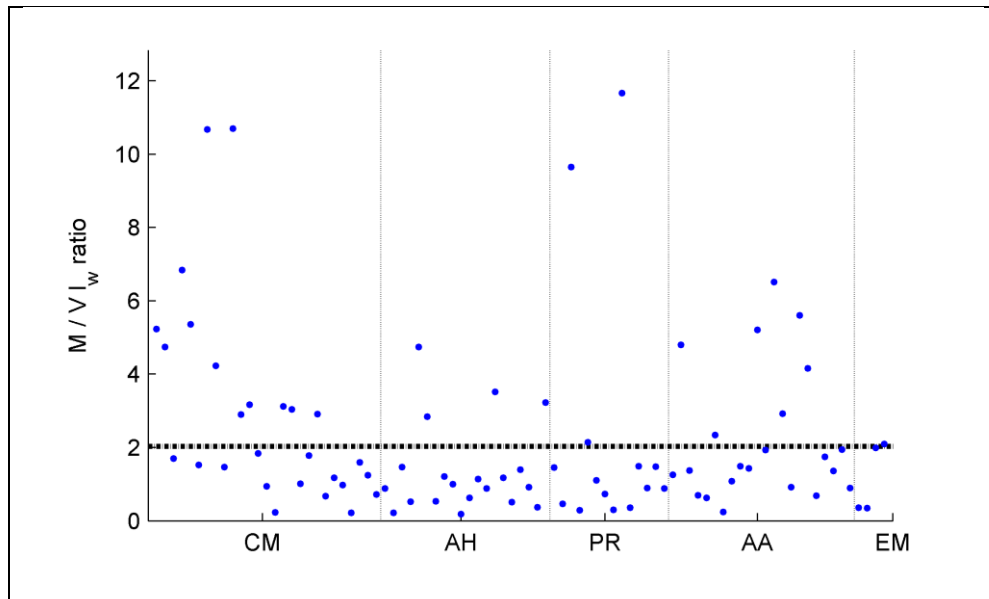
Figure 3.3. M/Vl_w ratio of walls of damaged buildings

The vertical loads and the M/Vl_w ratios were obtained from finite element models of the buildings using ETABS software (Computers & Structures, 2011) and following the Chilean Code NCh433 (INN, 2009). The finite element models were constructed by Westenenk et al. (2012). The M/Vl_w ratio is an important property for the behavior of walls, where M is the moment at the base of the wall, V the shear load and l_w the length of the wall. If this ratio is small the wall is considered squat and probably will exhibit a shear mode of failure (Hidalgo et al., 2002). This ratio was calculated at the base of the walls using the finite element models. The seismic load following the NCh433 (INN, 2009) was considered for the calculation of M and V . The wall length (l_w) was obtained from the structural drawings of the buildings. The average of the mean M/Vl_w ratios of the selected walls of damaged buildings is 2.02, which means that these walls are not squat, and hence, flexural behavior is relevant. The M/Vl_w ratios of walls from the damaged buildings and the average ratio are shown in Figure 3.3.

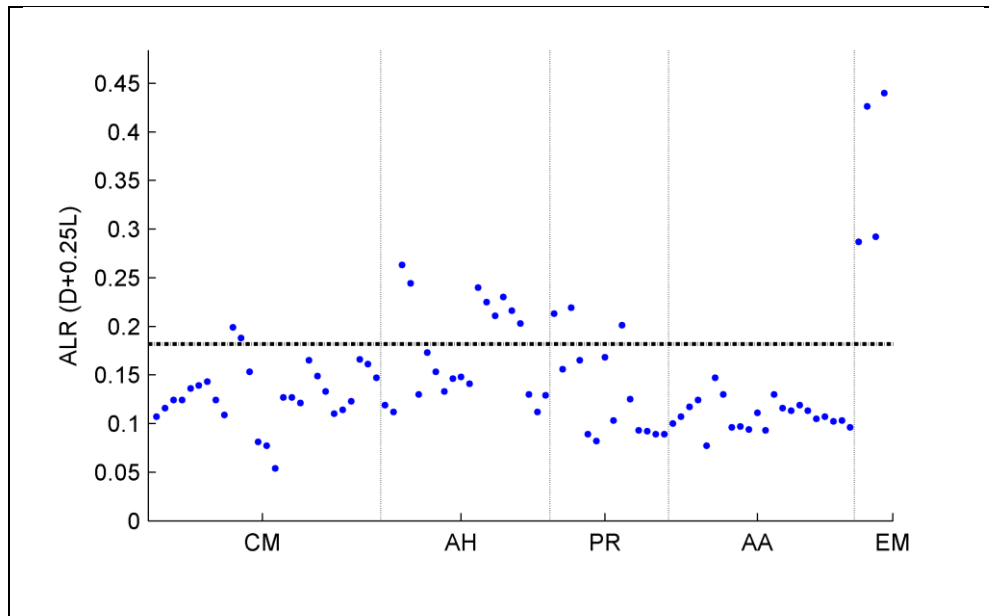
Figure 3.4. Axial load ratio due to gravity loads in walls of damaged buildings

The ALRs of the surveyed walls of the damaged buildings for gravitational load considering dead load and 25% of live load ($D+0.25L$) are shown in Figure 3.4. The average of the mean ALRs of walls of the five damaged buildings is 0.18. The ratios are distributed mostly between 0.1 and 0.25 in CM, AH and PR buildings. The average ALR of the walls is 0.13, 0.17, 0.13, 0.11, and 0.36, for buildings CM, AH, PR, AA, and EM, respectively.

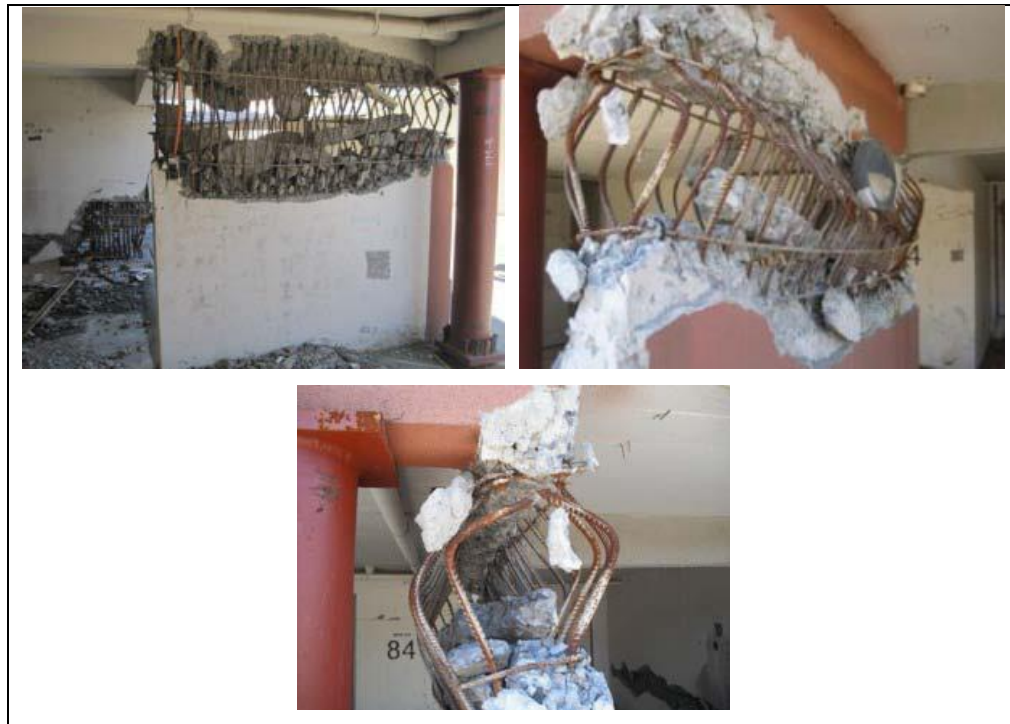
Figure 3.6. Observed failure in selected wall

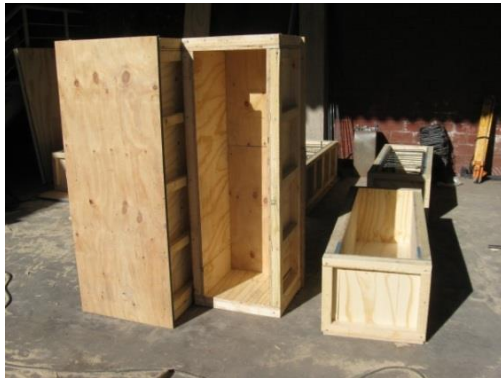
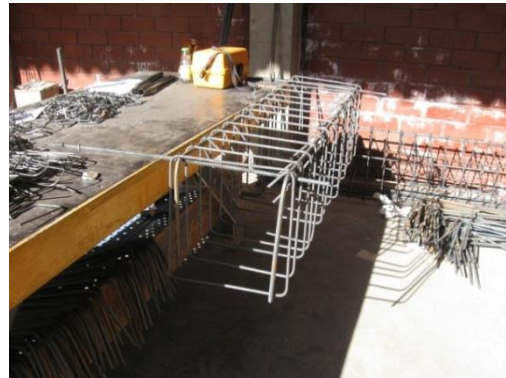
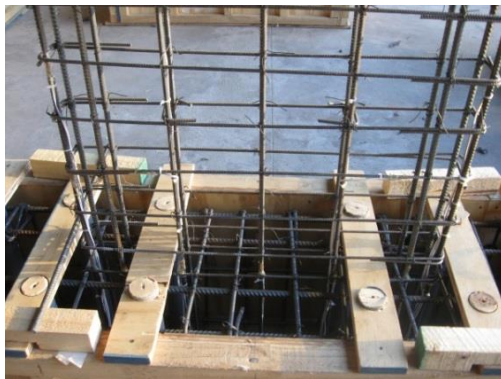
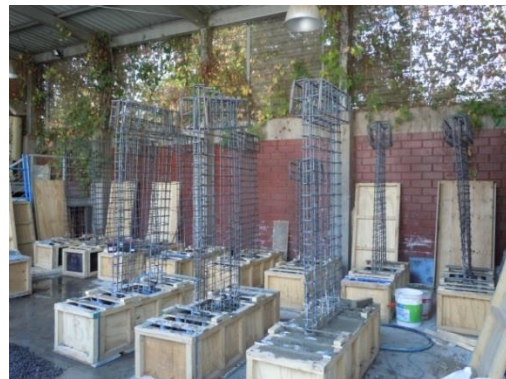
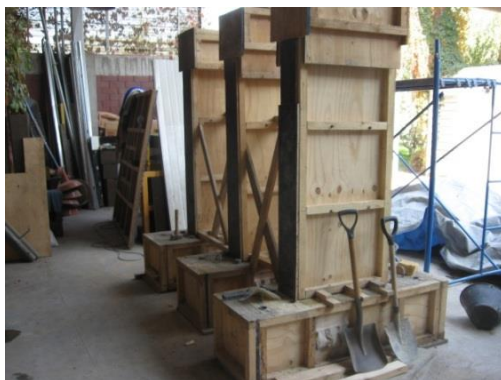
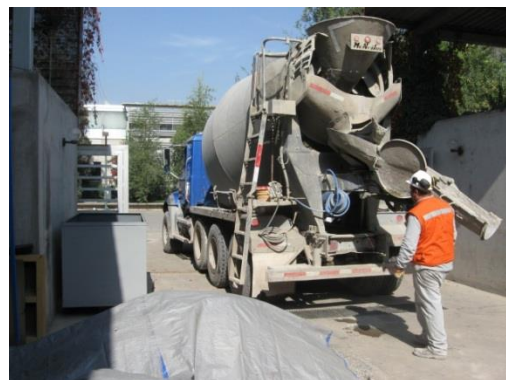
(a) Wooden formwork

(b) Folding of base reinforcement

(c) Reinforcement of walls

(d) Reinforcement of walls and beams

(e) Wooden formwork assembled

Figure 4.3. Wall specimen construction process

A total of 11 wall specimens were built in the laboratory of the Structural and Geotechnical Engineering Department at Pontificia Universidad Católica de Chile. Three of these walls are part of this thesis which is aimed to study the effect of axial load and their design was described in Section 4.1. The other eight walls are not part of this thesis and were built to study the effect of other parameters such as wall thickness, M/Vl_w ratio and reinforcement detailing. Pictures of the construction process are shown in Figure 4.3. The wall specimens were built with wooden formwork and the steel bars were bent at the construction site. The concrete of the bottom bases was cast at the construction site using a mixer. Eight days later, the concrete of the walls and top bases was cast using pre-mixed concrete. The specimens were cured with plastic for 7 days at both stages and the finished walls are shown in Figure 4.4.

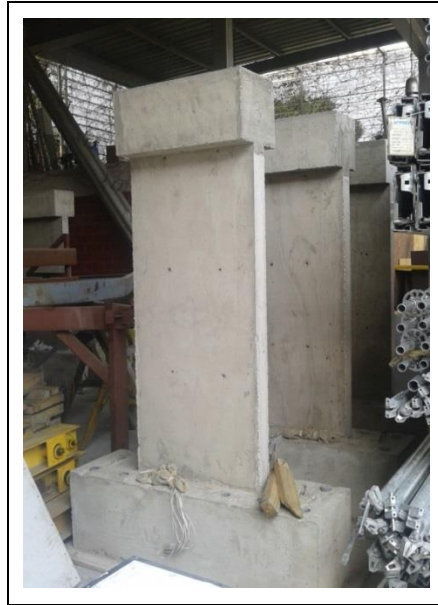
Figure 4.4. Wall specimens W1, W2 and W3

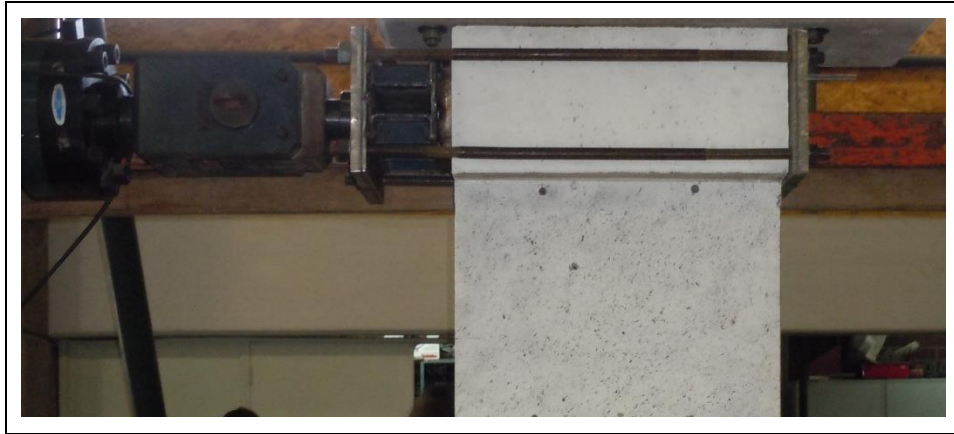
Figure 4.8. Horizontal actuator attached to the top beam

horizontal 500kN actuator was pinned at its two sides and was attached to the top RC beam with 4 steel bars that were bolted against 400 x 300 x 30 mm steel plates at each side of the specimen. This connection (Figure 4.8) could transfer the lateral load reversals. At the other end, the horizontal actuator was supported by a steel IN beam which was bolted to the steel frame. As the horizontal load was applied at the center of the top beam, the effective height of the wall specimen is 175 cm. A 50 kN concrete counterweight was connected to the clevis of the horizontal actuator at the specimen side using two pulleys. This counterweight was used to hang the actuator and eliminate the vertical reaction induced by the actuator weight in the specimen. The vertical 700 kN actuator was bolted to the steel frame and connected to the specimen using rollers to allow horizontal displacement of the top beam (Figure 4.9). Therefore, the P-delta effect was included in the test setup. The out-of-plane displacement of the wall specimens was restrained with rolling supports that were connected to a steel I beam at each side of the top beam (Figure 4.5).

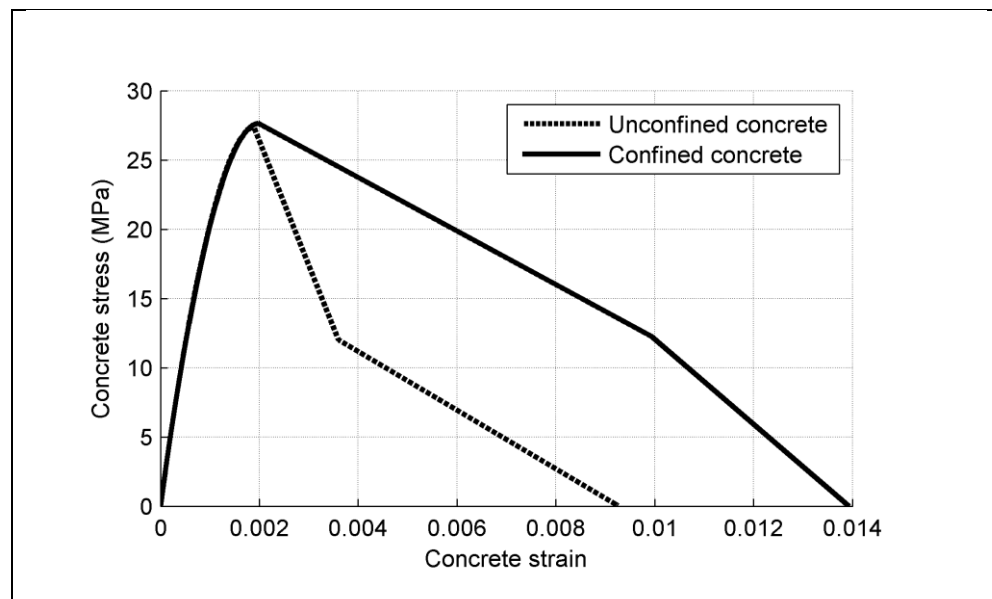
Figure 5.2. Concrete stress-strain relationships following Karthik and Mander (2011) model

The Karthik and Mander (2011) stress-strain model is considered for the behavior of confined and unconfined concrete. The compressive concrete strength considered in this model is $f'_c = 27.4$ MPa (section 4.3). As discussed in previous chapters, the wall specimens were designed with similar properties than walls from damaged Chilean buildings, hence the confinement is low. The confined concrete area of the wall section at the stirrups level is shaded in Figure 5.1 and at midway between stirrups the effective confined concrete area is only 3.3% of the concrete core (Mander et al., 1988). Based of the amount of horizontal reinforcement, the confinement ratio of this section is $K = f'_{cc}/f'_c = 1.01$, where f'_{cc} is the compressive concrete strength of the confined core. Table 5.1 shows the properties for unconfined and confined concrete and their constitutive models are shown in Figure 5.2, where the tensile strength of concrete is neglected.

Parameter	Unconfined Concrete	Confined Concrete (K=1.07)
Peak Stress (MPa)	27.4	27.6
Peak Strain	0.0019	0.0020
Ultimate Stress (MPa)	12	12.3
Ultimate Strain	0.0036	0.010
Failure Strain	0.0093	0.014
Concrete Modulus (MPa)	26154	26154

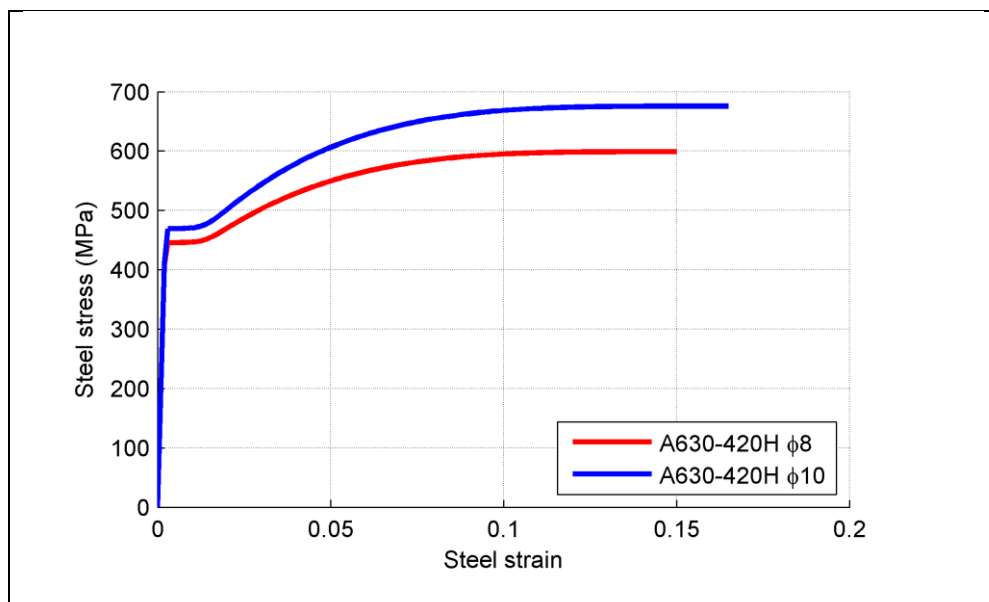
Figure 5.3. Steel stress-strain relationships following Karthik and Mander (2011) model

The realistic stress-strain model proposed by Karthik and Mander (2011) for reinforcing steel (Figure 5.3) was adopted using the average measured properties (Table 4.2). The modulus of elasticity was not measured in the test and $E = 200,005 \text{ MPa}$ is assumed. Thus, the yield strain for the $\phi 10$ bar, which is the most relevant as it is located near the wall edge, is 0.0023.

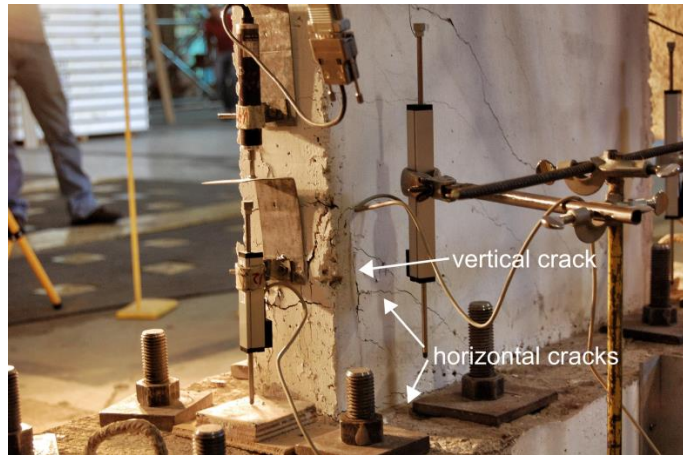
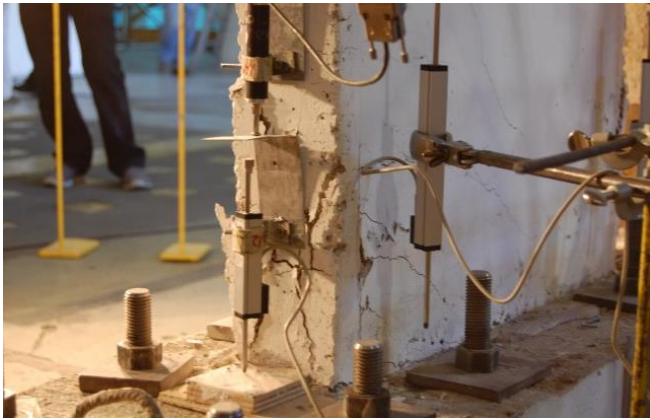
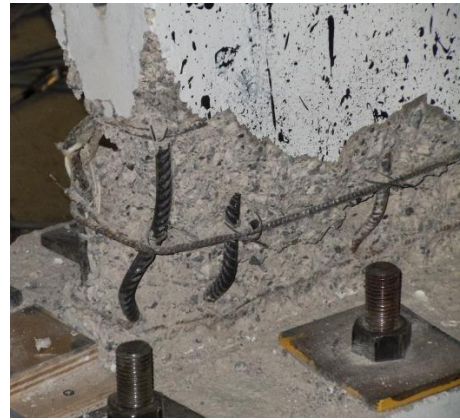
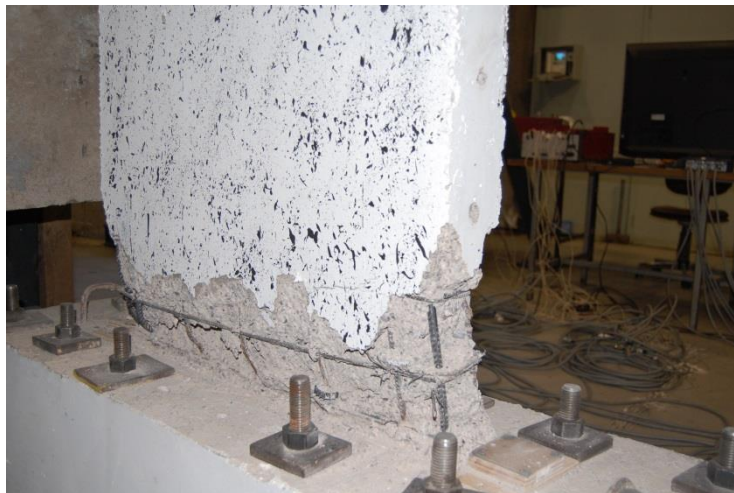
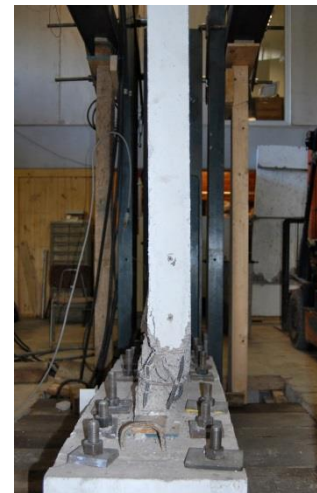
(a) First crack

(b) Cracking development at $\delta=24.2$ mm (1.4% drift)

(c) Cracking development at $\delta=31.3$ mm (1.8% drift)

(d) Reinforcement buckling

(e) Concrete crushing failure

(f) Out-of-plane buckling

Figure 6.2. Specimen W2 observed behavior

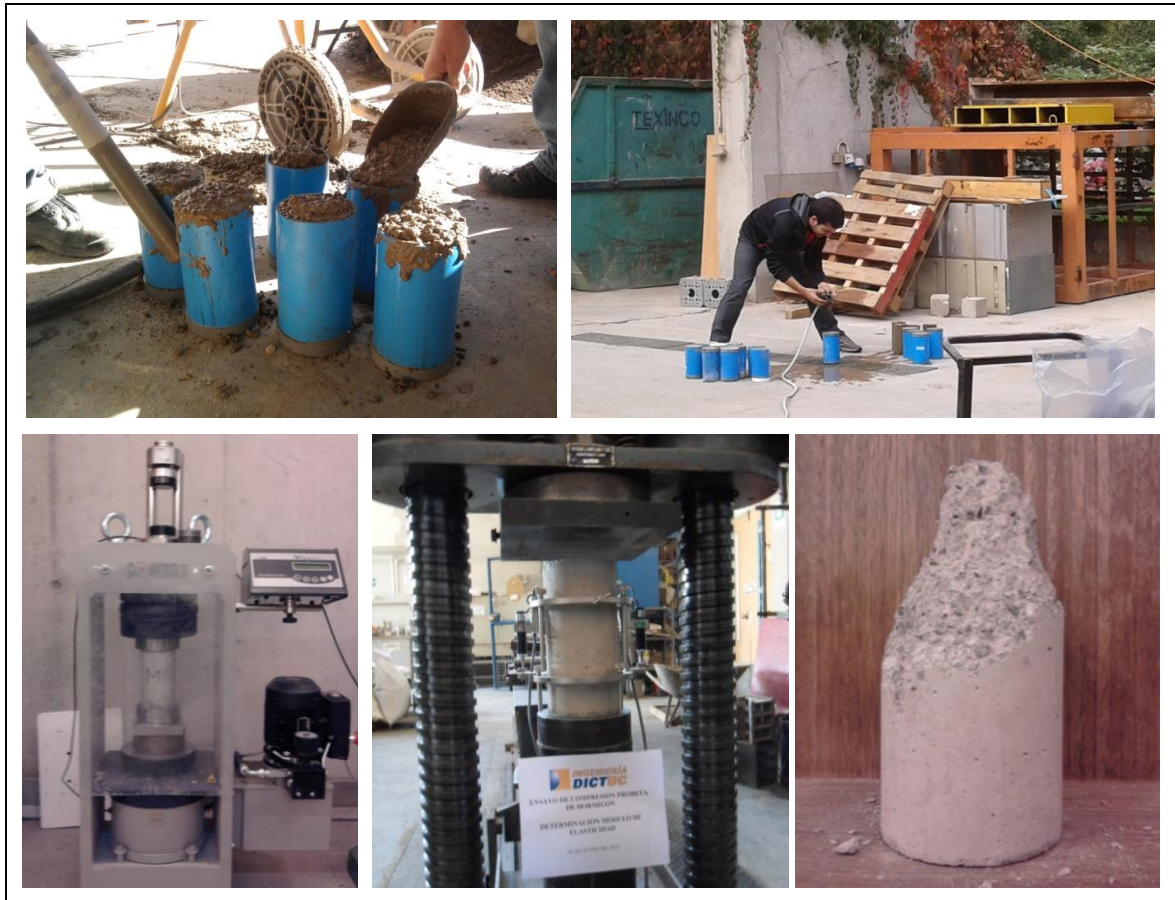
Figure A.1. Concrete samples and compressive test

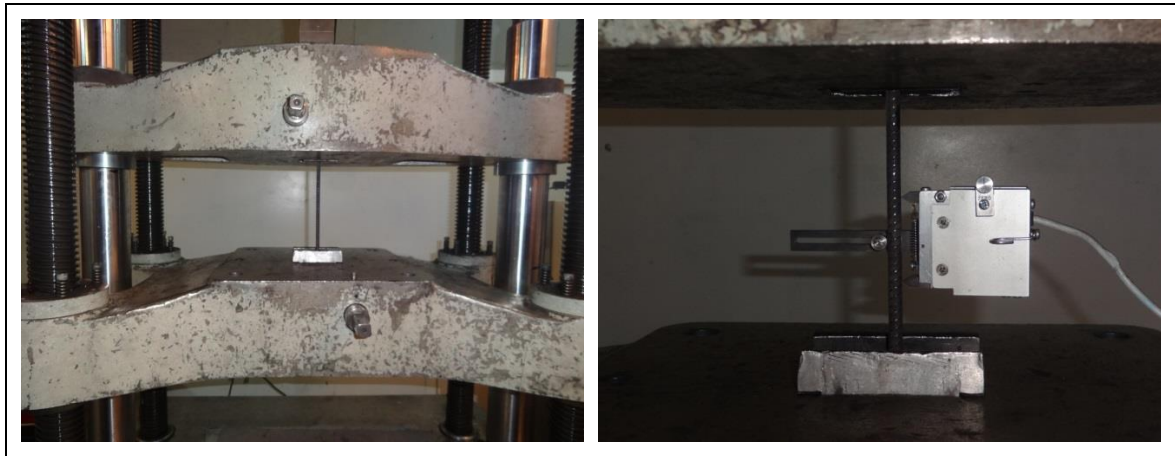
Figure A.2 Test setup for steel bars
