# **SEISMIC FRAGILITY ASSESSMENT OF UNREINFORCED MASONRY CHURCHES OF CENTRAL CHILE**

**NURIA CHIARA PALAZZI**

Thesis submitted to Pontificia Universidad Católica de Chile and University of Florence in partial fulfillment of the requirements for the Degree of Doctor in Engineering Sciences and Doctor in Architecture

Santiago of Chile, October, 2019

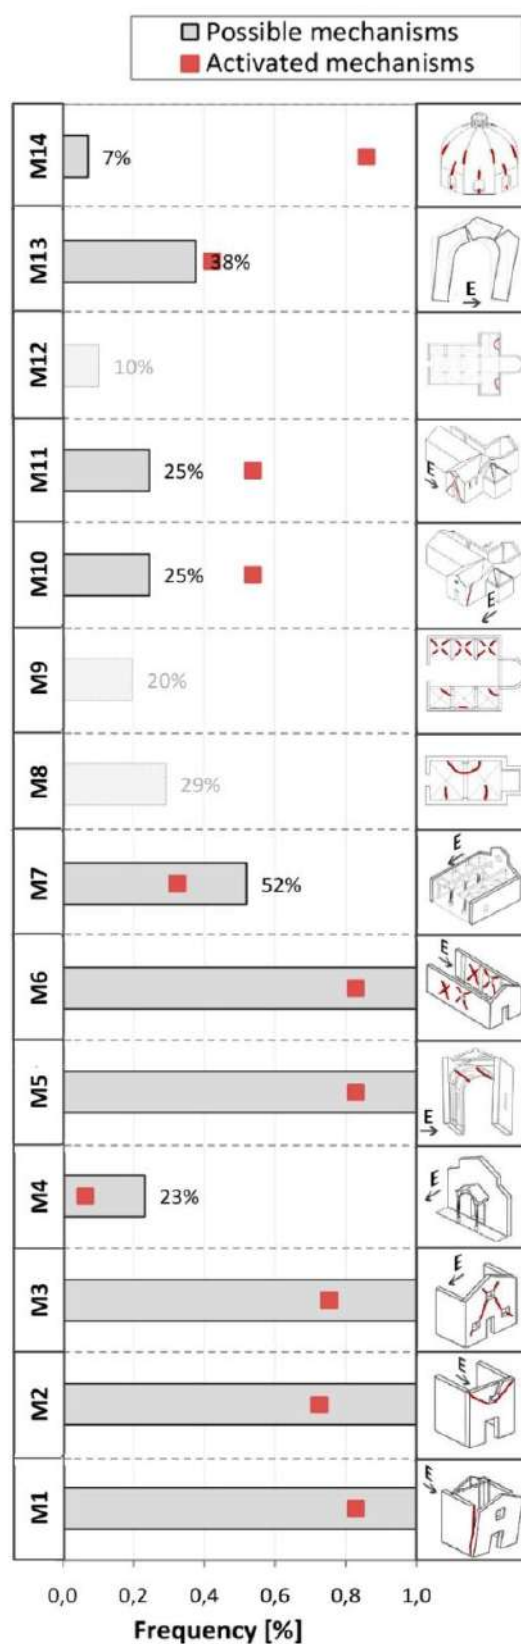
The presence of each macro-element (façade, triumphal arch, bell tower, etc.) is sufficient to make possible the activation of associated collapse mechanisms. Thus, in Fig. 4.4 the percentages of the potential failure modes that could be activated in the churches, i.e. possible mechanism [PM] even if they are not associated with damage, are shown together with a ratio

between the numbers of churches where the mechanisms were actually activated following the 2010 earthquake (effective mechanisms, EM), and the number of the possible mechanisms. The PM parameter highlights the specific features of Chilean URM churches with respect to the European religious buildings. Some mechanisms are absent, such as the damage involving the main nave (mechanism 8) and the side aisles (mechanism 9) vaults, due to the presence in churches of false vaults made of timber ribs clad in cane (present in about the 25% of the total stock) or *tijerales*. The mechanisms 1, 2 and 3, which analyze the in-plane and the out-of-plane behavior of the facade, and mechanisms 5 and 6, which respectively evaluate the transversal response of the central nave (and of the aisles, if present), and the in-plane response of the longitudinal walls, show that a systematic activation and the involved macro-elements, facade and central nave, are always present.

In all the bell towers, in-plane and out-of-plane damage was observed (mechanism 27 and 28), and the considered macro-element is present in almost all of the analyzed churches. The apse overturning causes frequent damage and through the interaction between the side walls and the roof structure (mechanism 16 and 19).

**Figure 4.4** -(a) Percentage of possible collapse mechanisms (relative to the total sample) and the mechanisms activated after the 2010 earthquake (compared to the possible sample).

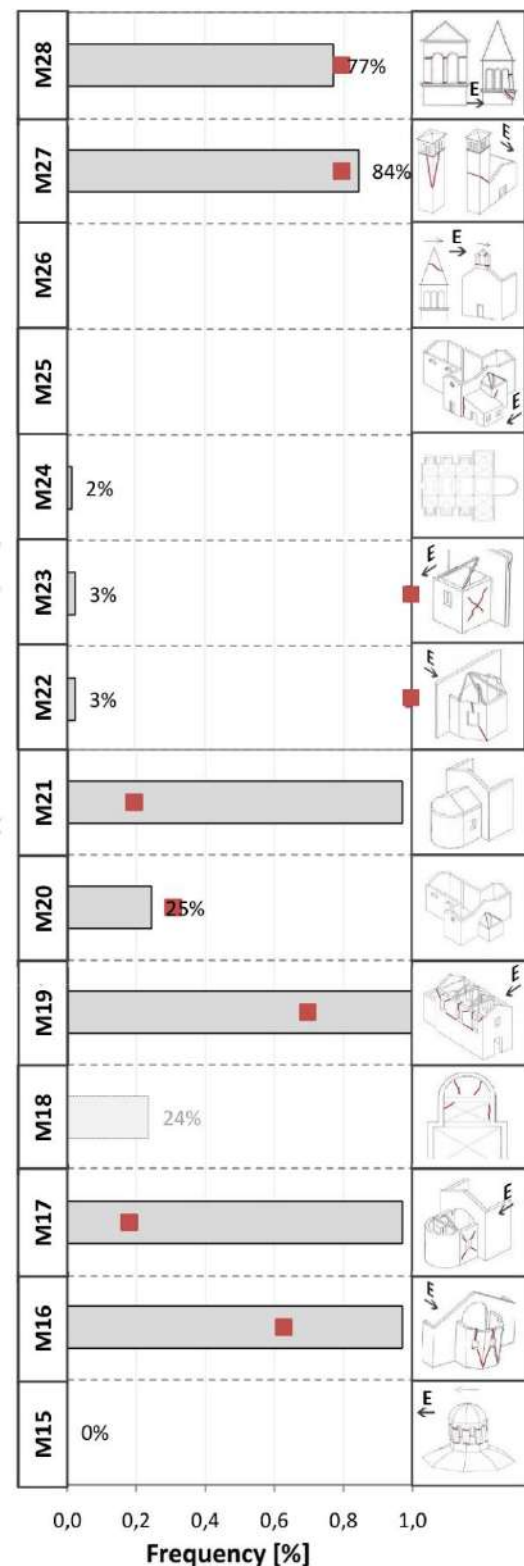
**Figure 4.4 -(b)**Percentage of possible collapse mechanisms (relative to the total sample) and the mechanisms activated after the 2010 earthquake (compared to the possible sample).

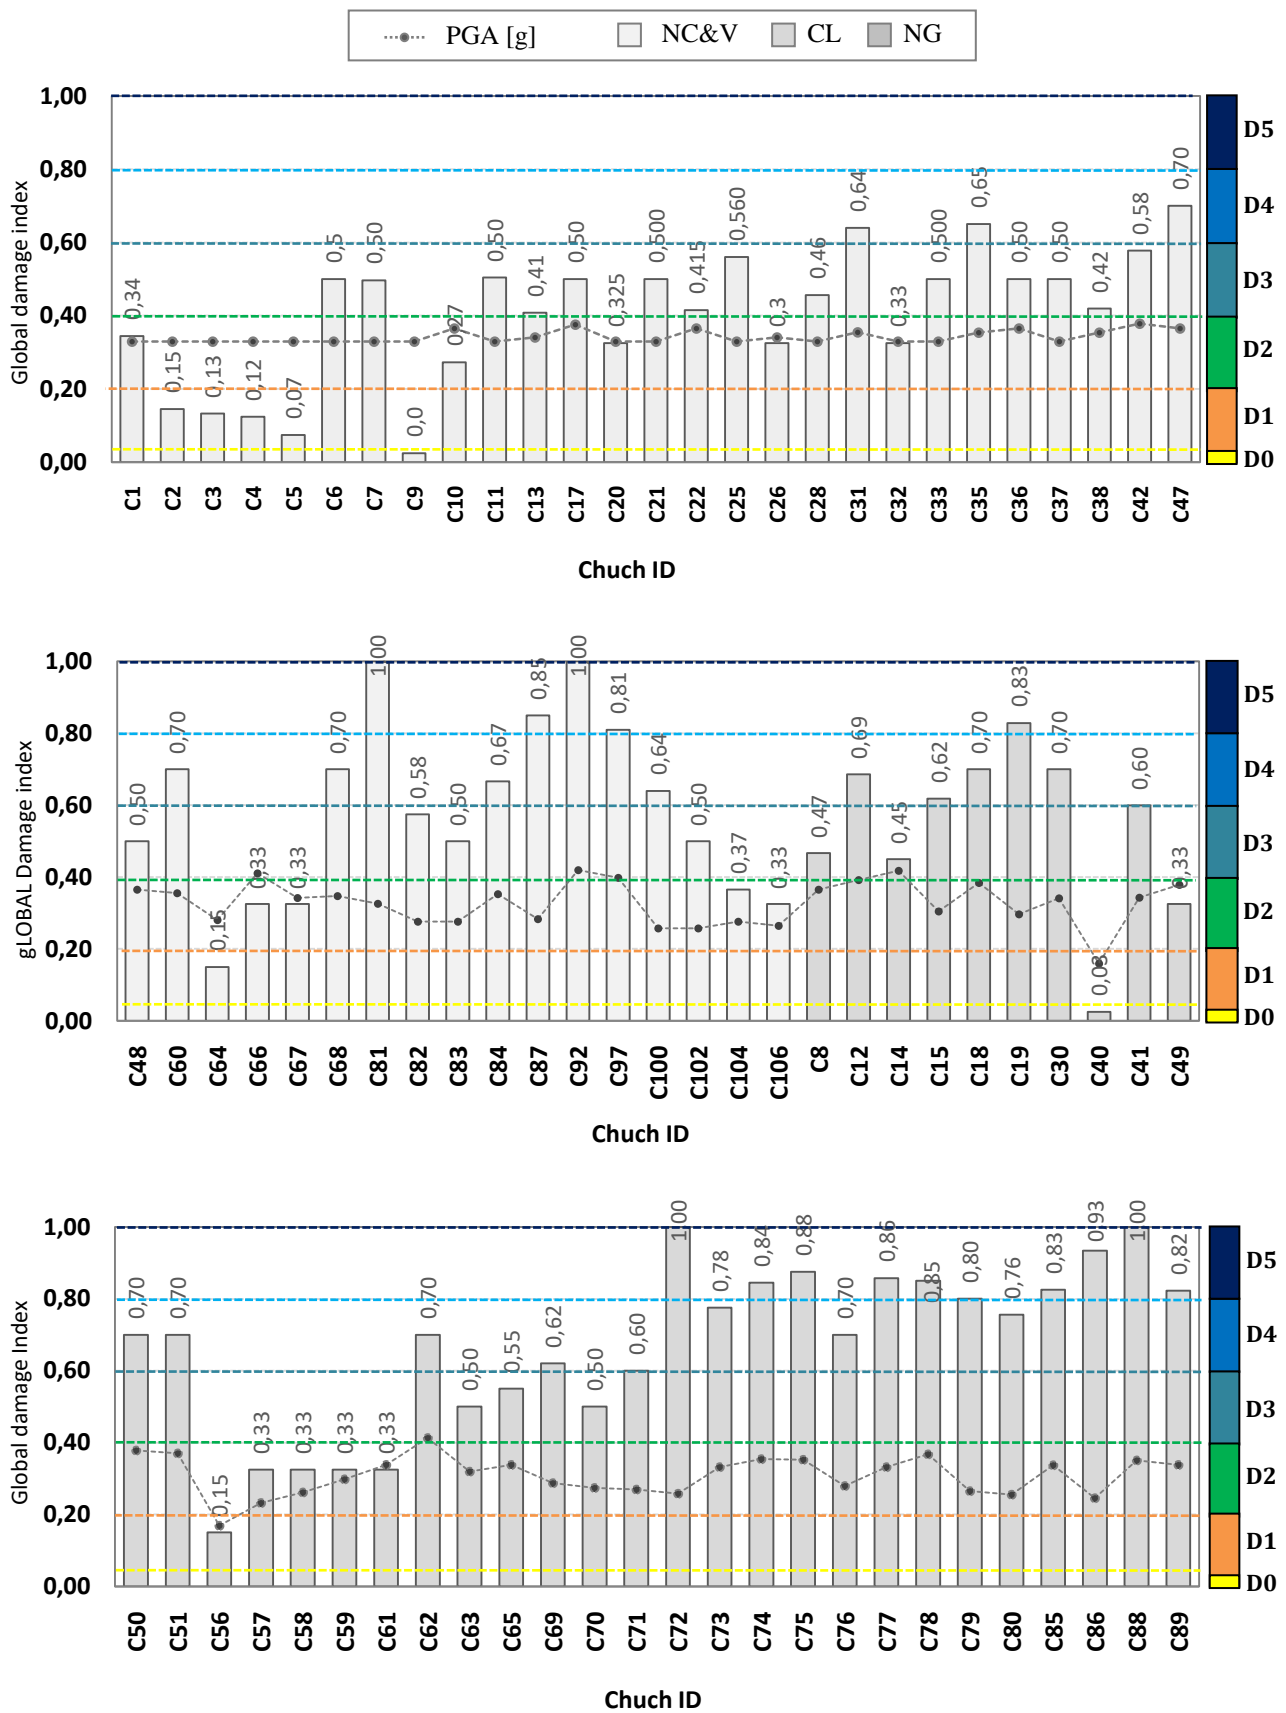
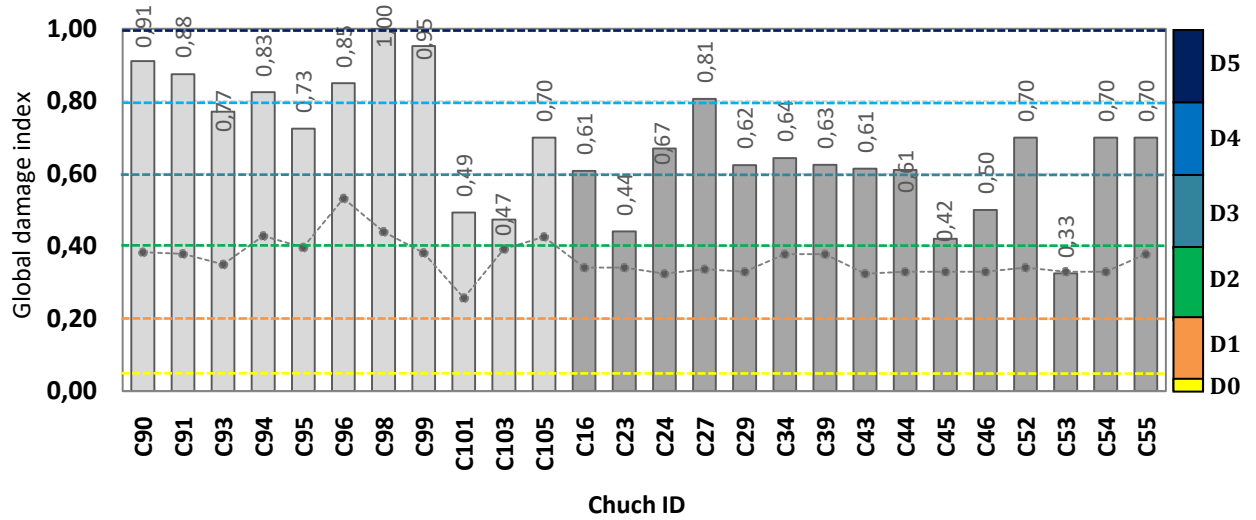
The results obtained by the damage index method, show better correlation in stone masonry churches (7 in totals) rather than brick and adobe structures. Indeed, during the Maule earthquake, CL and NG churches were the most damaged structures. Several of CL religious buildings, of which 57.4% were located in the both region 6<sup>th</sup> region (Libertador General Bernardo O'Higgins), underwent heavy structural damage. Extensive and deep cracks were observed activating local failure modes of different macro-elements, and in some case, total or near total collapse (66% of global damage levels in Colonial churches reached  $D_4$ - $D_5$ ).

The NG buildings located in the city of Santiago at 325 kilometers from the epicenter exhibited activation of failures of numerous macro-elements and a prevalent damage level  $D_k$  in 66.6% of the cases. Compared to the previously analyzed buildings, the NC&V churches have shown a better structural response, with moderate structural and non-structural damage, 75% of the cases. The stone churches are focused on a more limited range of PGA (range between 0.25g to 0.3g).

**Figure 4.7** - Damage levels according to Table 2 (Grunthal, 1998) and global damage index (Lagomarsino et al. 2004; Lagomarsino and Podestà, 2004b) for the 106 URM churches of Central Chile affected by the 2010 Maule earthquake.

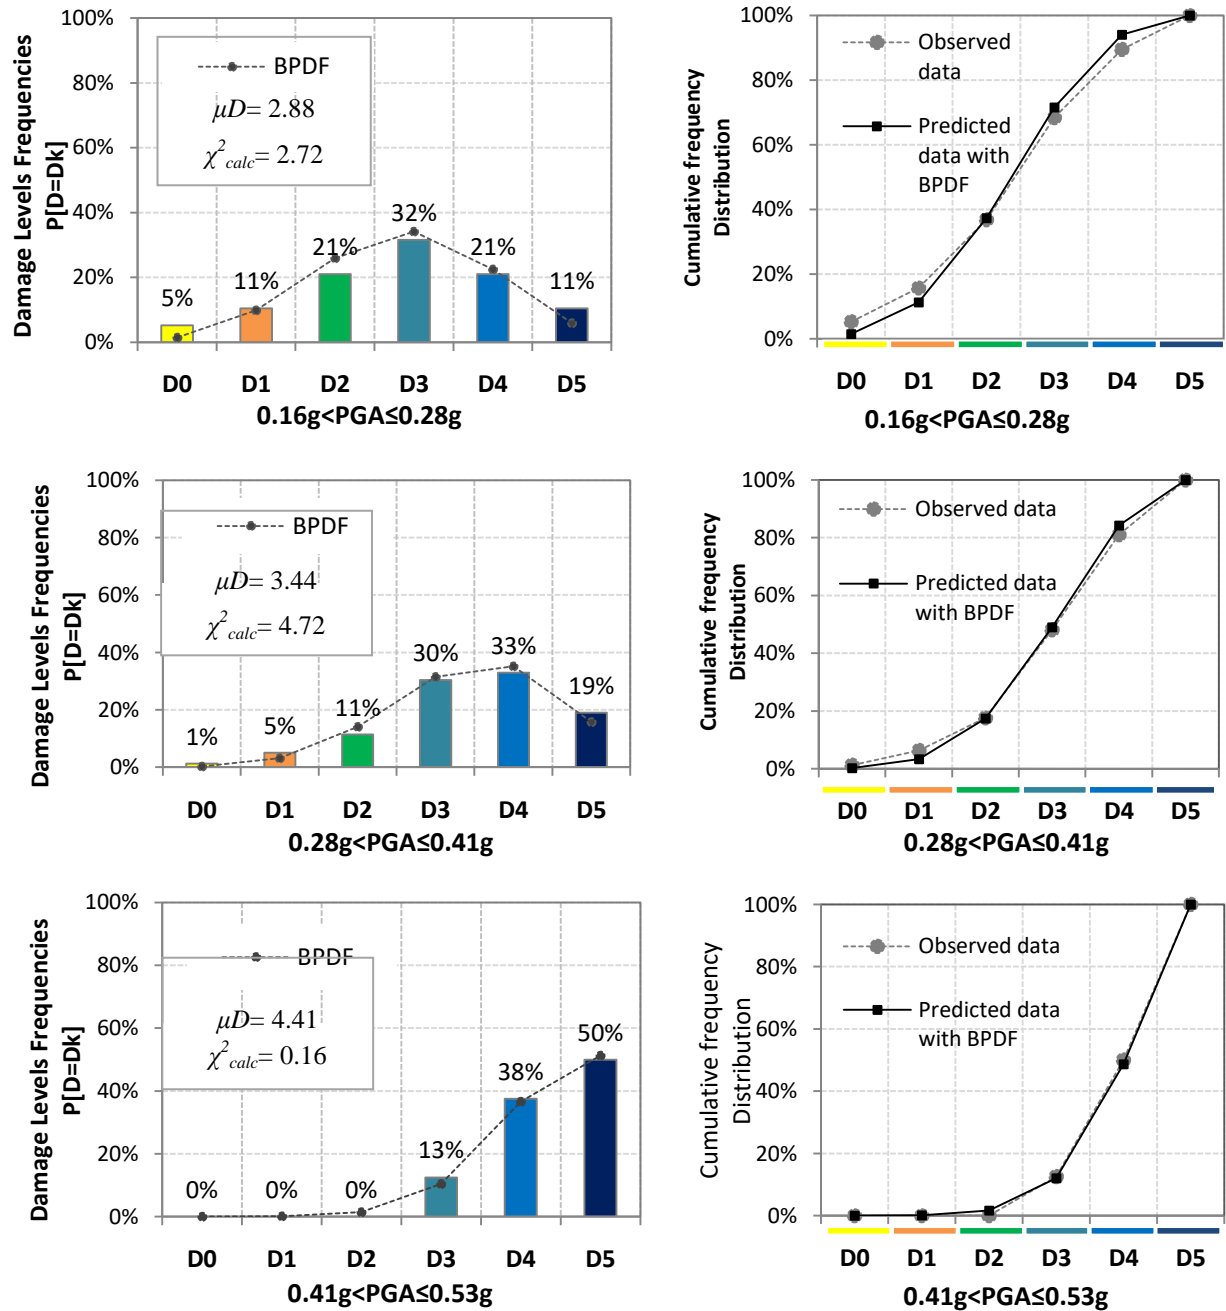
Considering the PMFs of church global behaviors (Fig.4.10) at intensity range from  $0.16g < PGA \leq 0.28g$ , the  $\chi^2_{calc}$  is equal to 2.72; at intensity range from  $0.28g < PGA \leq 0.41g$ ,  $\chi^2_{calc} = 4.72$ ; and at intensity range from  $0.41g < PGA \leq 0.53g$ ,  $\chi^2_{calc} = 0.61$ .

**Figure 4.10.** Probability Mass Functions (PMFs) and Cumulative Frequency Distribution (CFDs) for the whole sample using observed data and predicted data through Binomial Distribution (BPDF) for ground motion intensities in the range from  $0.16g < PGA \leq 0.53g$ .

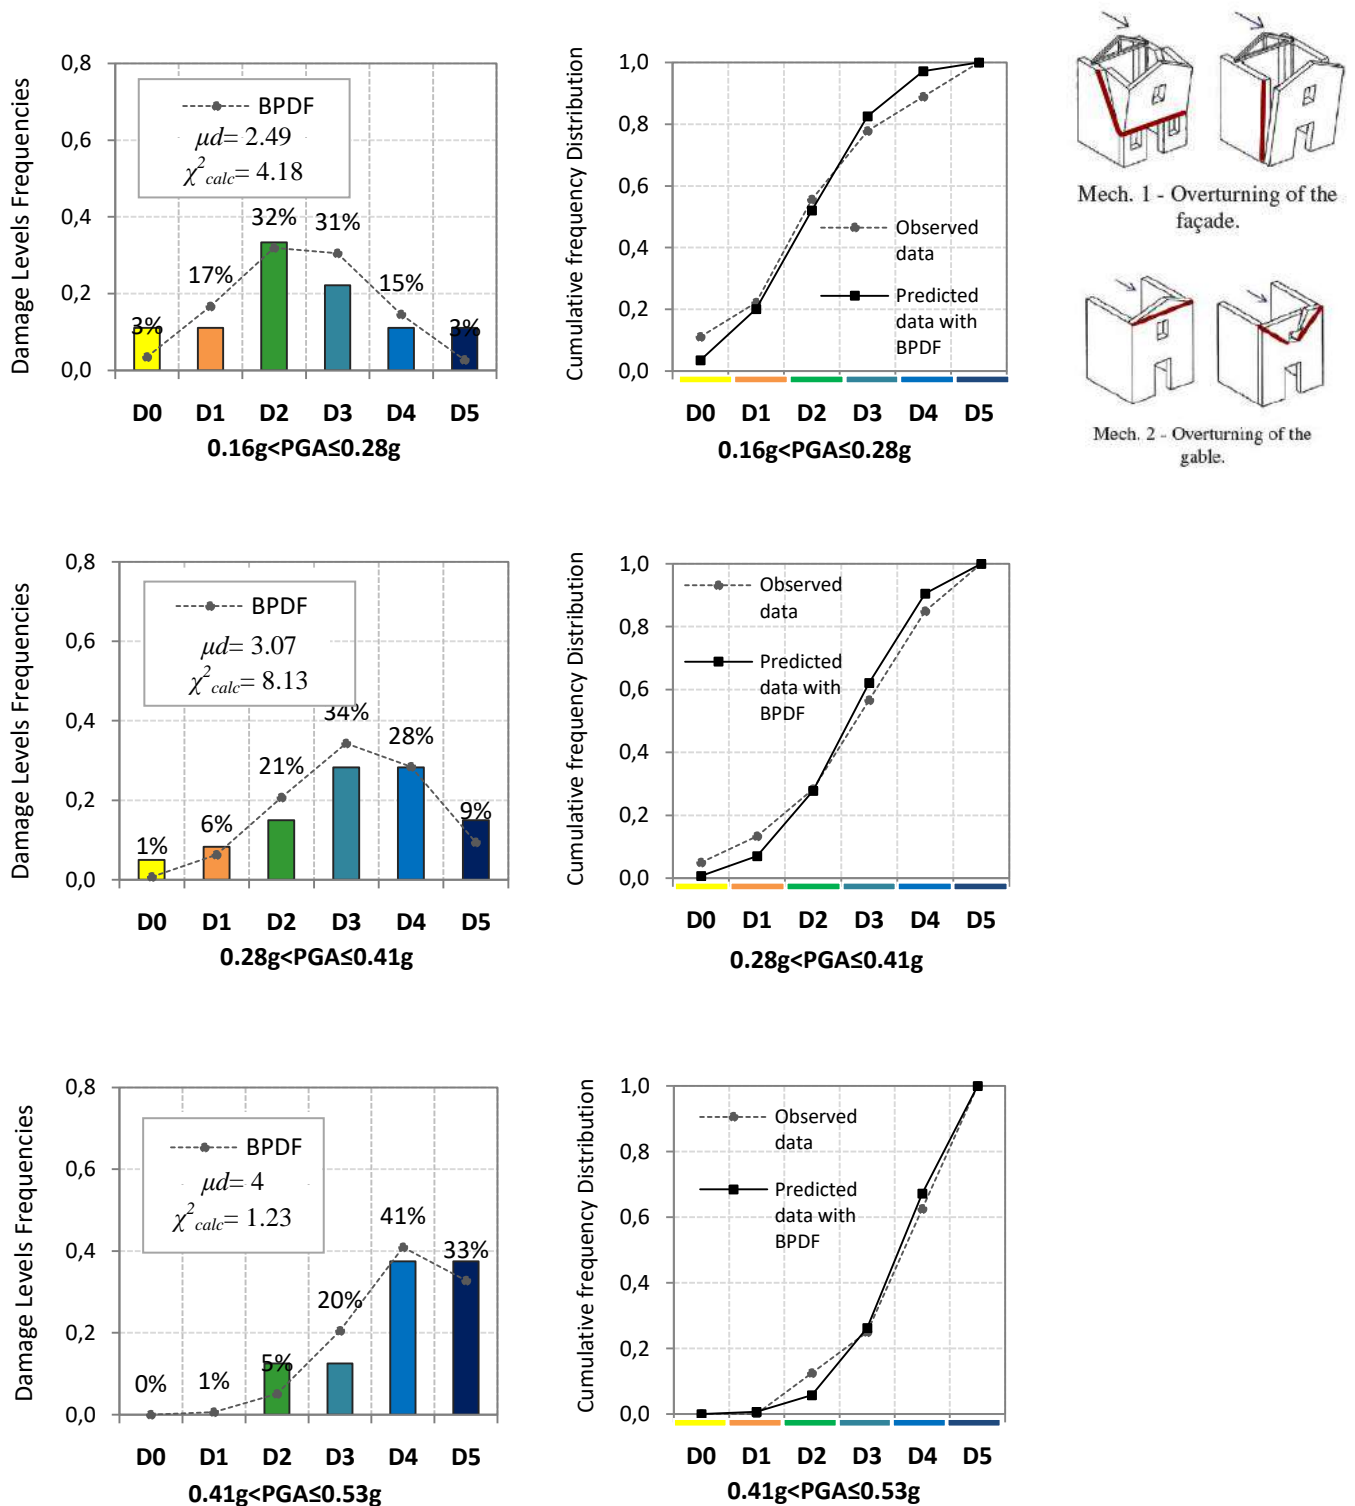
As concerning the PMFs for OOP behavior of façade macro-element (Fig.4.11): at intensity range from  $0.16g < PGA \leq 0.28g$ , the  $\chi^2_{calc}$  is equal to 4.18; at intensity range from  $0.28g < PGA \leq 0.41g$ ,  $\chi^2_{calc} = 8.13$ ; and at intensity range from  $0.41g < PGA \leq 0.53g$ ,  $\chi^2_{calc} = 1.23$ . For IN behavior of façade macro-element (Fig.4.12): at intensity range from  $0.16g < PGA \leq 0.28g$ , the  $\chi^2_{calc}$  is equal to 2.81; at intensity range from  $0.28g < PGA \leq 0.41g$ ,  $\chi^2_{calc} = 15.57$ ; and at intensity range from  $0.41g < PGA \leq 0.53g$ ,  $\chi^2_{calc} = 0.55$ .

**Figure 4.11** - Probability Mass Functions (PMFs) and Binomial Distribution (BPDF) for the out-of-plane behavior of the façade (M1, M2) for intensities ranging from  $0.16g < PGA \leq 0.53g$ .

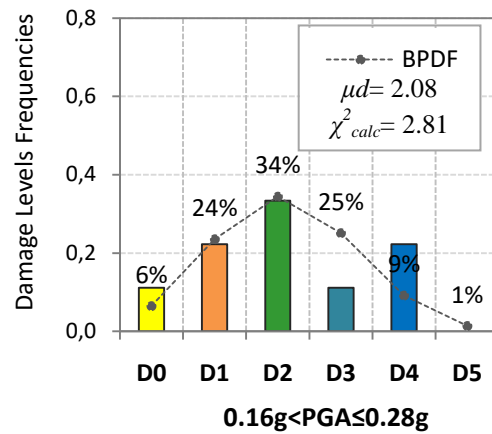
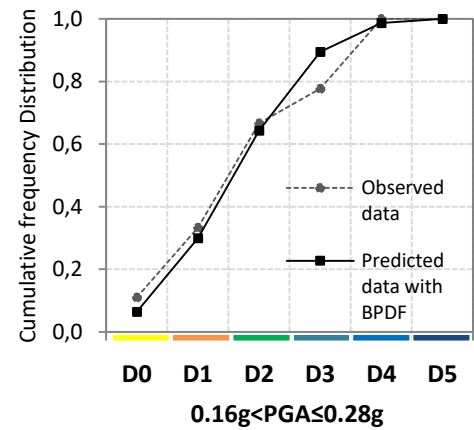
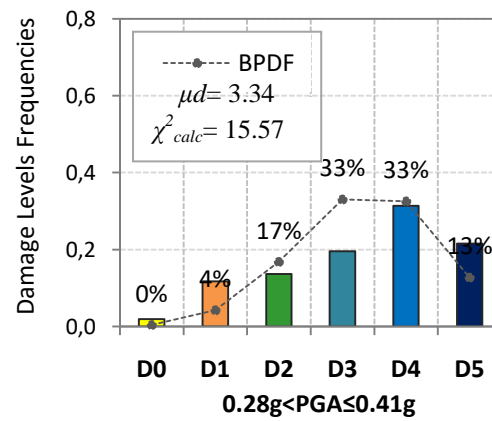
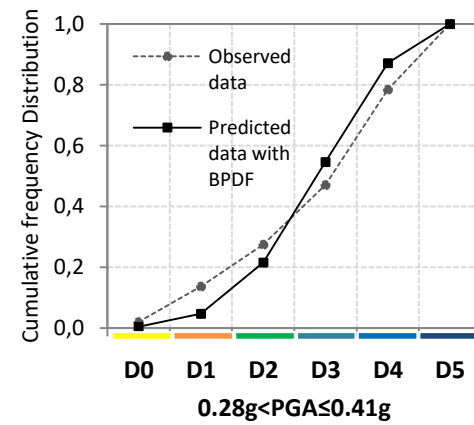
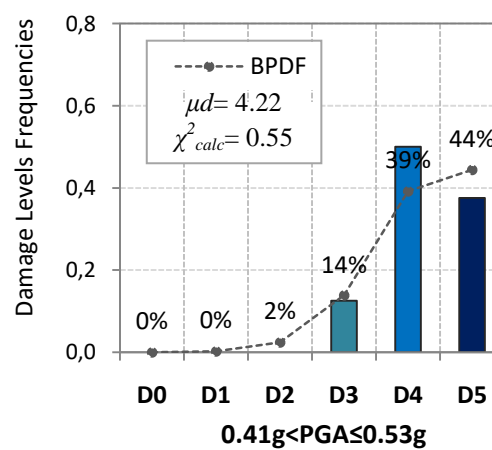
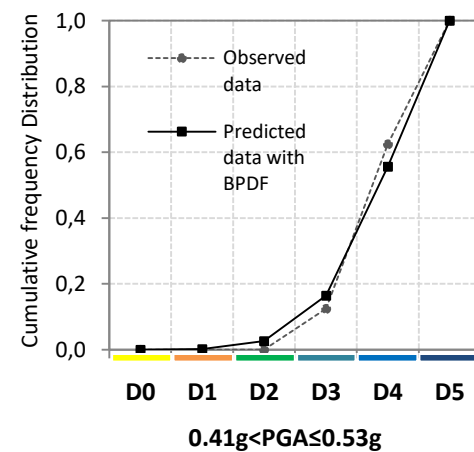
Figure 4.12 - Probability Mass Functions (PMFs) and Binomial Distribution (BPDF) for the in-plane behavior of the façade (M3) for intensities ranging from 0.16g < PGA ≤ 0.53g.

Unlike the side walls, the façade macro-element shows greater vulnerability in the in-plane rather than in the out-of-plane behavior (Fig.4.12):

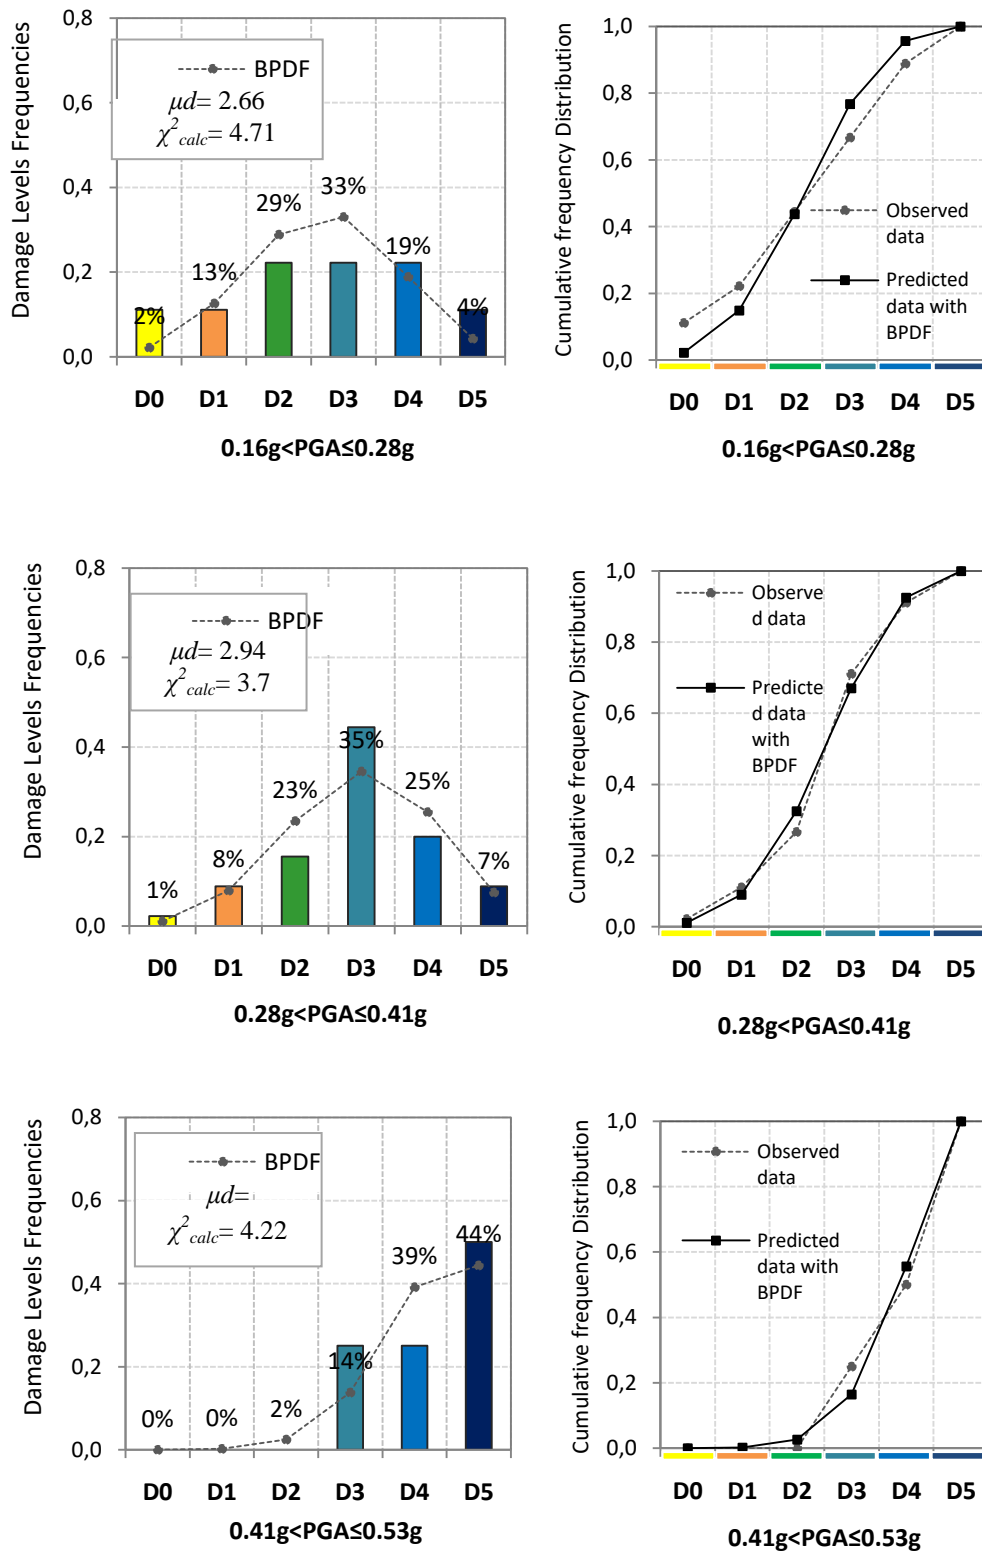
As concerning the PMFs for OOP behavior of lateral wall macro-element (Fig.4.13): at intensity range from  $0.16g < PGA \leq 0.28g$ , the  $\chi^2_{calc}$  is equal to 4.71; at intensity range from  $0.28g < PGA \leq 0.41g$ ,  $\chi^2_{calc} = 3.7$ ; and at intensity range from  $0.41g < PGA \leq 0.53g$ ,  $\chi^2_{calc} = 1.4$ . For

**Figure 4.13 - Probability Mass Functions (PMFs) and Binomial Distribution (BPDF) for the out-of-plane behavior of the lateral walls (M19) for intensities ranging from  $0.16g < PGA \leq 0.53g$ .**

Furthermore, for mechanisms that activate more frequently, say in-plane and out-of-plane behaviors involving the façade (M1 and M2 activated in 4/5 of the total sample) and the sidewalls (M19 activated in 3.5 / 5), specific PMFs were quantified. For the PMFs of the out-of-plane behavior (M19) of the nave macro-element (Fig.4.13) the following observations are obtained:

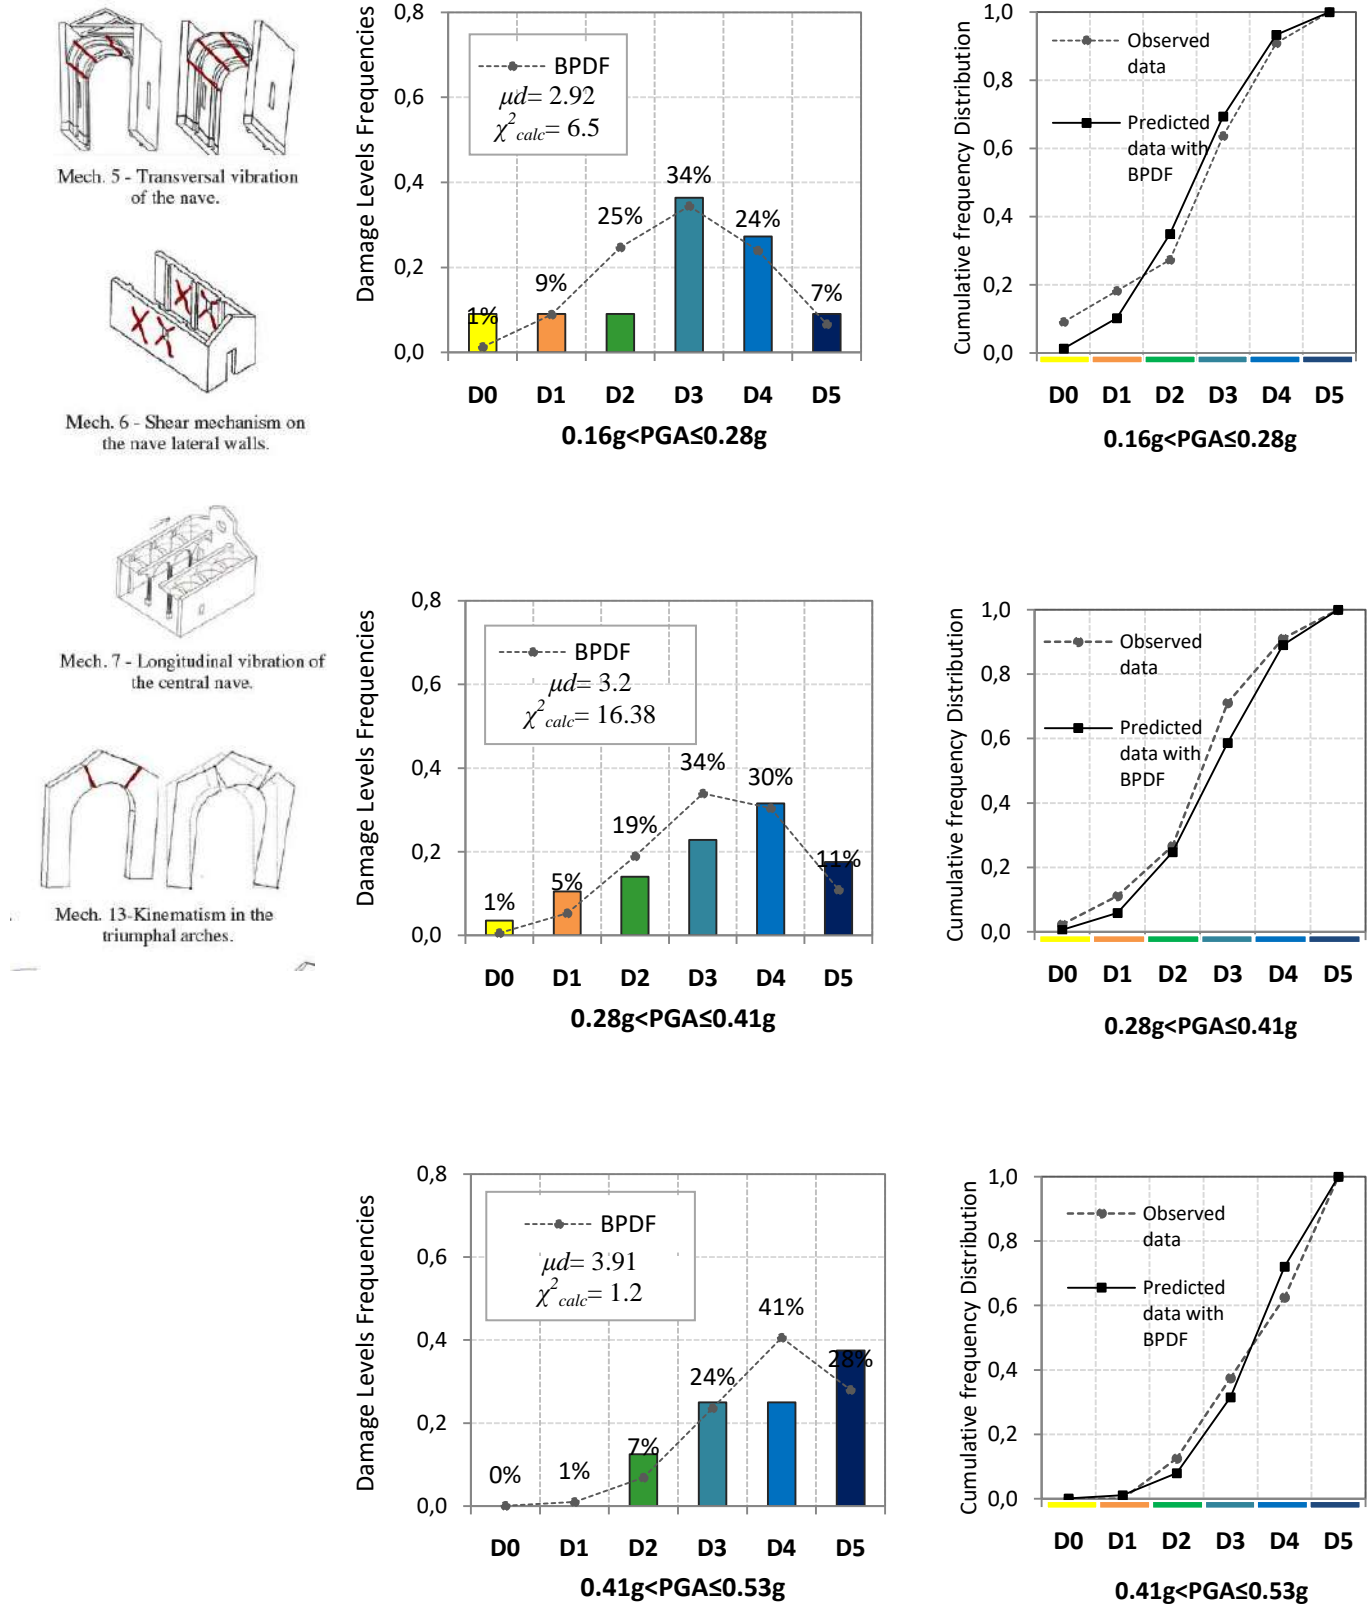
IN behavior of façade macro-element (Fig.4.14): at intensity range from  $0.16g < PGA \leq 0.28g$ , the  $\chi^2_{calc}$  is equal to 6.5; at intensity range from  $0.28g < PGA \leq 0.41g$ ,  $\chi^2_{calc} = 16.38$ ; and at intensity range from  $0.41g < PGA \leq 0.53g$ ,  $\chi^2_{calc} = 1.2$ .

**Figure 4.14 - Probability Mass Functions (PMFs) and Binomial Distribution (BPDF) for the in-plane behavior of the lateral walls (M5, M6, M7, and M13) for intensities ranging from 0.16g < PGA ≤ 0.53g.**

For the PMFs of the in-plane behavior of the same macro-element (M5, M6, M7, and M13)(Fig.4.14) the following observations can be obtained:

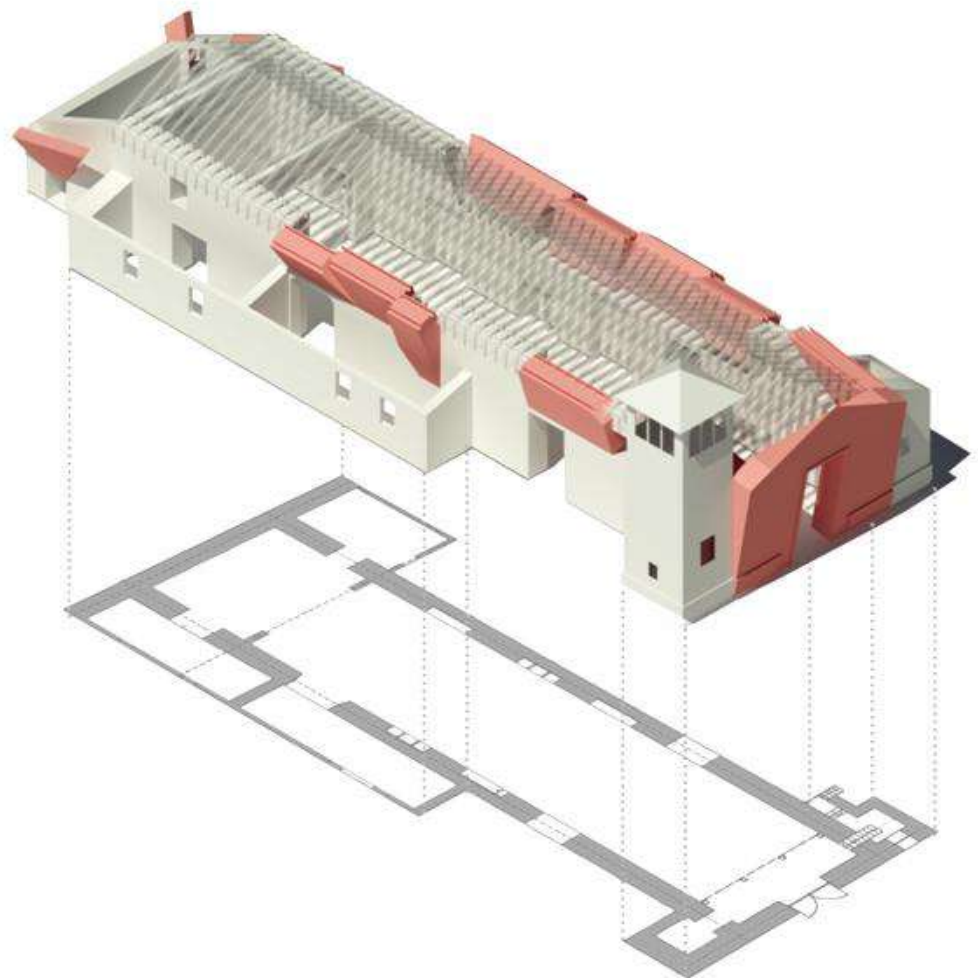
Firstly, the layout of the mechanisms that are most likely to be activated in the Parish has been defined for the current state and the identified mechanisms are shown in (Fig.5.1.11). The results of LKA (Kinematic multiplier  $\alpha_0$ , Participating Mass  $M^*$ , Mechanism Activation Acceleration  $a_0^*$ , the Demand Acceleration at ground and elevated levels) are shown in Table 5.1.5.

*Figure 5.1.11 – Identification of all local mechanisms in Malloa church.*

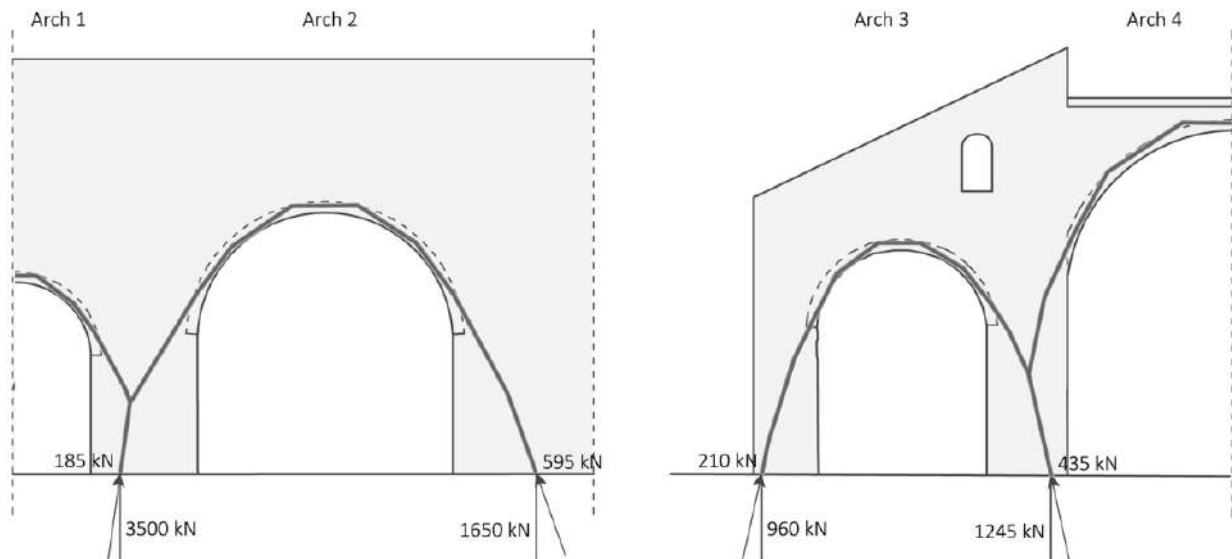
**Figure 5.2.11** - Thrust line for the arches 1, 2, 3, and 4.

To achieve a safety estimation of the static consistency of the church, a preliminary graphical analysis for vertical loads has been first carried out on a significant portion of the main nave and transept wall through the Safe Theorem of Limit Analysis (Heyman 1966). An equilibrated solution has been found (drawn as a set of thrust lines) contained inside the masonry structure, compatible with the loads and which does not violate the yield conditions. This condition has guaranteed the safety of structure for vertical loads. Fig.5.2.11 shows the thrust line of each arch (1, 2, 3, and 4) with the related values of thrusts. It is worth noting that the thrust line of the transverse arcade F highlights a limit condition for the stability of portion F4, considering the thrust position at the ground. As expected from direct surveying activities, the thrust lines converging on pillar F3 are influenced by loads of both the longitudinal arcade (3) and the transverse wall facing the transept (wall F), determining a high loading level on a reduced portion of masonry which is in fact heavily damaged. Linear static analysis for vertical loads on the global 3D FEM has been carried out, and results show comparable stress levels ranging 1–1.2 MPa on portions F3 and F4.

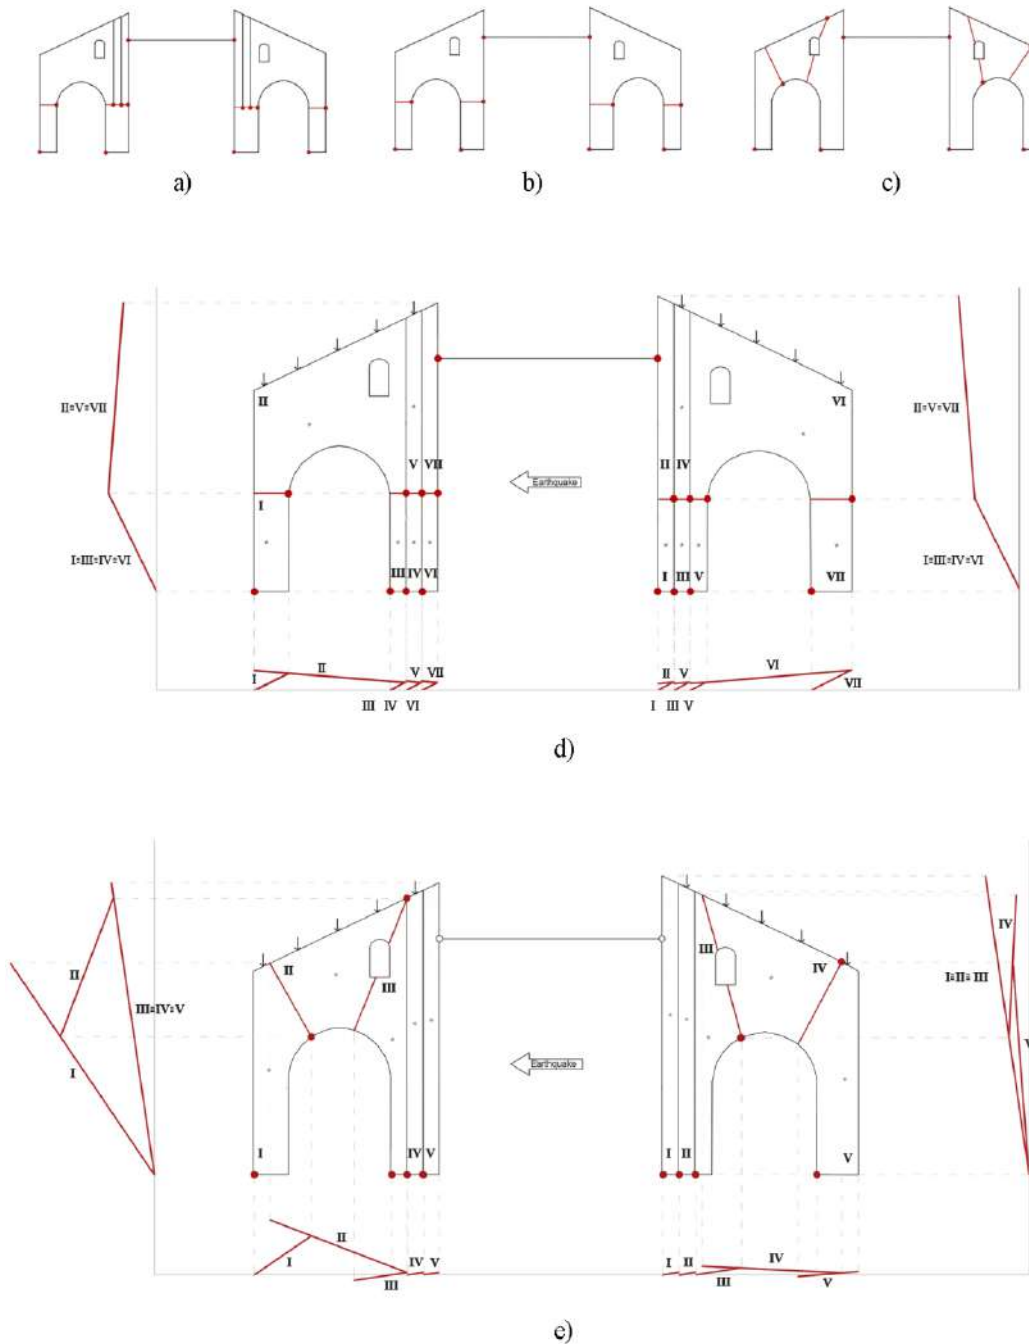
The response of the transversal arcade systems in the current state is analyzed through three mechanism scenarios, TA1, TA2, and TA3, based on visible crack patterns annotated during surveying activities (Fig.5.2.12). Different scenarios represent an increasing quality of the masonry of longitudinal walls (axis 2 and 3; see Fig.5.2.1). Mechanism TA1 represents walls 2 and 3 as a two-leaf masonry, thus by means of two blocks (Fig.5.1.12a), while mechanism TA2 assumes the same masonry quality for wall 2 and 3 but a complete effectiveness of the anchoring of the piers (Fig.5.1.12b).

Mechanism TA3 (Fig.5.1.12c) represents the longitudinal walls as a monolithic masonry with full effectiveness of the anchoring intervention on piers. The hypothesized direction of the action induces a counter- clockwise mono-lateral rotation of piers and a consequent clockwise rotation of upper blocks.

**Figure 5.2.12** - In-plane mechanism of the transverse arcade. Possible activated mechanisms: a) TA2 (current state) longitudinal wall made up of a two-leaf masonry and complete effectiveness of the anchoring of the piers; b) TA3 (current state) longitudinal walls as a monolithic masonry with complete effectiveness of the anchoring intervention on piers and c) TA5 (state before concrete reinforcements) longitudinal walls as a monolithic masonry. Horizontal and vertical virtual displacement diagram: d) TA1 (current state) longitudinal wall made up of two-leaf masonry and e) TA4 (state before concrete reinforcements) longitudinal wall made up of two-leaf masonry (Jorquera et al., 2017).

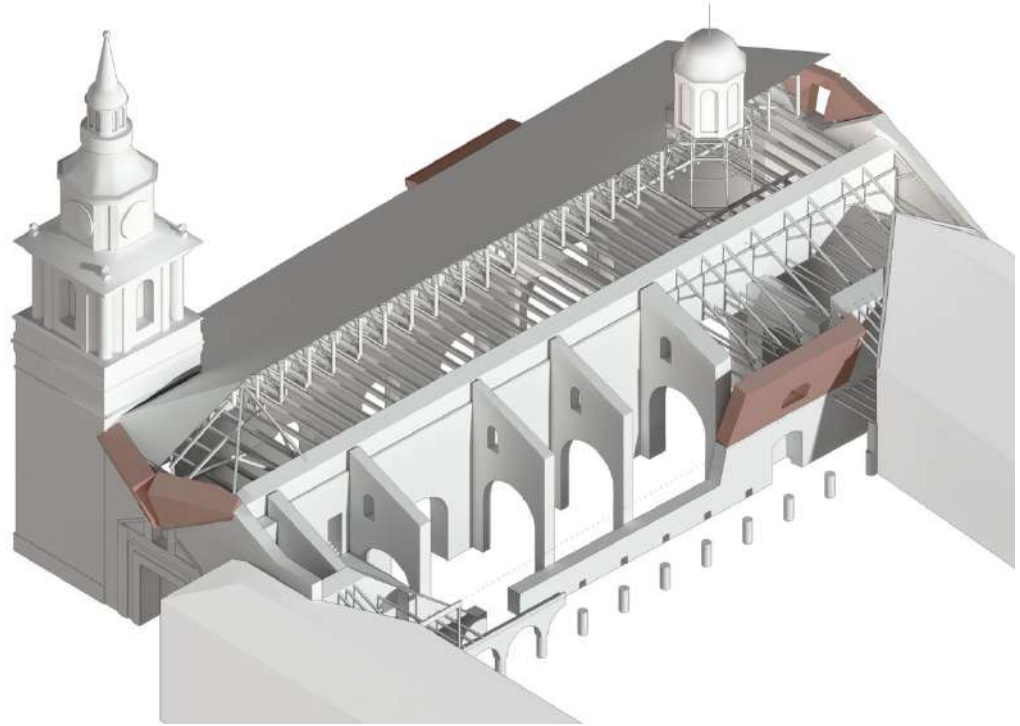
Fig.5.1.13 shows the out-of-plane mechanisms identified for the current state. Mechanisms represent the overturning of gables of façade, and behind presbytery wall, i.e., MF and BP in Table5.2.4, whose cuneiform macro-blocks rock around two oblique cylindrical hinges, and the overturning of the north and south transept walls around cylindrical hinges placed 60 cm off the ground, NT and ST (Table5.2.4).

**Figure 5.1.13** - Local mechanisms of collapse in current state (Stefanini, 2016).

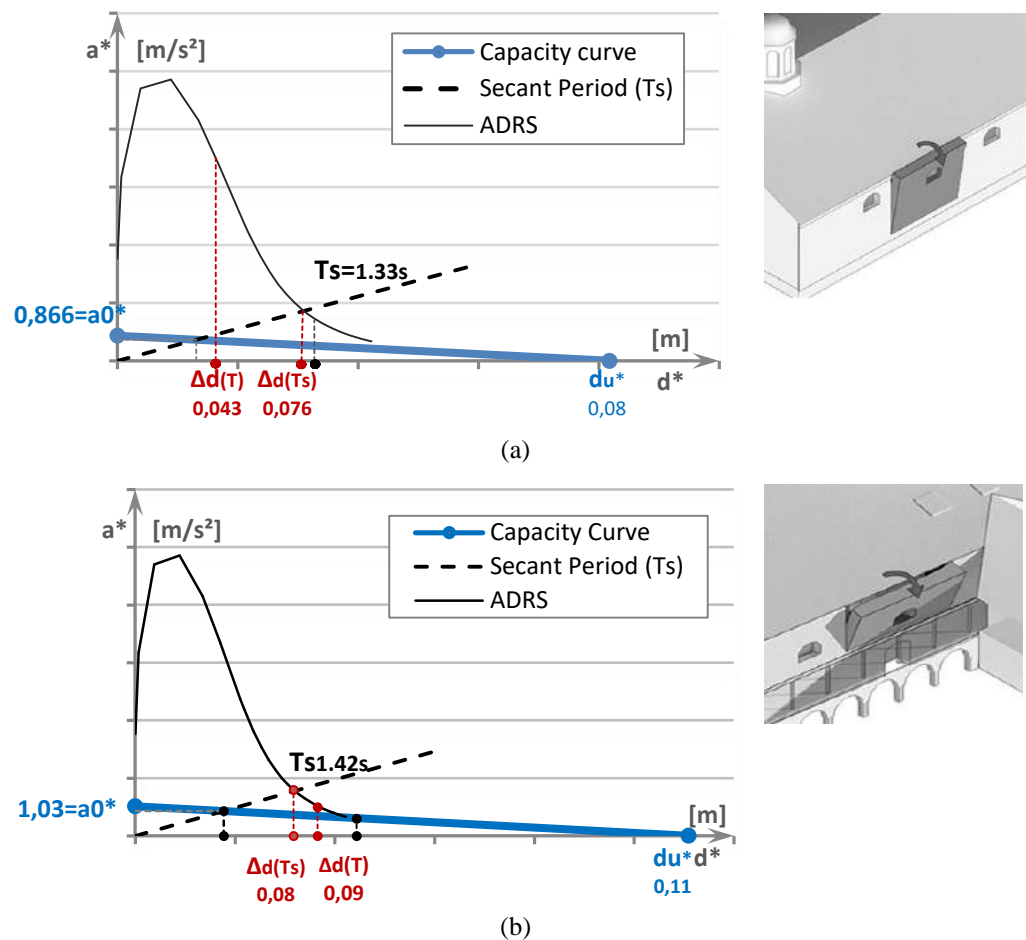
on varied geometrical configurations, repeatedly applying the principle of virtual works, assuming an increasing forcing action that cannot induce any transitory recovery of the block after the activation of motion (eq. 5.8 and 5.9). The displacement capacity curve obtained through IKA initiates with the value of acceleration necessary to activate the mechanism,  $a_0^*$ , and descends linearly, describing how the mechanism evolves until final failure, i.e., when the curve reaches nil value. Results of IKA can be used on properly damped response spectra but does not constitute an alternative to estimations offered by a nonlinear dynamic. Real out of plane mechanisms NT and ST are thus transformed into equivalent SDOF systems, whose capacity in displacement have to be compared with the related Acceleration Displacement Response Spectrum (ADRS) according to Nch2745Of.2013, as shown in Fig.5.2.15. From the comparison between the displacement Capacity and Demand (5.9) of both the transept walls, the tests are satisfied (Fig.5.2.15). Despite the activation of the mechanisms, both macro-elements (NT and ST) show a satisfactory capacity in displacement, which justifies the absence of the collapse.

**Figure 5.2.15** - Capacity and demand curves of incremental kinematic analysis: (a) north transept wall; and (b) south transept wall; and Acceleration Displacement Response Spectrum (ADRS) according to Nch2745Of.2013 (Palazzi et al., 2018c).

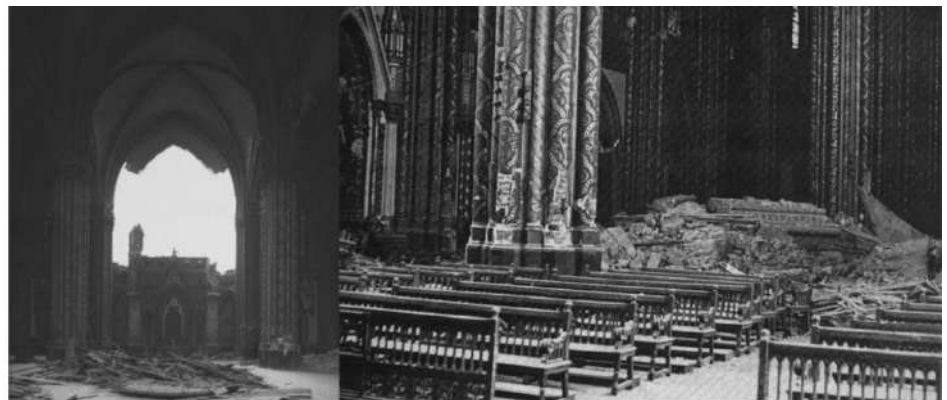
Following the 1985 seismic event, the upper part of the transept walls within two columns of the central nave arcades collapsed (Fig.5.3.3). The security measures started the same year and involved the reconstruction of the west and east transept walls with steel elements and gypsum structure, and the insertion of a ring-beam of reinforced concrete in the central apse. Two R.C. columns were erected, bound to the top of the lateral wall of west aisle. Since then, the church has remained inaccessible.

**Figure 5.3.3** - Photo (a) west transept wall, and (b) two central nave columns, collapsed after the 1985 earthquake (Ministry of Public Works).
