# **SEISMIC FRAGILITY ASSESSMENT OF UNREINFORCED MASONRY CHURCHES OF CENTRAL CHILE**

**NURIA CHIARA PALAZZI**

Thesis submitted to Pontificia Universidad Católica de Chile and University of Florence in partial fulfillment of the requirements for the Degree of Doctor in Engineering Sciences and Doctor in Architecture

Santiago of Chile, October, 2019

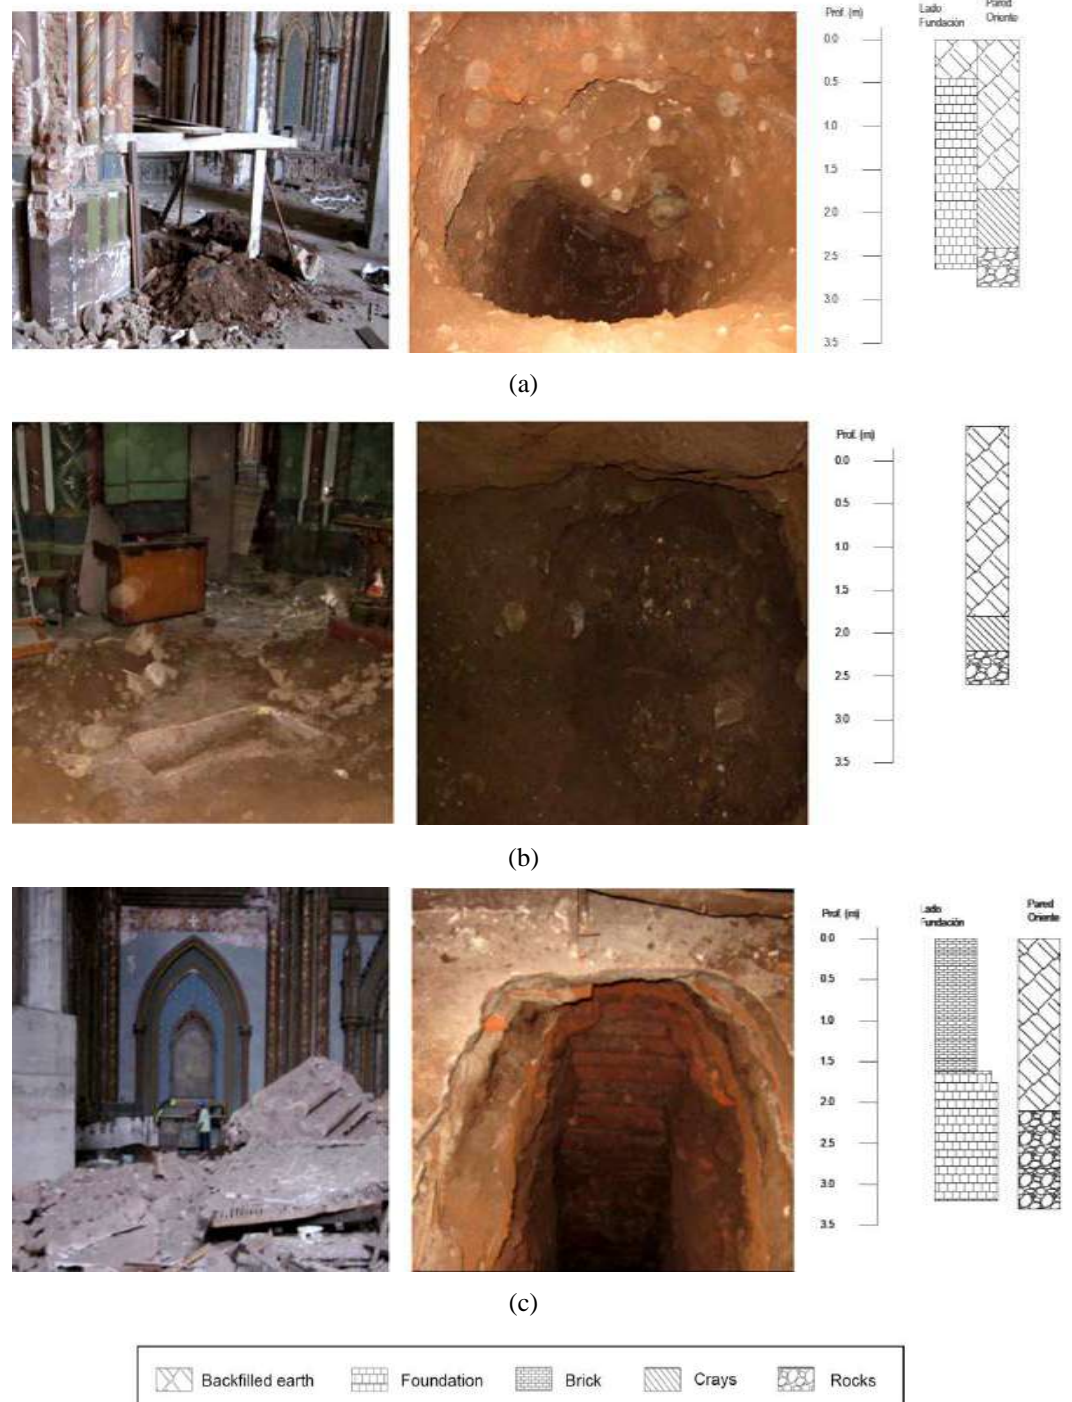
Based on the Chilean Code NCH433 of 96 (INN, 1996) and D.S.61, 2011 (MINVU, 2011), the soil having very dense and stable ground,  $V_{s30} > 500$  ms<sup>-1</sup>, was classified as soil type B, with soil coefficient  $S=1$ .

**Figure 5.3.10** –Localization and soil stratigraphy of (a) excavation E1 in the west side aisle; (b) excavation E2 in the central nave; and excavation E3 in the east minor apse, (DICTUC, 2013).

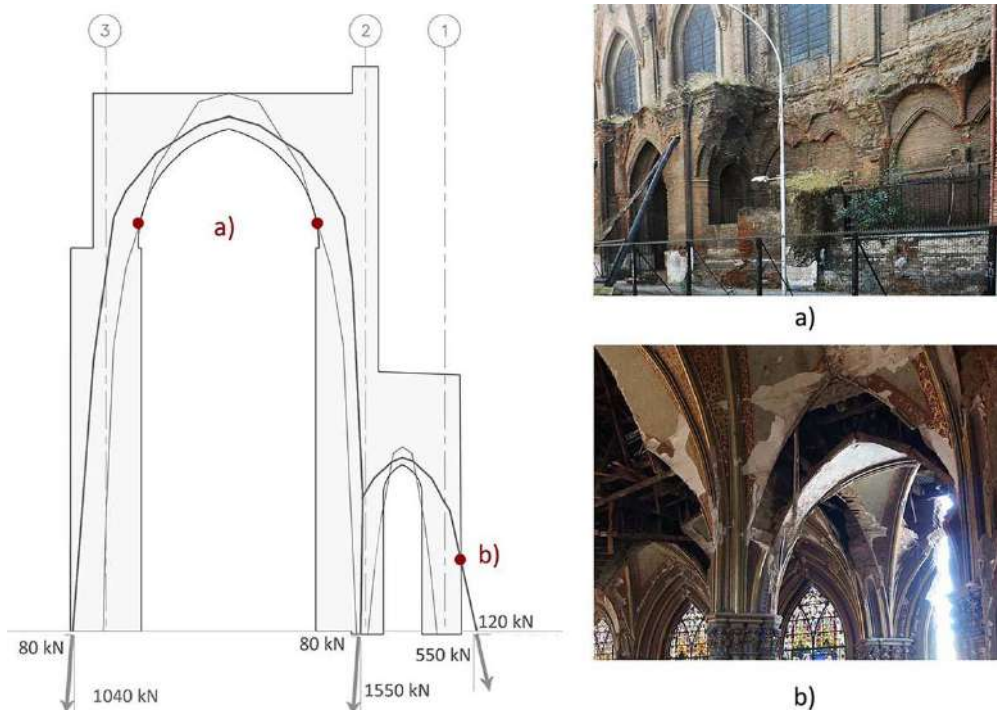
**Figure 5.3.13.** Thrusts line of wall portion in interception of longitudinal walls 3, 2 and 1, and transverse arcade D.

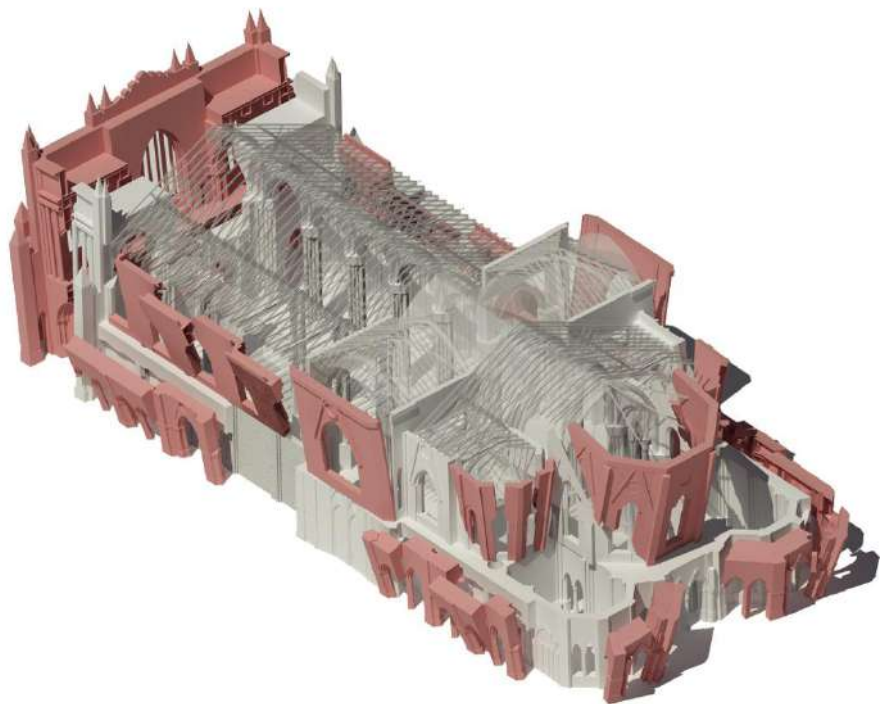
**Figure 5.3.15** - Identification of local mechanisms of collapse in the current state of Basilica.

- (ii) All out-of-plane failures detected at the present state are identified in (Fig.5.3.15). The mechanisms represent the simple overturning of the rigid sub-blocks that made up the west side aisle, SAw1-2; the central, west and east lateral apses, APc, APe-w1, APe-w2, APe-w3, around cylinder hinge placed 8.5m off the ground at the level of the external gallery roof. The macro-blocks, that composed the outer walls of the gallery, EAw-e1 and EAw-e2, rock around cylinder hinge placed at ground level.

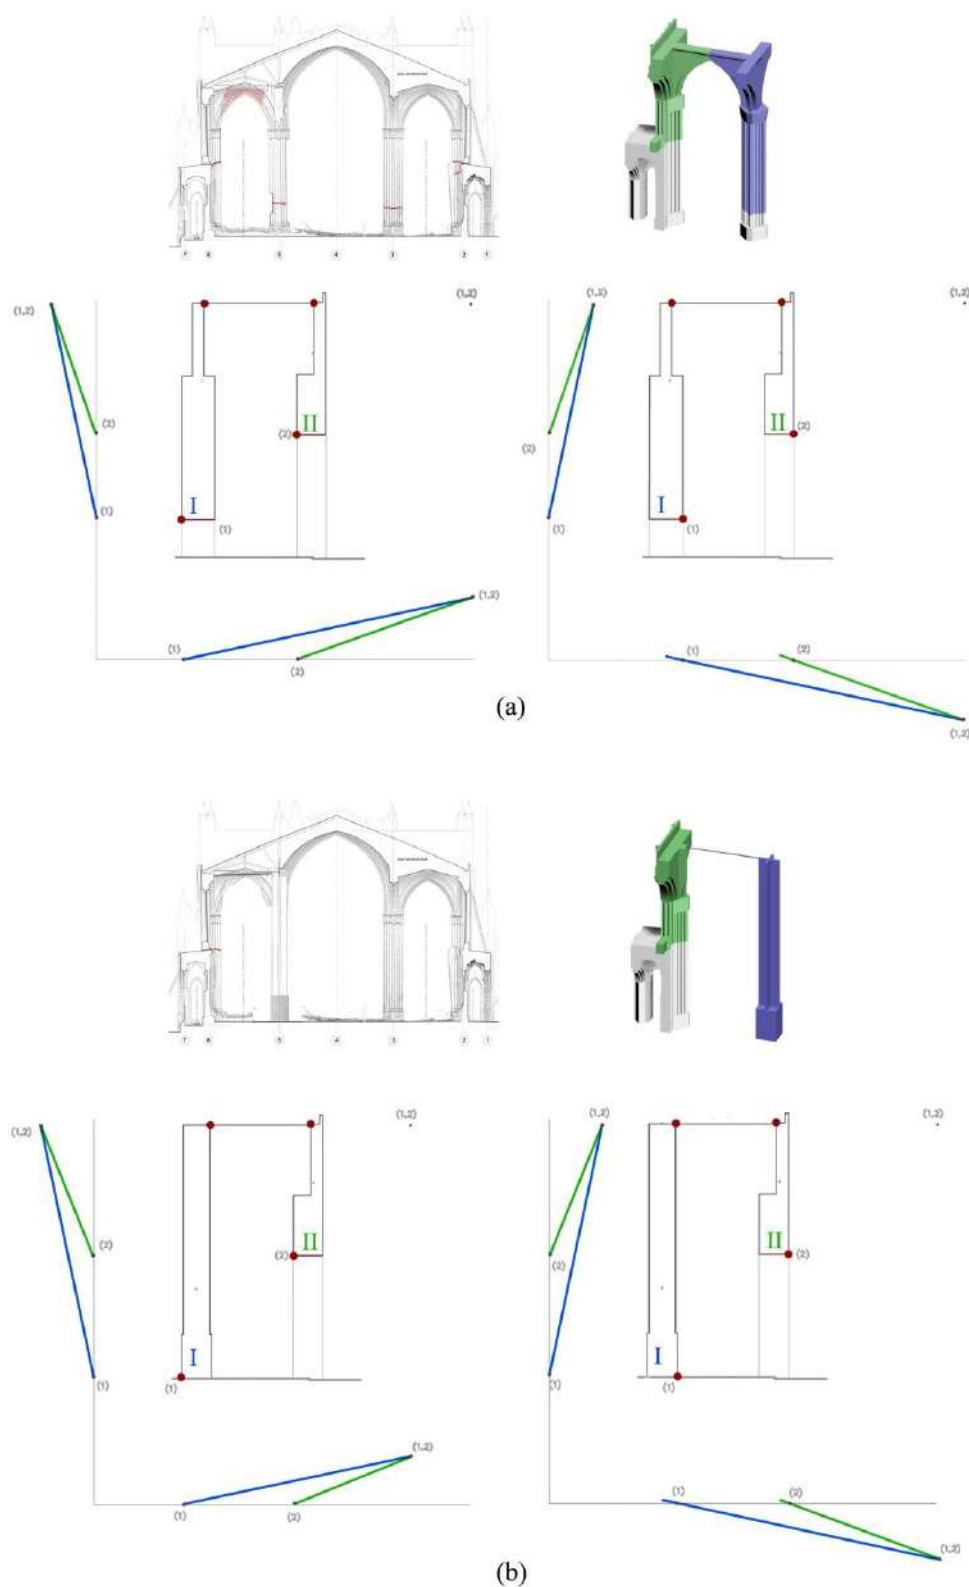
- (i) Concerning the in-plane behavior, the activation of four-hinge collapse mechanisms has been detected in all the transverse arcades of the side aisles (Fig.5.3.11). As predicted by the theoretical models (Romano&Ochsendorf, 2009; Misseri&Rovero, 2017), this failure depends fundamentally on the thickness of arch (defined by the ratio of the thickness compared to the pointed radius,  $t/R_{point}$ , and the ratio of the eccentricity compared to the circular radius,  $e/R_{circ}$ ) and on the angle of embrace ( $\alpha$ ). In fact, the transverse arcades of the Basilica present a

thin pointed arch ( $t/R_{\text{point}}=0.143$ ;  $e/R_{\text{circ}}=0.536$ ) with a large angle of embrace ( $\alpha=90^\circ$ ), consistently with the values proposed in (Romano&Ochsendorf, 2009). These collapse phenomena were recorded in several neo-gothic churches of Santiago, made up in fire-brick: San Saturnino, Santa Filomena, Los Sacramentinos, San Pedro churches (CMN, 2008; 2010; 2014). All these buildings have reported deep cracks in the intrados at the crown and at the base extrados of the arches, developing the activation of the in-plane mechanisms of the arcades. Generally, the collapses occurred due to the formation of fourth hinge or to the sliding. As confirmed by historical sources (Berg et al., 1996), the in-plane mechanisms that have involved the transverse arcades of the Basilica del Salvador were iterative, relapsing and had triggered degenerative processes. At the current state all the transverse arches, which connected the walls of the aisles to those of the central nave, are collapsed together with the arches of the longitudinal west wall.

**Figure 5.3.17** – In-plane mechanism of the transverse arcade of the side aisles: (a) SAw-e (original configuration) west and east side aisles; and (b) SAw3-4 (current state) west side aisle.

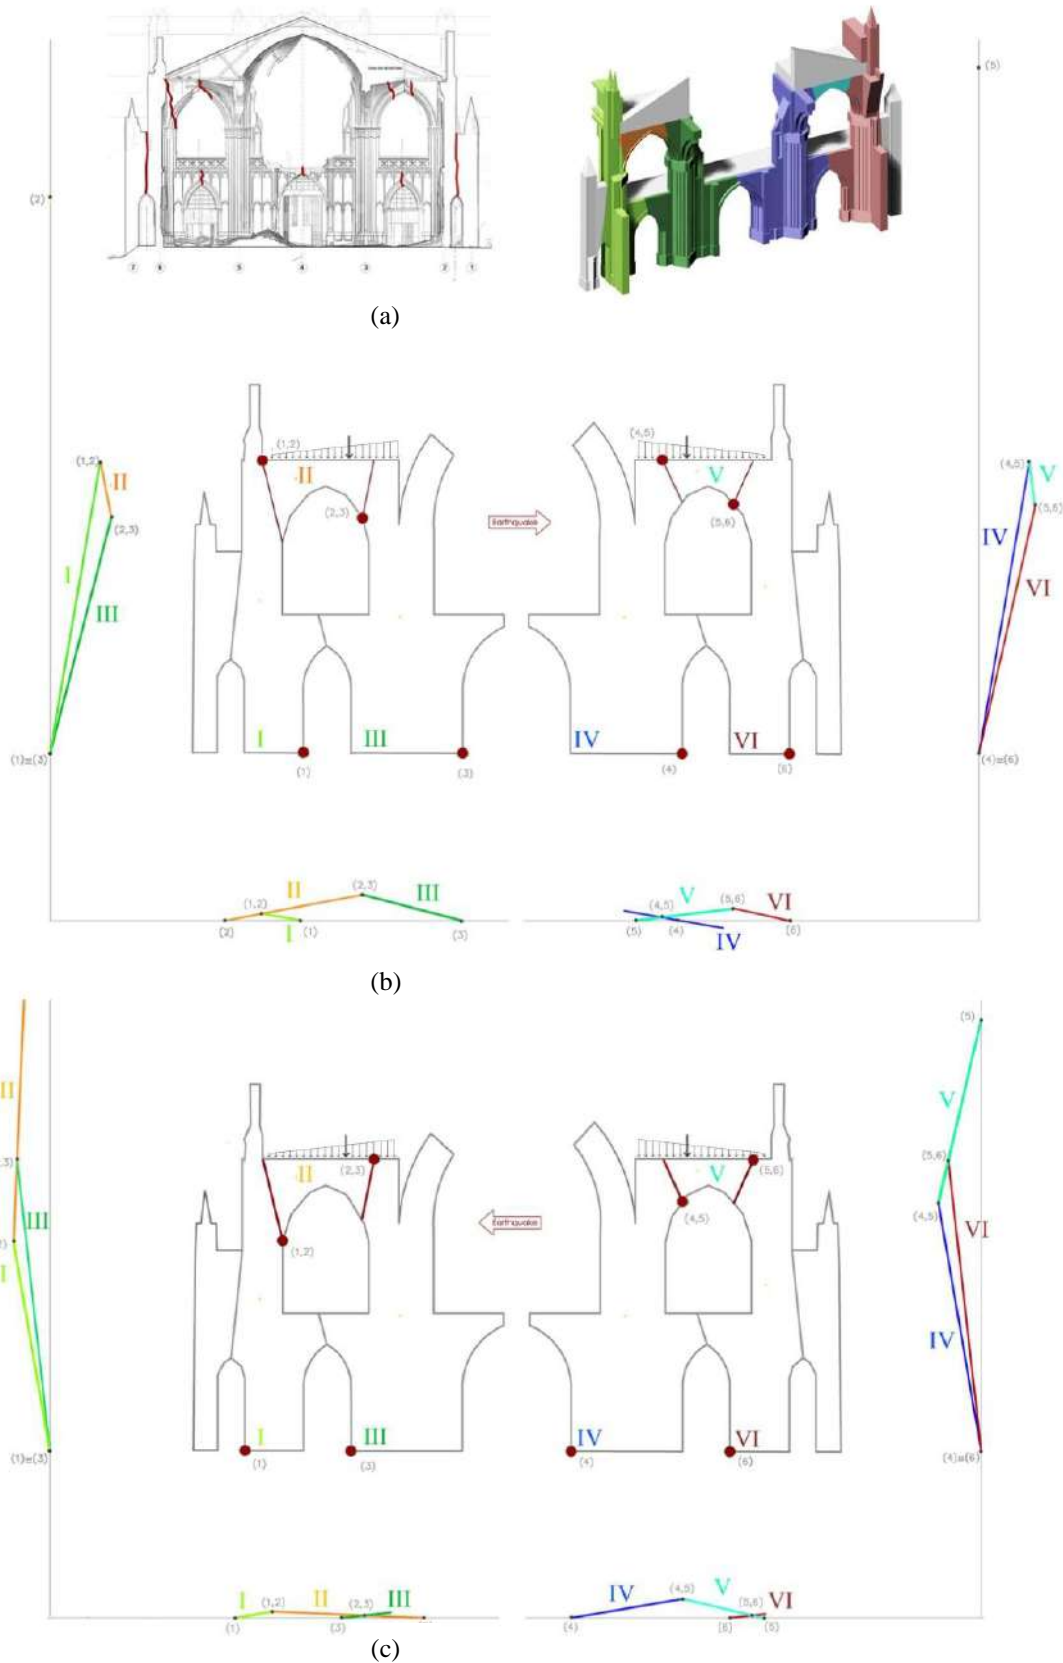
In relation to the in-plane behavior of the transverse arcade-walls of the narthex, dangerous disconnections occurred in the arches system during past seismic shake, both in the 1985 and 2010 earthquakes. If on one hand, the RC slab

Figure 5.3.18– In-plane mechanism of the transverse arcade of the Narthex at the current state.

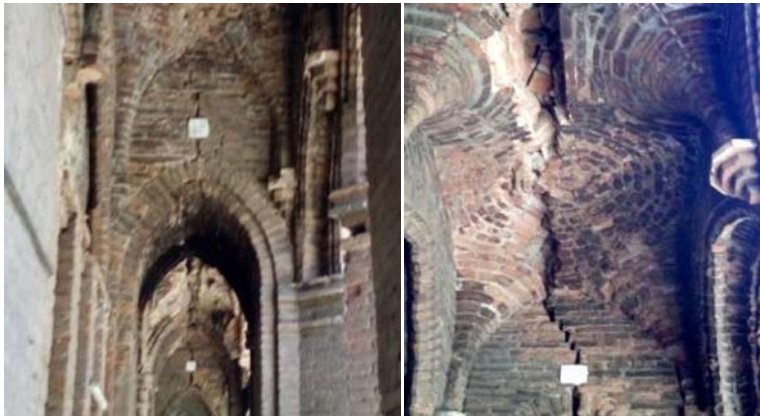
**Figure 6.2** - Deep cracks in the transverse arches of external gallery of Basilica del Salvador.

The out-of-plane behaviors of the external walls of the east and west gallery are associated with worryingly horizontal fractures along their entire length, present in the intrados of the firebrick vaults, indicating a separation of the external walls of the side aisles.

**Figure 6.2** – Deep cracks in the transverse arches of external gallery of Basilica del Salvador.

For example, in the case of the Basilica del Salvador (Chapter 5.3), the introduction of TRs would effectively counteract the activation of overturning mechanism of the EAw-e1 macro-elements that compose the outer walls of the external gallery (Fig.6.2).

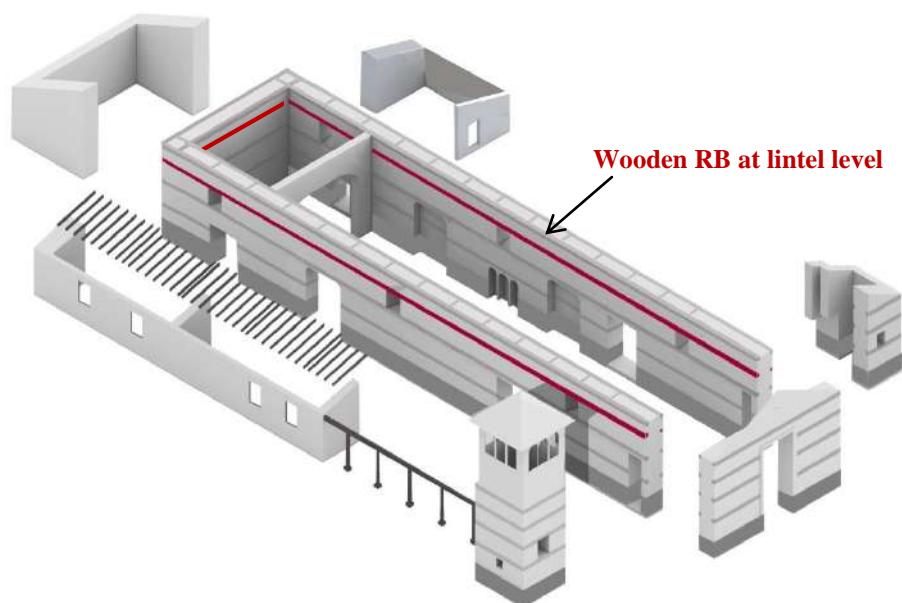
**Figure 6.5** - Retrofitting intervention for Malloa church: wooden ring-beam at lintel level

restraint device, and the length of the timber element which depends on the presence of carpentry links. In the case of the Malloa church, the distance between the top ring-beam and the next one is 2.72m, due to the presence of big openings.

This excessive distance between the two RBs resulted in the devices being ineffective and leads to the activation of out-of-plane collapse mechanisms in the masonry portions between them. Thus, an effective consolidation intervention would introduce a new RB among the original ones in order to reduce the free inflection length of the wall (Fig.6.5).

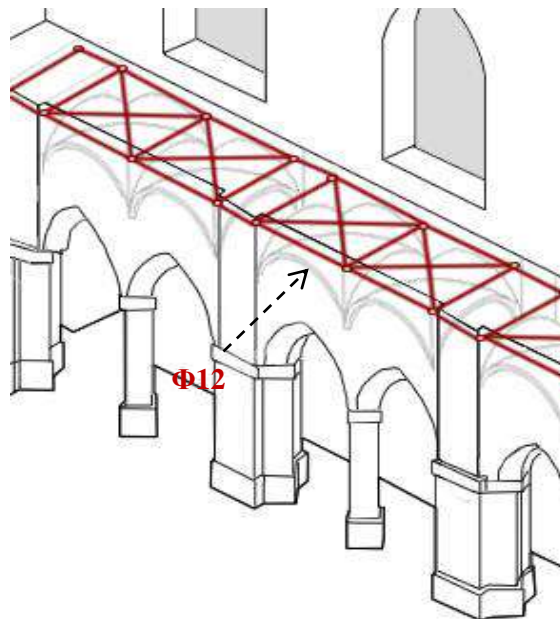
**Figure 6.8** - Retrofitting intervention for Basilica del Salvador: steel tie-rod.

The current seismic performance of Basilica del Salvador gallery vaults, the only one building with masonry vaults between the 106 churches analyzed in Chapter 2 and 4, and the modified behavior due to the introduction of CBs devices are checked in Table 6.11, Fig.6.8, using IKA analysis. The load kinematic multiplier,  $\alpha_0$ , of EAw-e1 macro-blocks is equal to 0.112 and the spectral acceleration,  $a_0^*$ , is equal to  $0.815 \text{ [m/s}^2\text{]}$ , (Table5.3.1). The Demand Acceleration at ground level is  $2.91 \text{ m/s}^2$  according to Nch2745Of.2013. For each bay it is considered a circular section of four cross bracings (two transversal CBs with length 5.91m, two diagonal CBs with length 8.36m, all CBs with diameter 12mm, Young modulus  $2100000 \text{ daN/cm}^2$ ,  $f_y=2350 \text{ daN/cm}^2$ , and  $\gamma=7850 \text{ daN/m}^3$ ). The  $\alpha_{0CB}$  is 0.401 for  $T_{CB} = \min(T_t, T_m) = \min(106 \text{ kN}$ , and  $344 \text{ kN})$ .

The comparative analysis of the current state and the state after the retrofitting intervention (Table 6.11) shows the achievement of the required safety levels ( $I_s=1$ ) for the OOP mechanism of EAw-e1. The IQI Index results equal to 1.8.

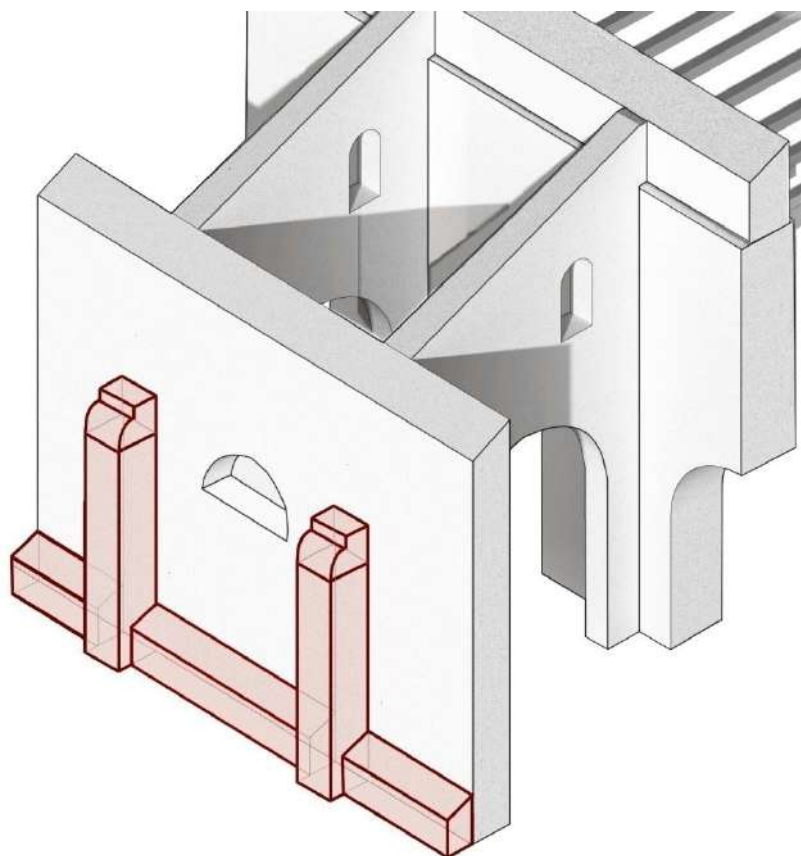
*Figure 6.11 - Retrofitting intervention for San Francisco church: Brick Buttresses.*

As seen in Chapter 5.2 the most vulnerable macro-element in San Francisco church after the 2010 Maule earthquake were the transverse arcades (TA). In particular, preliminary safety estimation, through Safety Theorem of Limit Analysis (Fig.5.2.11) of the static consistency of the church, showed the limit condition of the thrust line of the transverse arcade F. Moreover, corresponding to this macro-element, LKA and LDA analyses show the activation of OOP mechanisms in the transept walls.

Considering the recommendations for buttresses design of Guidelines for earthquake resistant non-engineered construction (Arya et al., 2014), the only requirement not met is  $a \geq 3t$ , due to the need to realize an intervention respectful of the stylistic typology (NC&V), that has  $a = t$ . For practical reasons due to the lack of sufficient transit space in the sidewalk adjacent to the church wall:  $L = 8.65 \text{ m} \leq 10t = 10 \text{ m}$ ,  $L = 8.65 \text{ m} \geq t^2/h = 0.095 \text{ m}$ ,  $a = 1 \text{ m} \geq t = 1$ ,  $c = 1 \text{ m} \geq t = 1 \text{ m}$ ,  $h = 10 \text{ m} < 8t = 8 \text{ m}$ .

With the aim of averting the triggering of the OOP failures of the NT macro-element and the in-plane behavior of transverse arcade TA, the introduction of buttresses is proposed, Fig.6.11, imposing  $a_0^*$  equal to the Demand Acceleration at ground level ( $2.31 \text{ m/s}^2$ , according to Nch2745Of.2013).

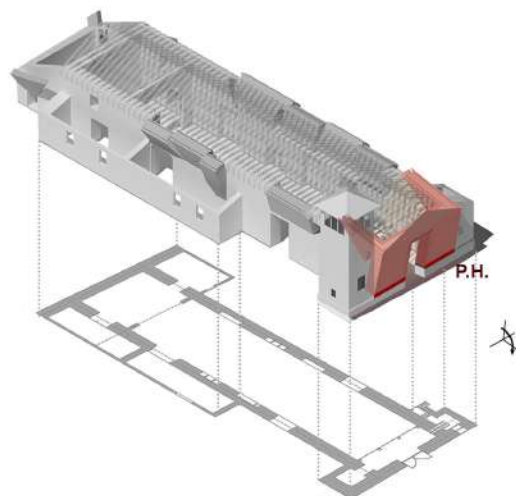
## CRACK PATTERN OF MALLOA PARISH\_MP01

— Crack pattern after 2010 Maule earthquake

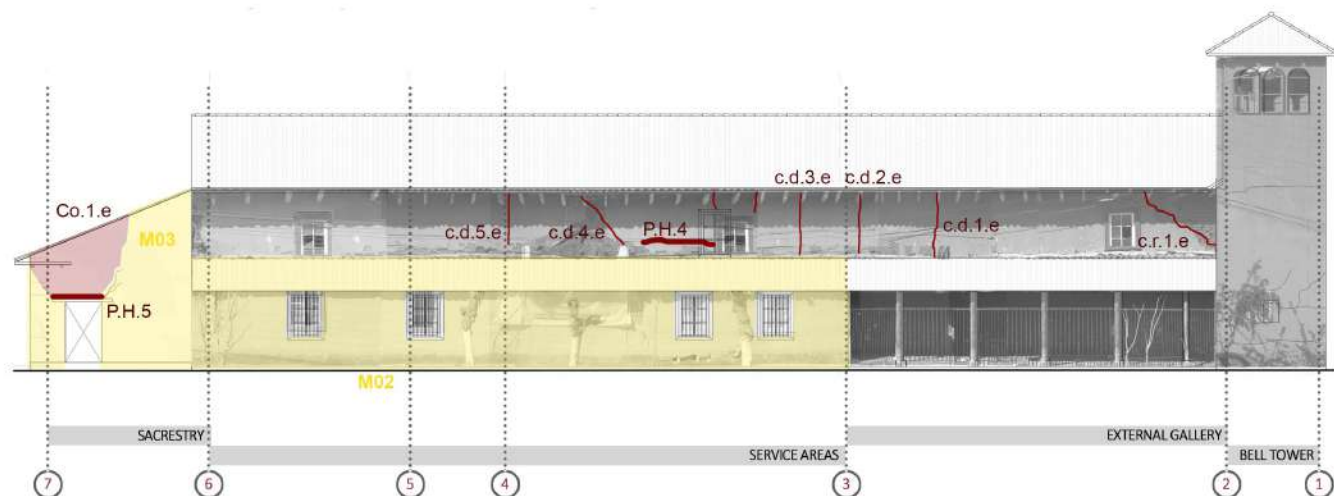
WEST ELEVATION, AXIS A

## CRACK PATTERN OF MALLOA PARISH\_MP02

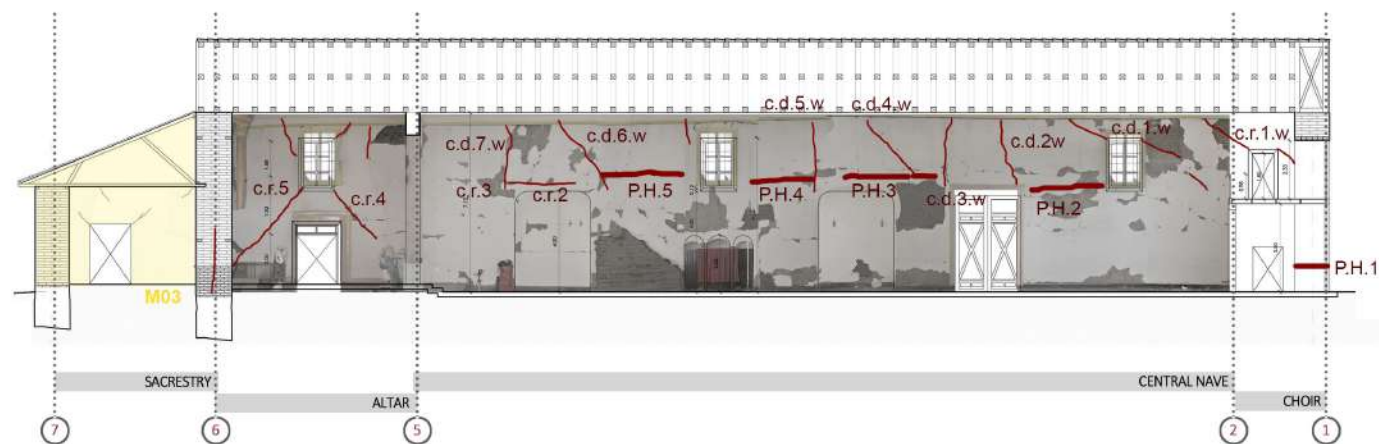
WEST ELEVATION, AXIS B

## CRACK PATTERN OF MALLOA PARISH\_MP03

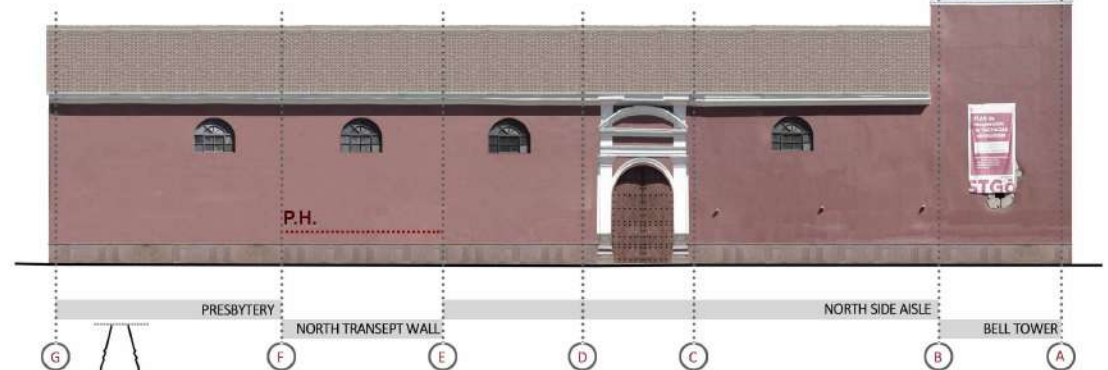
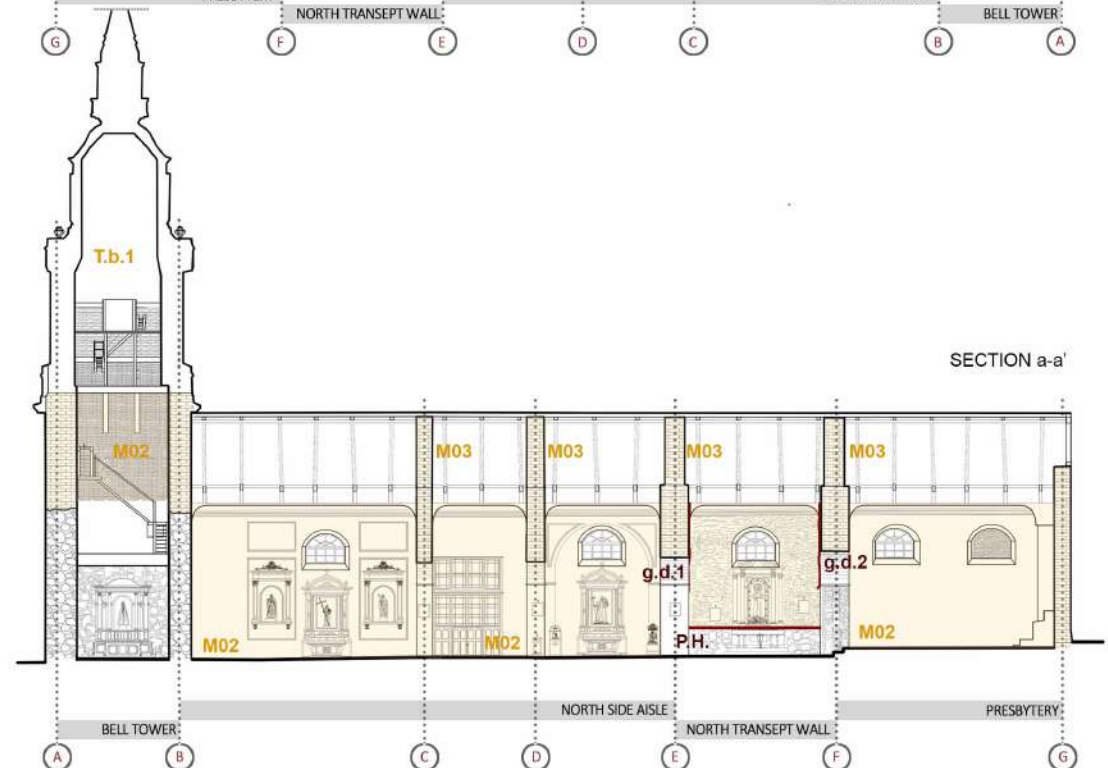
SOUTH ELEVATION, AXIS 1

## CRACK PATTERN OF SAN FRANCISCO CHURCH\_SF01

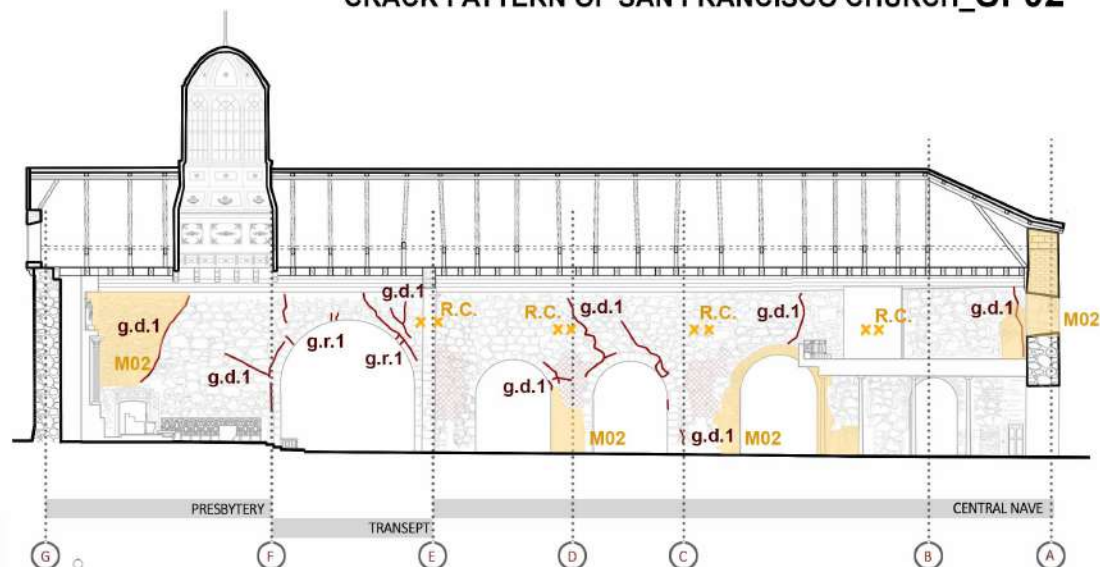
SECTION b-b'

## CRACK PATTERN OF SAN FRANCISCO CHURCH\_SF02

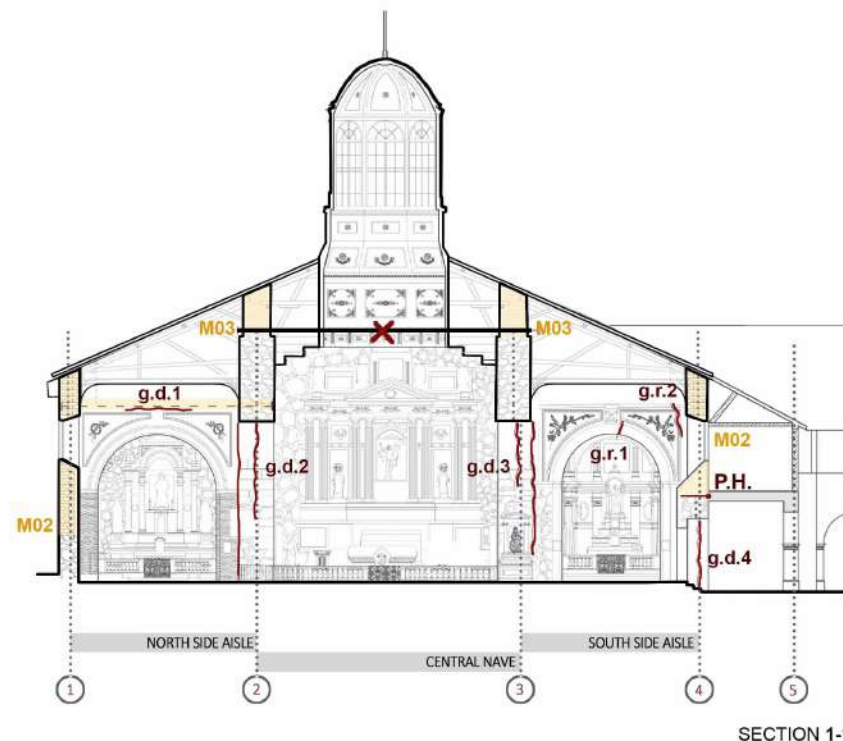
SECTION 1-1'

## CRACK PATTERN OF SAN FRANCISCO CHURCH\_SF03

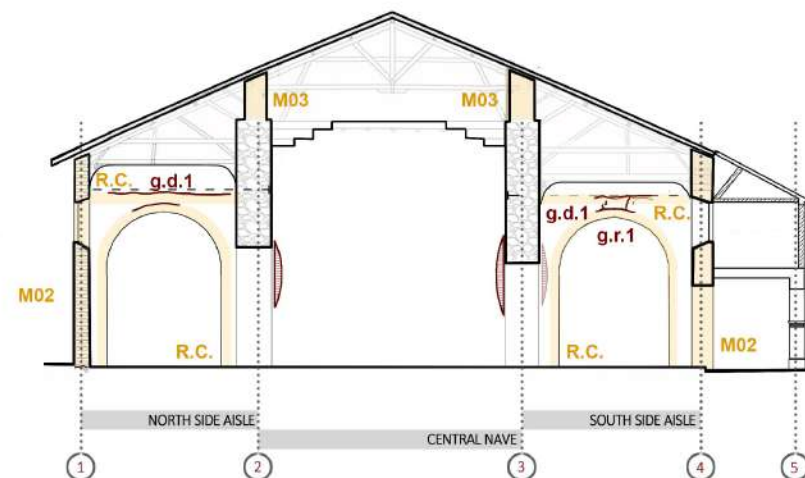
SECTION 3-3'

## CRACK PATTERN OF SAN FRANCISCO CHURCH\_SF04

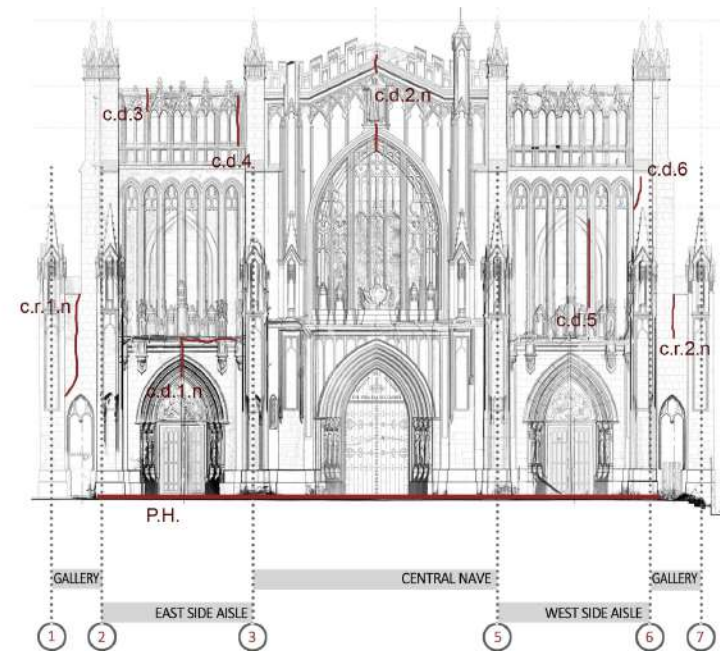
NORTE ELEVATION, AXIS B

## CRACK PATTERN OF BASILICA DEL SALVADOR\_BS01

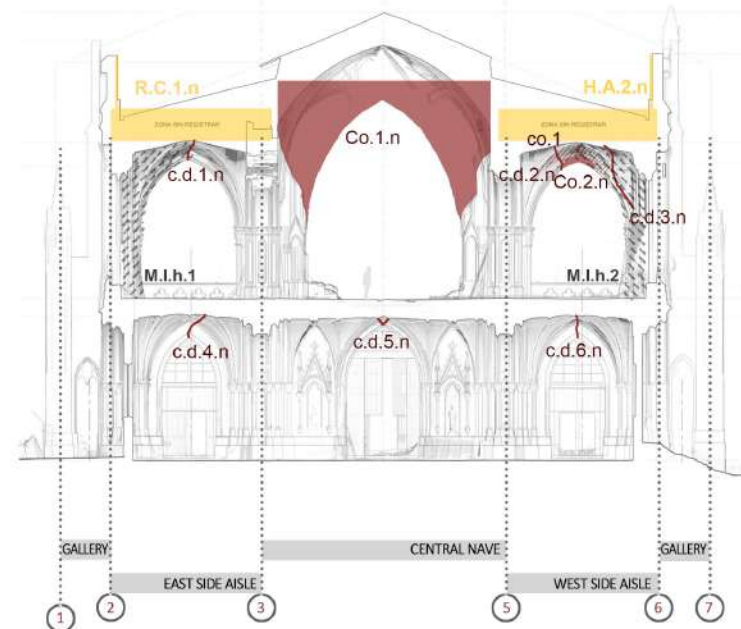
NORTH ELEVATION, AXIS C

## CRACK PATTERN OF BASILICA DEL SALVADOR\_BS02

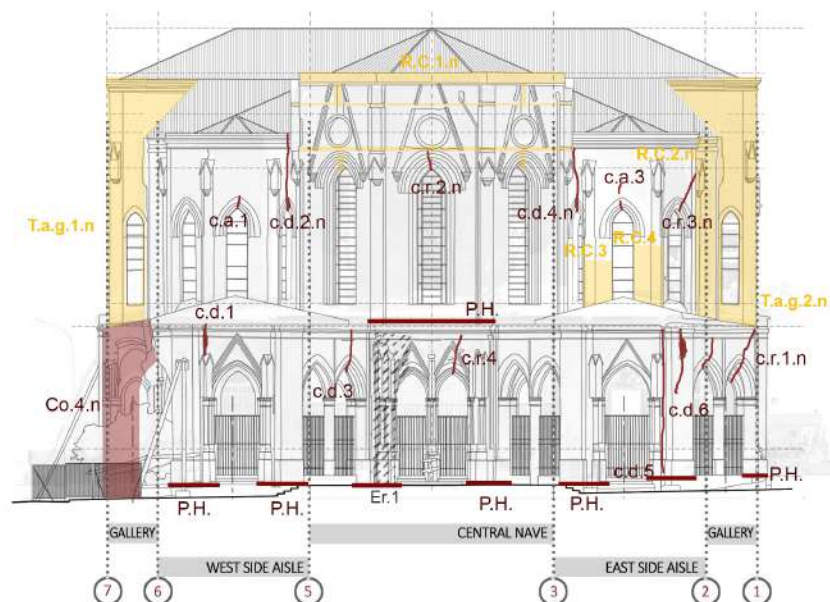
NORTH ELEVATION, AXIS P-J

## CRACK PATTERN OF BASILICA DEL SALVADOR\_BS6

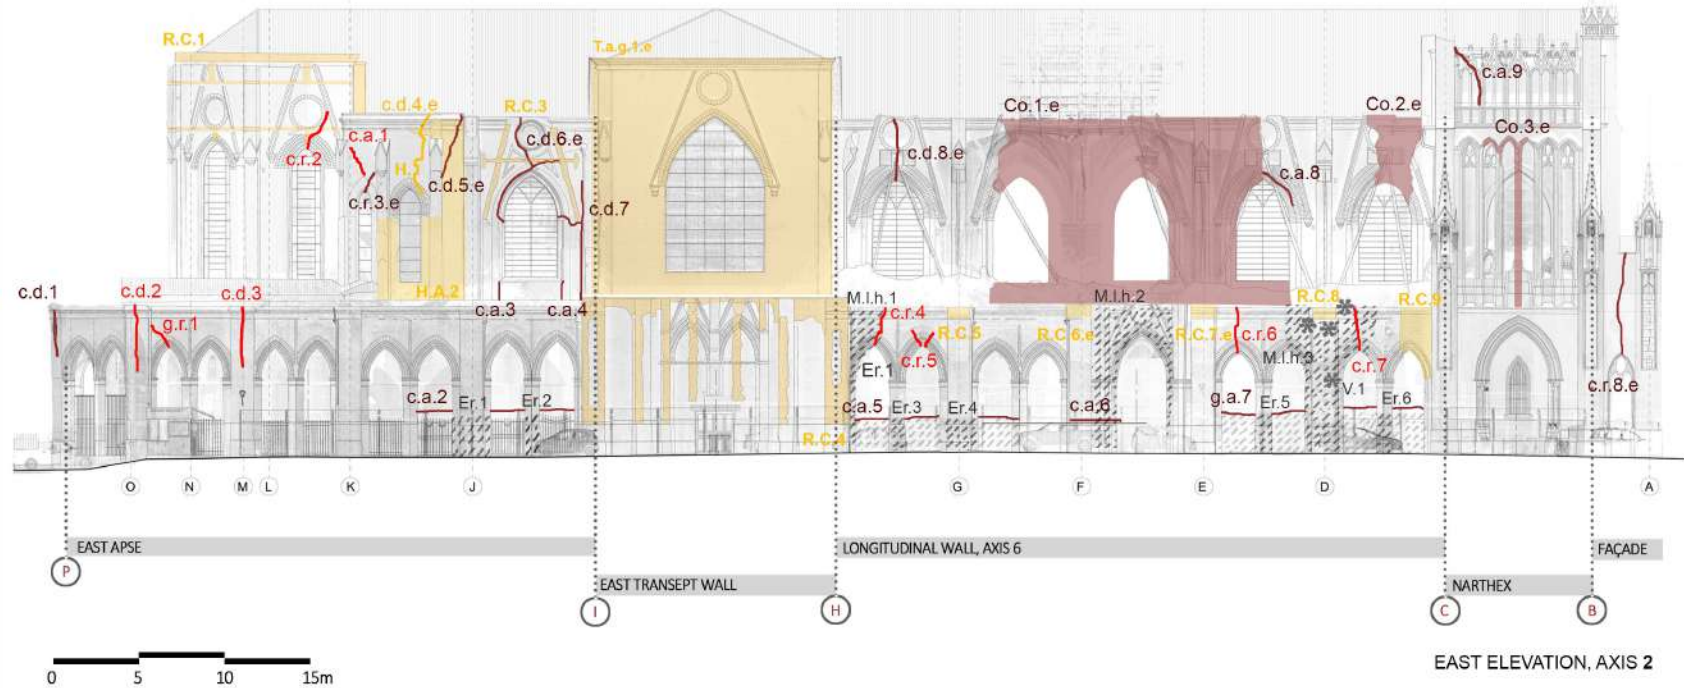
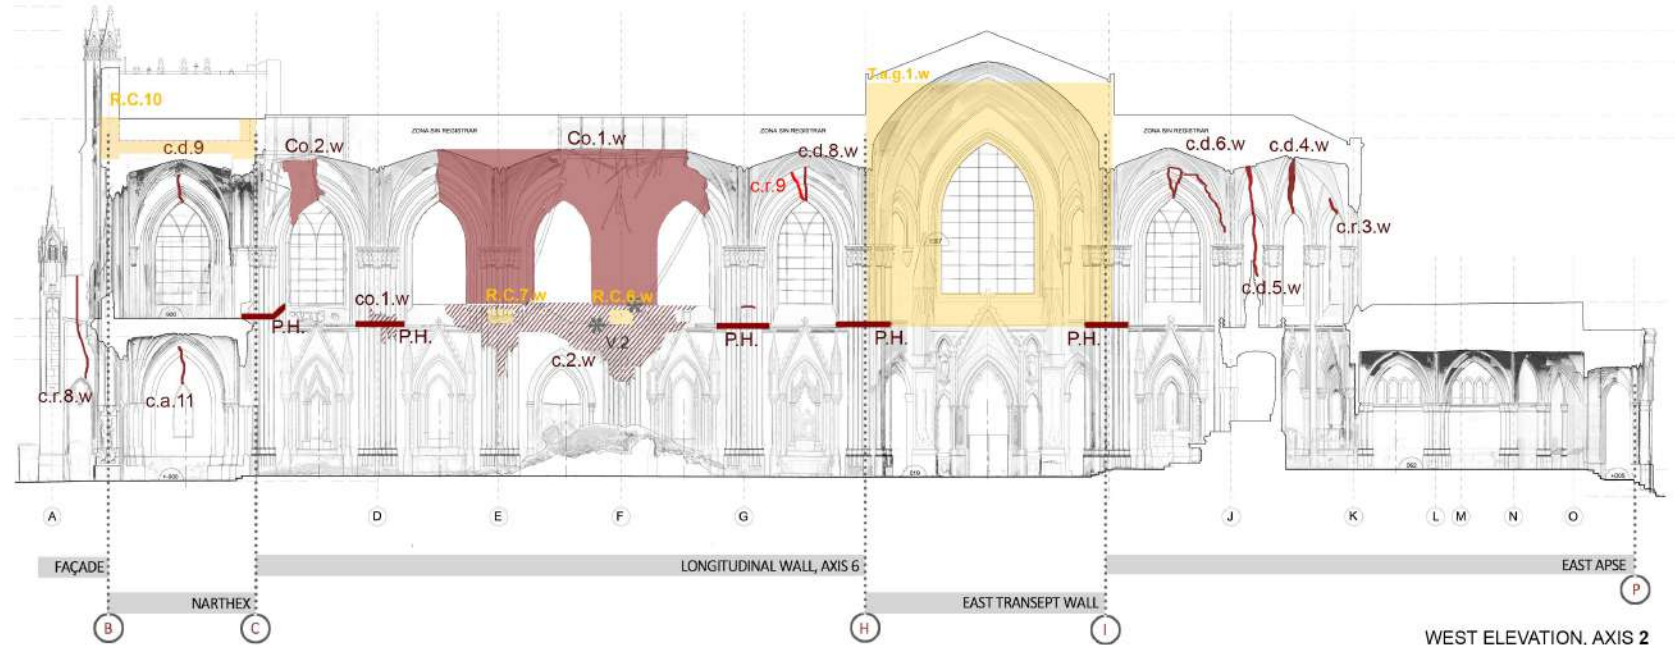
WEST ELEVATION, AXIS 2

## CRACK PATTERN OF BASILICA DEL SALVADOR\_BS07

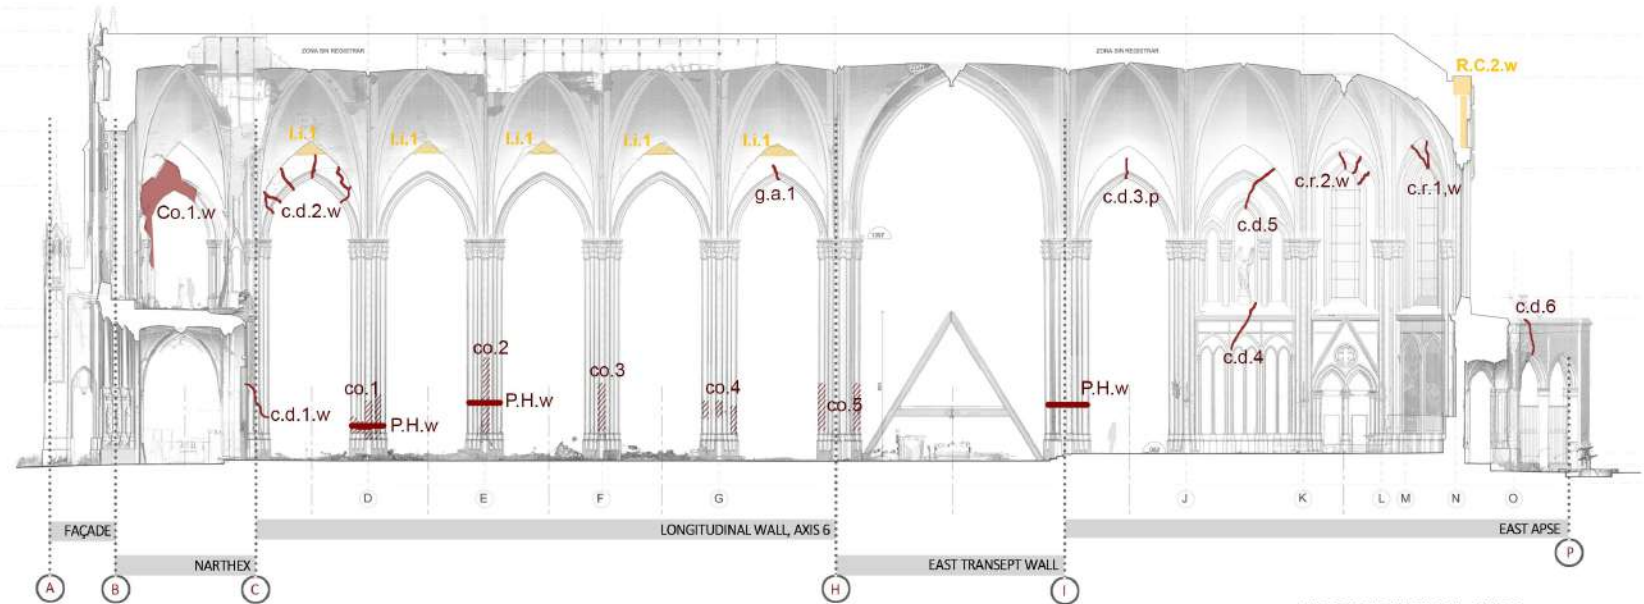
WEST ELEVATION, AXIS 3

## CRACK PATTERN OF BASILICA DEL SALVADOR\_BS08

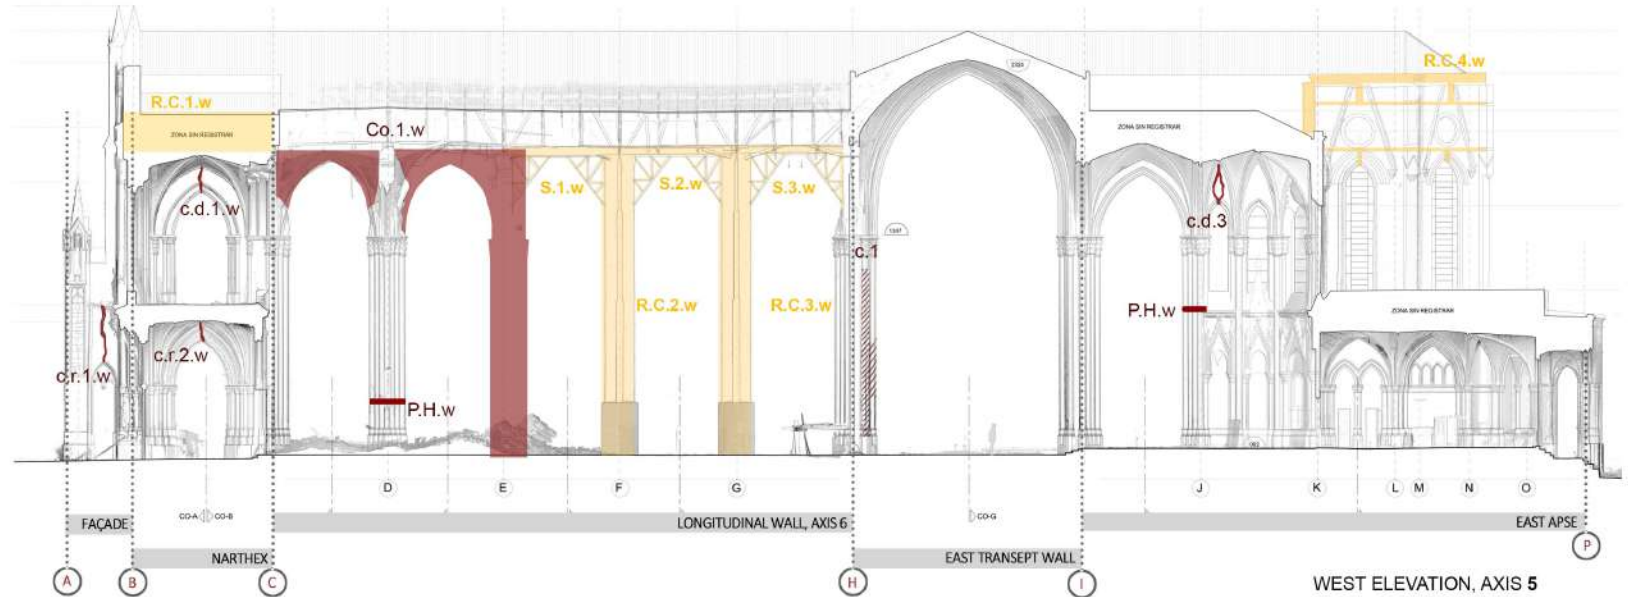
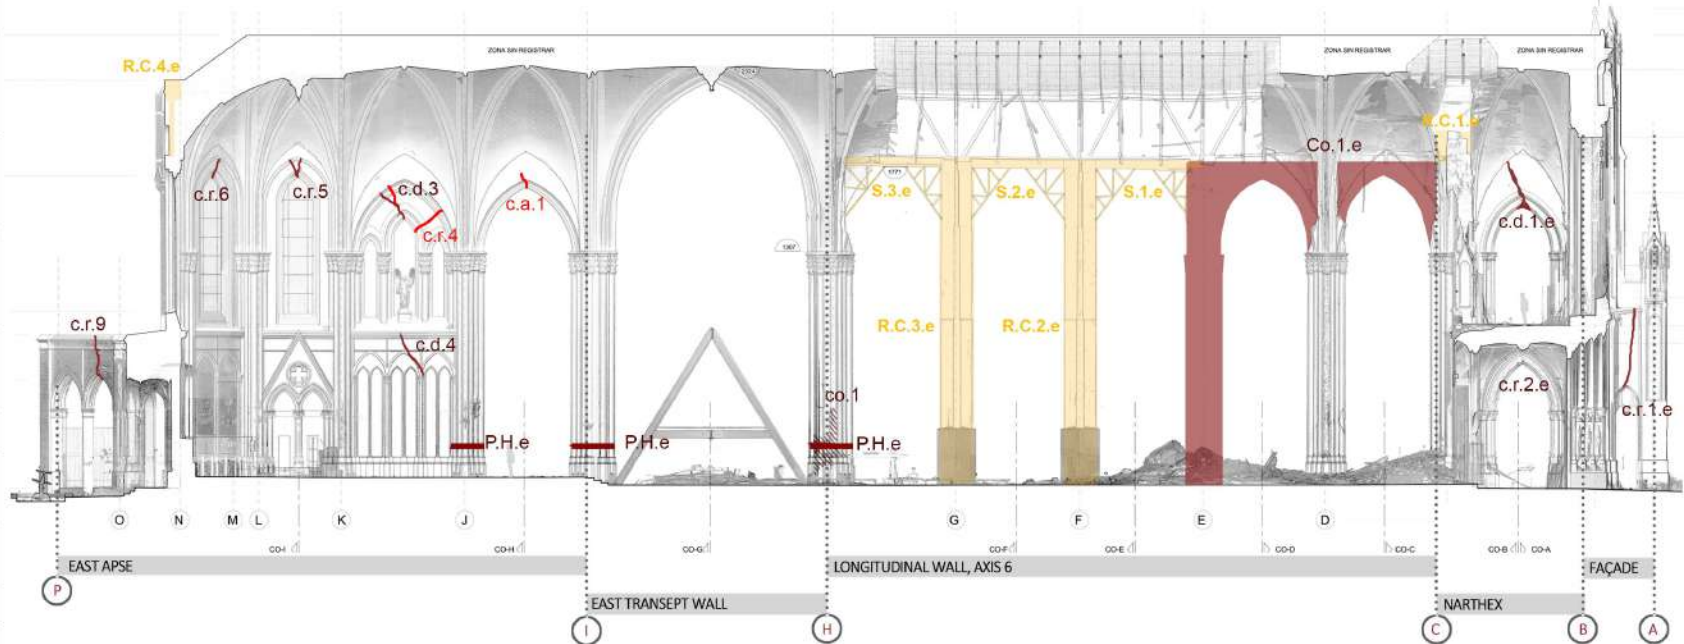
EAST ELEVATION, AXIS 5

## CRACK PATTERN OF BASILICA DEL SALVADOR\_BS09

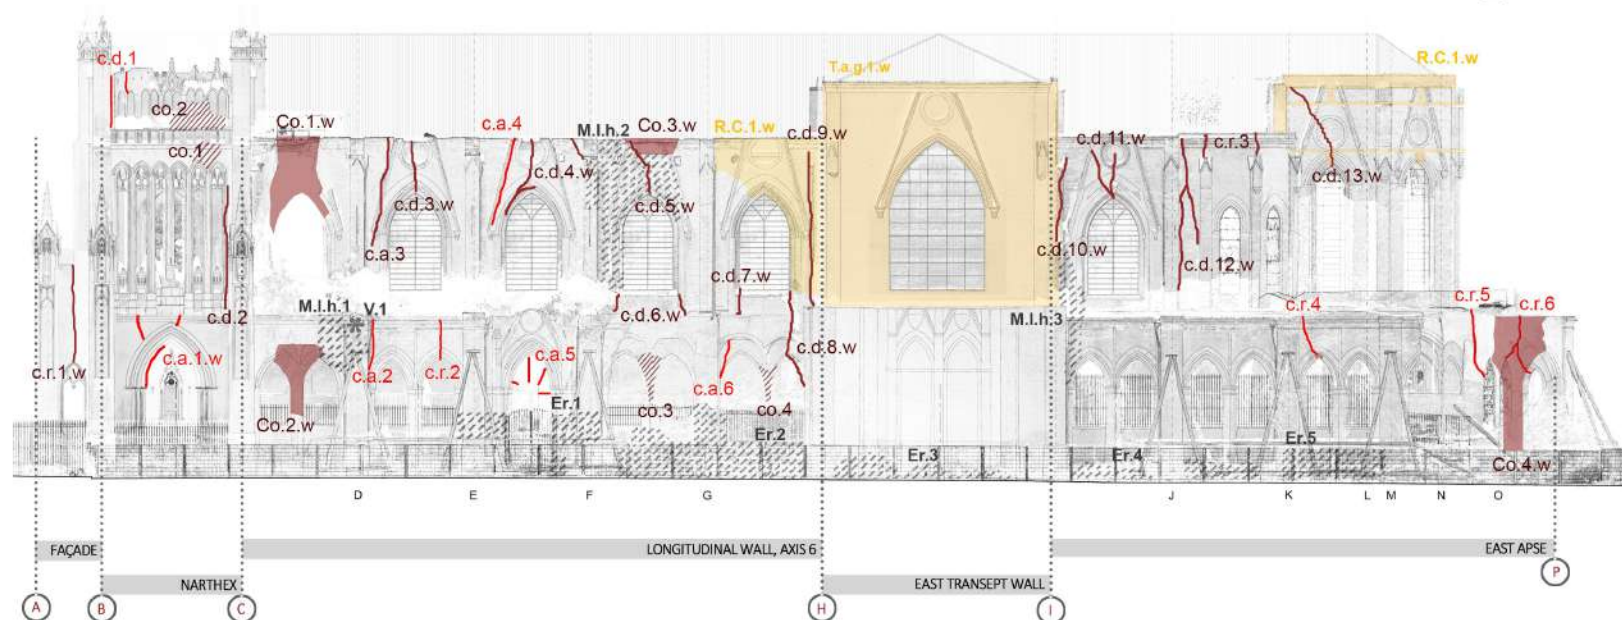
SIDE WEST ELEVATION, AXIS 6

## CRACK PATTERN OF BASILICA DEL SALVADOR\_BS10
