PART I: RESPONSE OF REINFORCED CONCRETE BUILDINGS IN CONCEPCION DURING THE MAULE EARTHQUAKE

Thesis submitted to the Office of Research and Graduate Studies in partial fulfillment of the requirements for the Degree of Master of Science in Engineering

Santiago de Chile, (December, 2011)

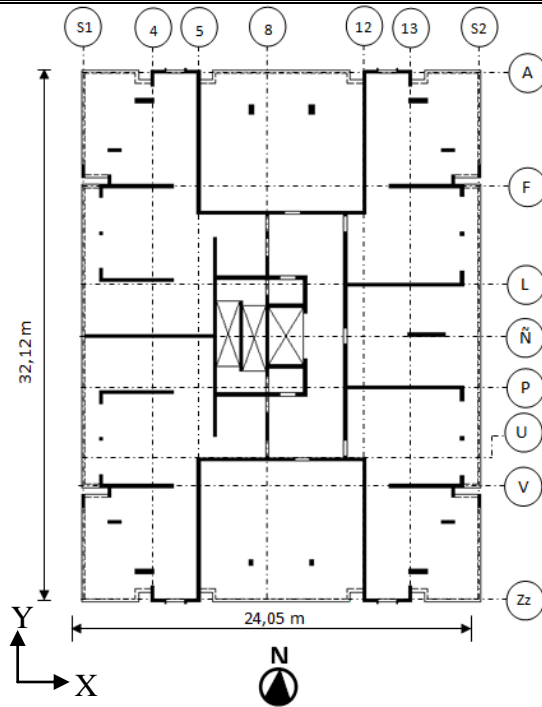
(c) AH-2 structural building plan

This building sustained wall crushing and global wall buckling in the first story and in subterranean levels of EW walls toward the North end of the building (Figure 2-4c). Figure 6-2a and 6-2b show characteristic wall damage. The damage resulted in building subsidence especially toward the North-west corner of the building, resulting in sloping floors in several units.

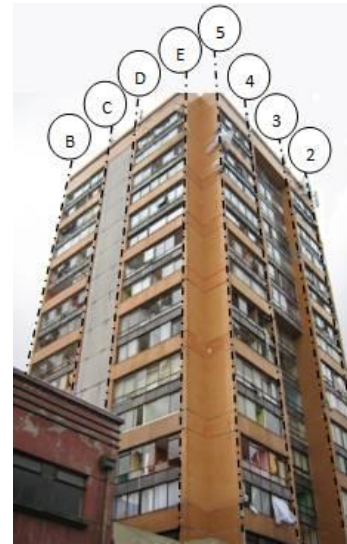
(h) TL-4 photo

Shear walls sustained combined shear and flexure/axial failures in the lower story walls oriented in the EW direction (framing lines 2-5, Figure 2-4g). Failures also occurred over the building height due to flexural coupling of spandrels framing out-of-plane into the edges of L-walls at building corners. Figure 6-4 shows typical wall damage in lower stories, illustrating diagonally oriented web reinforcement.

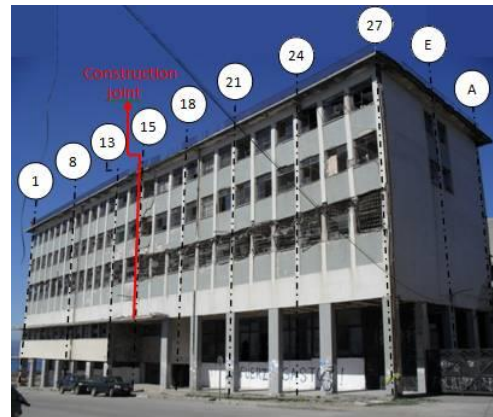
(j) MD-5 photo

Building MD-5 had significant damage in the columns of the 3rd story (double height level). While building MD-5a showed total hinge formation, building MD-5b showed partial hinge formation (in framing lines A and I, Figure 2-4i). Top stories in MD-5a moved to the West regarding its original configuration. Figure 6-5 shows typical column damage, illustrating smooth bars and corrosion.

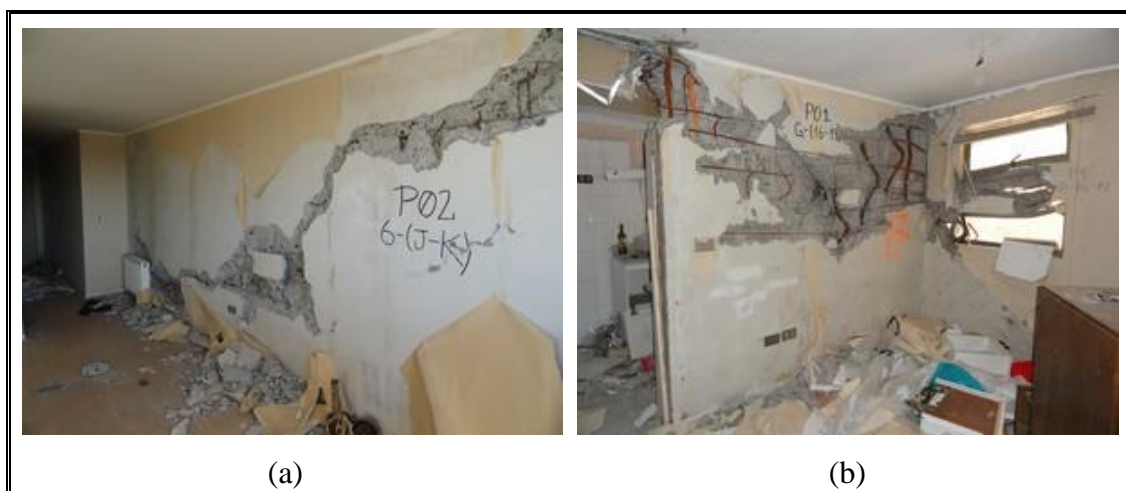
Figure 6-1: Examples of wall damage in building AA-1

Building AA-1 had significant vertical irregularity at several levels (Figure 2-4b), but wall damage concentrated in the lower two stories. Wall setbacks at the lower level may have contributed to flexure-axial crushing failures beneath the setback, but the building also sustained shear failure (passing through vertical wall piers separated by openings) and crushing failure at multiple locations, in both EW and NS oriented walls in the North half of the building (Figure 2-4a). Building subsidence led to severe damage to upper level framing system as well. Figures 6-1 shows examples of wall damage.

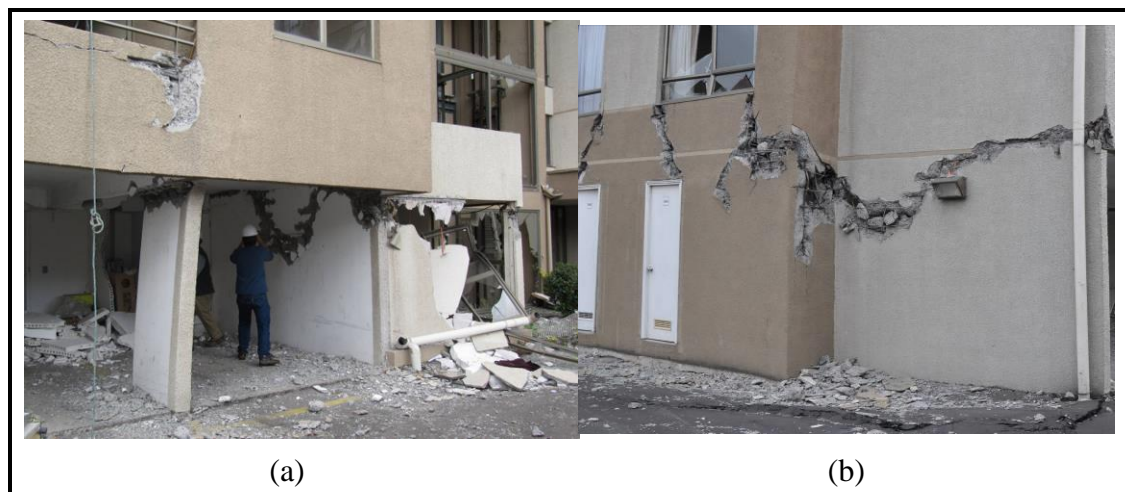
Figure 6-6: Examples of wall damage in building PR-6

This building comprised two similarly configured wings separated by a construction joint (Figure 2-4k). The wing along framing lines A-M, with longitudinal axis oriented approximately EW, was relatively undamaged. The wing along lines N-W sustained severe wall flexural and shear damage in the EW (transverse) walls, with heaved soils around the foundation suggesting rocking response. Stories one and two were the most damaged ones. Figure 6-6a shows characteristics damage to transverse walls along lines O and Q while Figure 6-6b shows characteristic damage along lines V and W.

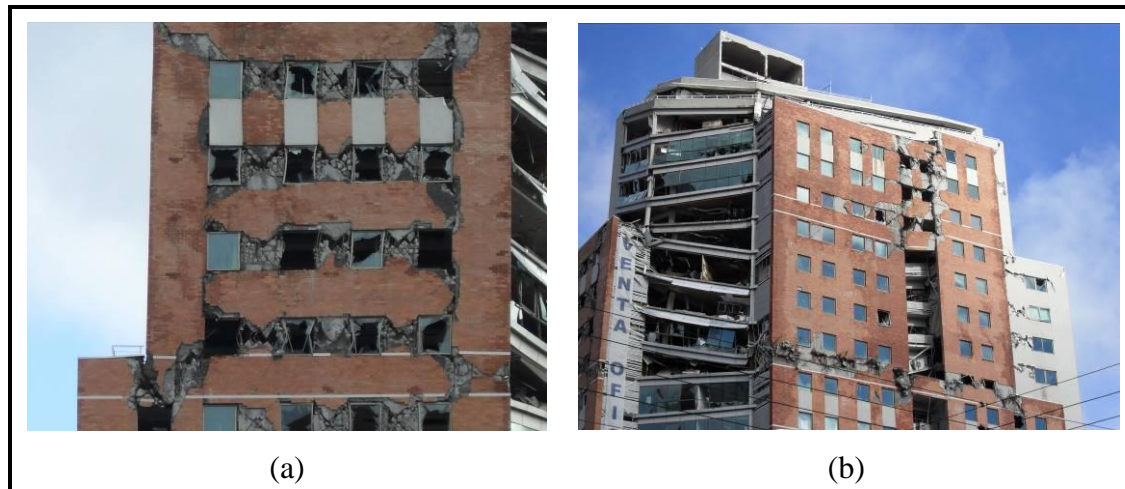
Figure 6-8: Building TO-9; (a) Shear damage in axis 1A; (b) main collapse in story 12

This building was somewhat unique among the buildings for its multiple vertical and plan irregularities. Floor masses were eccentric to the core walls over many stories, with framing setbacks especially along the eastern portion of the building, possibly leading to accentuated torsional response. Damage was relatively light in the lower twelve stories. Partial story collapses occurred at each of levels 12, 16, and 20, each story corresponding to a significant vertical or plan irregularity (Figure 2-4q). Additionally, wall piers sustained shear failures over a significant

height of the building (Figure 6-8a). The main collapse area can be seen in Figure 6-8b.

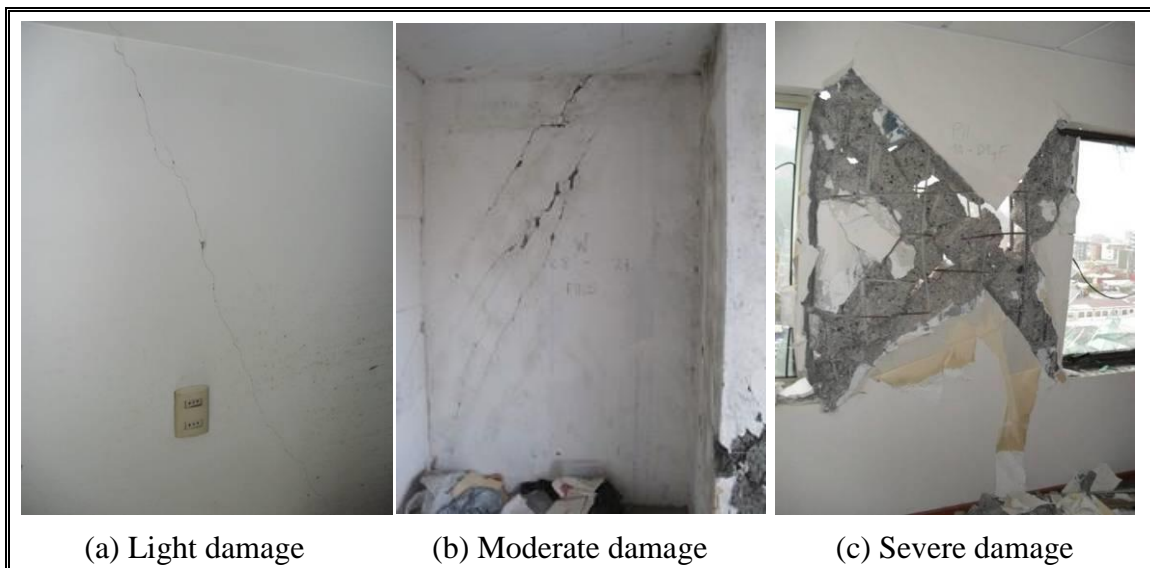
Figure 7-1: Examples of light, moderate and severe damage

The classification “Light Damage” was assigned to elements with minor cracking that lost approximately 20% or less of the original strength capacities. “Moderate Damage” referred to elements with more severe damage, likely corresponding to a modest reduction in force-resistance capacity, on the order of 50% of the original capacity. “Severe Damage” was assigned to elements that appeared to have lost a significant portion of their original force-resistance capacity, on the order of 80% of the original

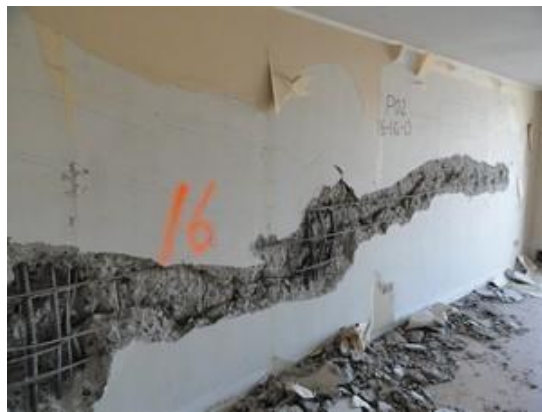
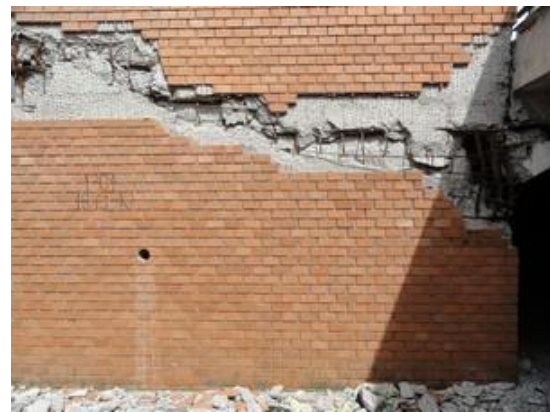
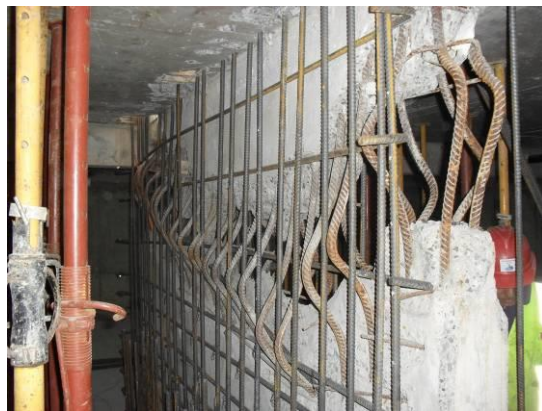
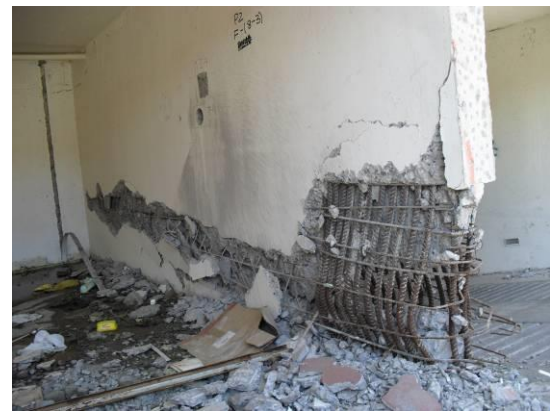
Figure 7-6: Examples of severe wall damage

Excluding building AH-2, which has localized damage in the walls of lower stories, damage in the rest of the buildings involves more than 5% of the shear walls. Buildings with considerable severe wall damage are PR-6, TO-9, RT-8 and AA-1; maximum wall damage occurs in PR-6. Damaged walls tend to occur in lower stories, 1st or 2nd with the exception of TO-9 where damage concentrates in the 12th story. Examples of the severe wall damage observed are shown in Figure 7-6.

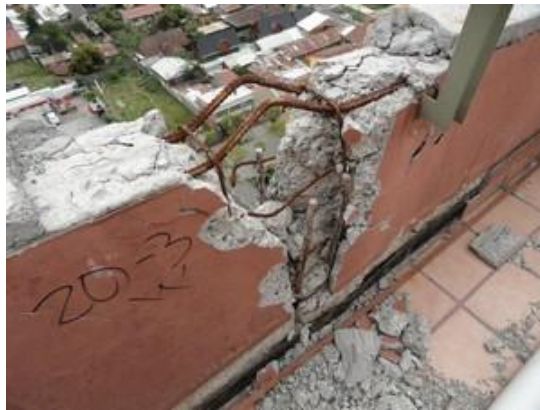
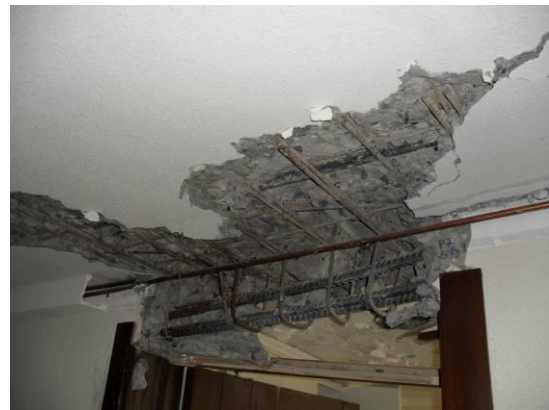
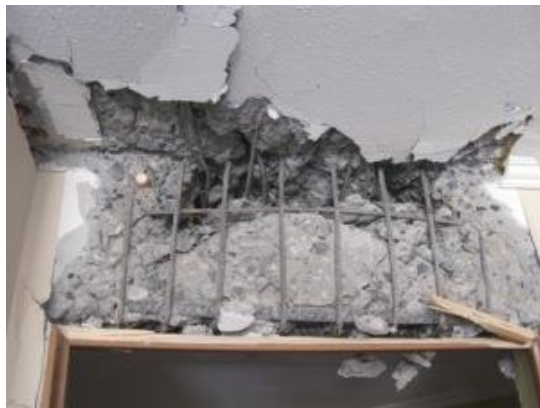
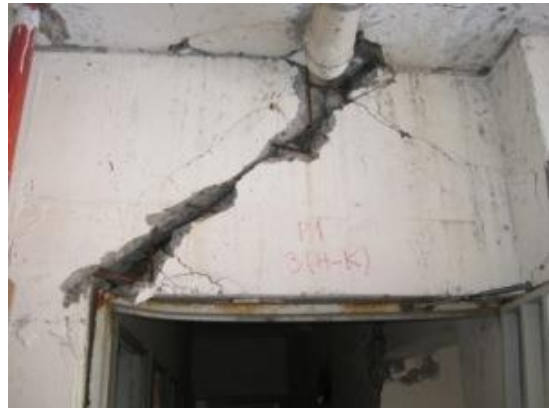
Figure 7-11: Examples of severe beam damage

Excluding AH-2, CM-3 and MD-5, all buildings have damage ratios larger than 10% in damaged beams, being larger for buildings PP-7 and RT-8. Total damage is significant for AA-1, PR-6, PP-7, RT-8 and TO-9. In TO-9 the percentage of severely damaged beams than other type of damage is considerably higher (9.30% against 0.84% for light damage and 2.95% for moderate damage). In all buildings, the stories with larger beam damage correspond to lower or upper stories, except for MD-5. This building had specific damage at story 3 which made beams at ends suffer local damage. Examples of the severe beam damage observed are shown in Figure 7-11.

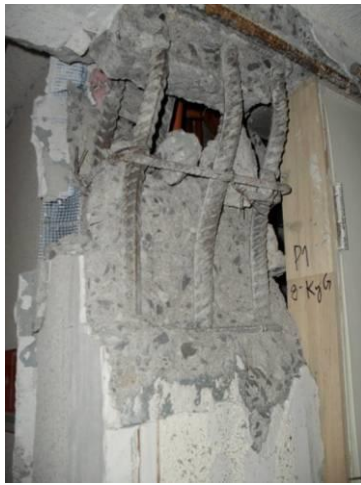
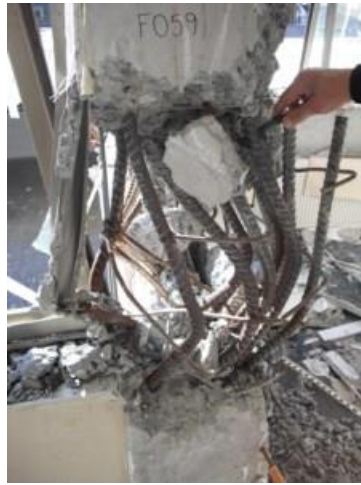
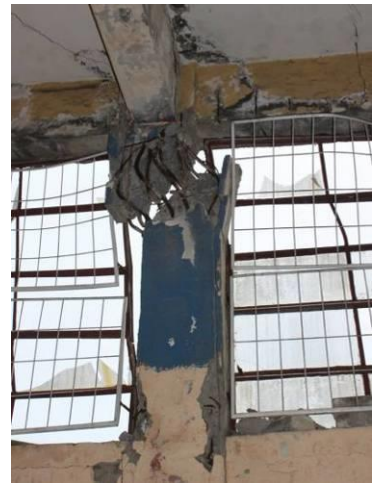
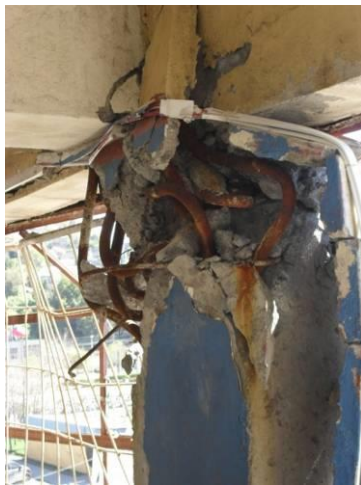
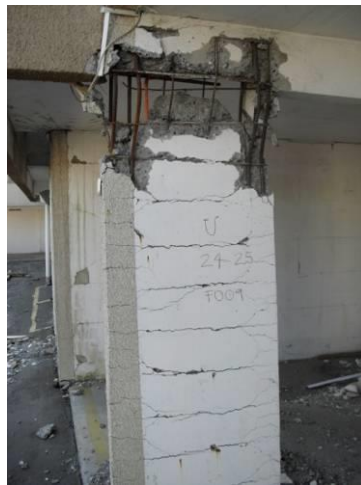
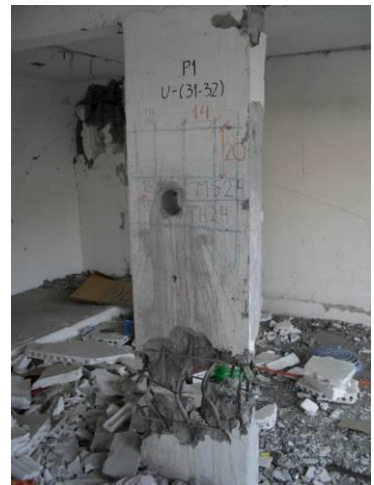
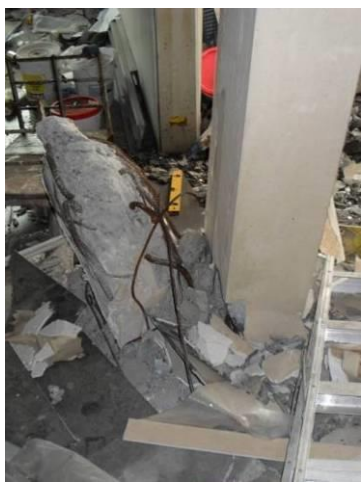
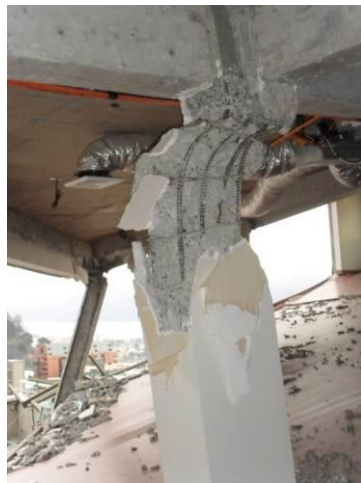
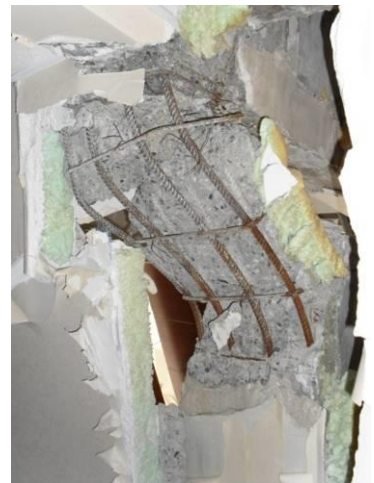
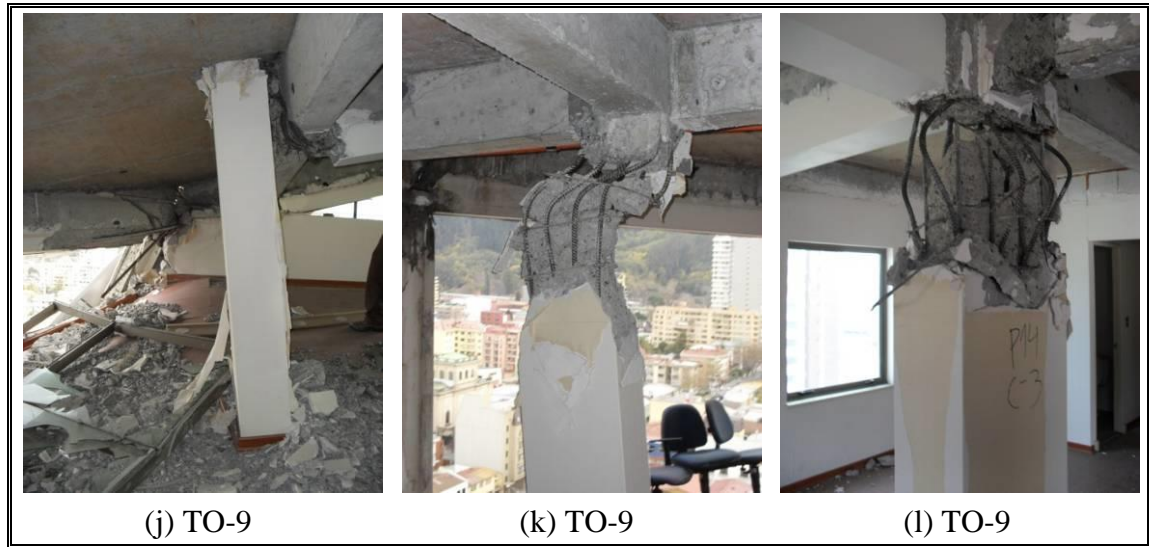
Figure 7-16: Examples of severe column damage

Please note that in general, with the exception of MD-5 and TO-9, the total plan area of columns is considerably smaller than that of shear walls. Damage in columns may be summarized as follows: building AA-1 shows light damage in story 2; column damage in AH-2 was observed in stories 1 and 15, with moderate damage in story 1; CM-3 shows damage between stories -1 and 5, with maximum severe damage in columns of story 1; severe damage in PR-6 concentrates in the first story and decreases in upper stories; buildings PP-7 and RT-8 show column damage only in the first story. In TO-9 severe damage in columns starts at the 12th story and upward, and compromises seriously the stability of the structure—column joints lack concrete and bars are buckled while punching of the slabs is

Critical conditions in columns are found in buildings TO-9, PR-6 and MD-5. These structures present about 20%, 7% and 6% of their columns severely damaged, respectively. Column damage in TO-9 is uniformly distributed between stories 12 and higher. For building PR-6, almost 70% of column damage is concentrated in story 1, while in MD-5 approximately 75% of total column damage concentrates in story 3. Examples of the severe column damage observed are shown in Figure 7-16.

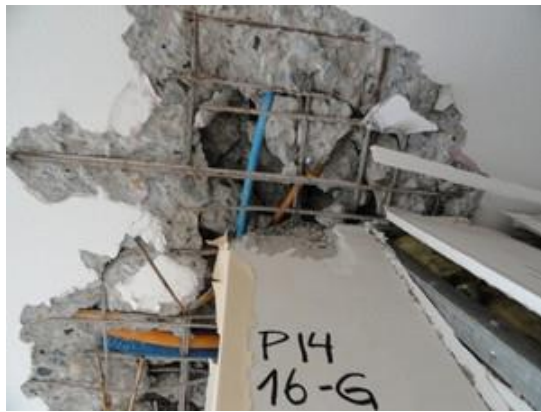
(a) AA-1

Buildings AA-1 and TO-9 are the ones with the largest slab damage ratios, 15.9% and 13.5%, respectively. In AA-1 slab damage peaks in 2nd story (matching damage in other elements). Practically all slab damage in TO-9 is severe and well distributed through stories above floor 12. For MD-5, approximately 80% of damage in slabs is present at story 3. Examples of the severe slab damage observed are shown in Figure 7-21.

Figure 7-21: Examples of severe slab damage

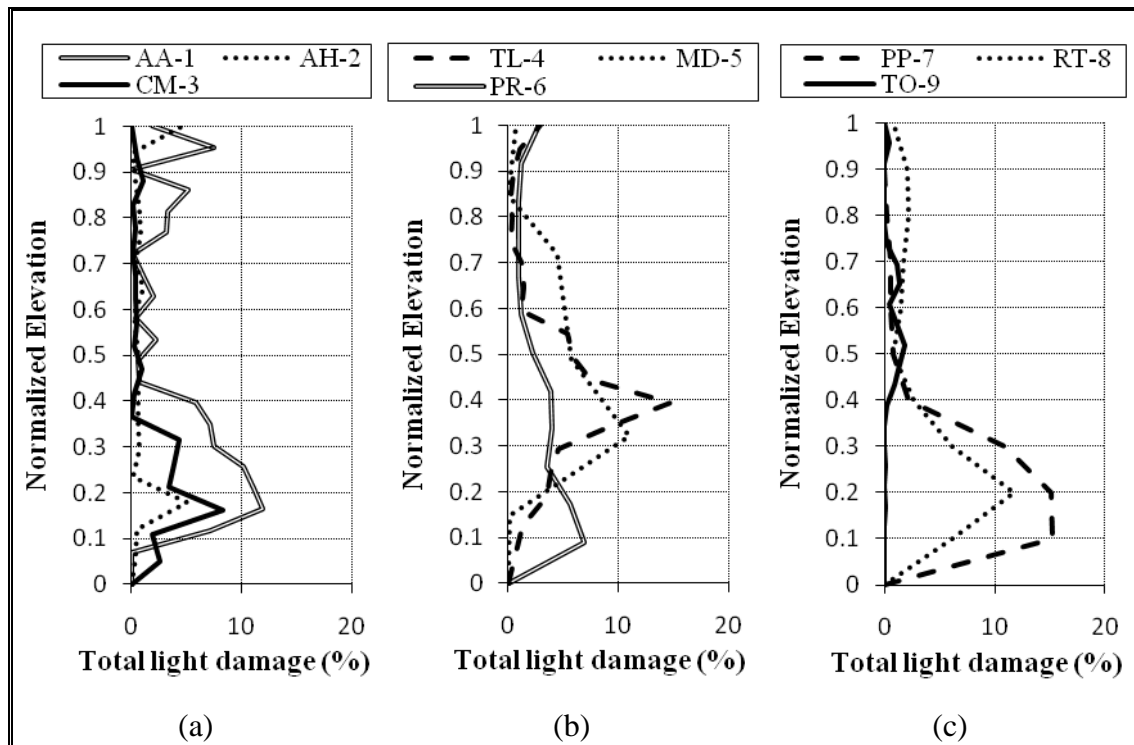
Figure 7-22: Total light damage

As expected, damage tends to concentrate in the lower stories, but the damage pattern varies among structures. Building AA-1 shows more elements with severe damage than with other intensities. This damage is higher in its lower stories. Note that moderate, severe and total damage peaks locally at stories 14 and 17 where significant irregularities are found. In AH-2 all kind of damage follows the same distribution, reaching its maximum at lower stories with a local rise at upper levels. The same behavior (but more severe) in lower levels occurs in building CM-3. For this structure maximum is reached in story -1 (with similar values at story 1 and 2). Severe damaged elements in building TL-4 are mainly present in stories 1 and 2. Maximum total damaged elements are observed in 2nd story. MD-5 shows mainly severe damage in its MD-5a structure. At story 3; moderate, severe

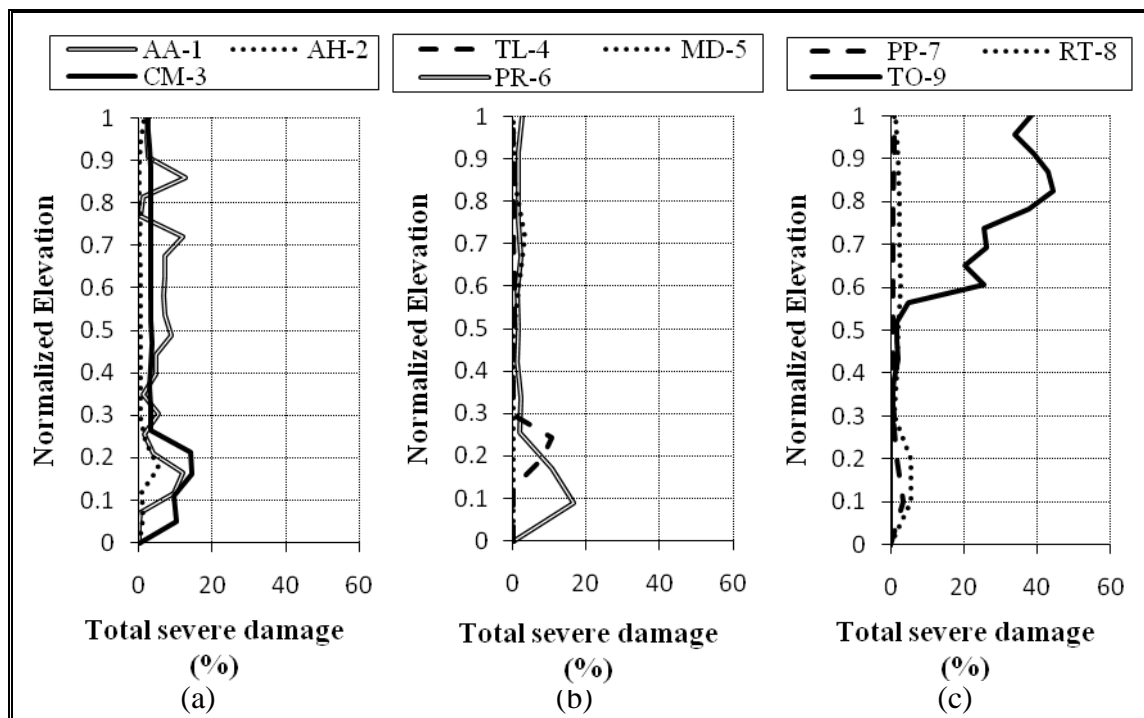
Figure 7-24: Total severe damage

and total damage is focused mainly because of the failure of columns at this double height story. Severely damaged elements in PR-6 are the most common ones. This damage is concentrated at story 1. PP-7 and RT-8 shows same distribution of damaged elements with intensity variation (RT-8 has more severely damaged elements than PP-7). Damage in both of this structures peaks at lower stories. Almost all of the damage observed in TO-9 is severe. It peaks at story 17 but similar values are found in stories 12 and 16 (where partial collapses exist). For stories between 5 and 11 few elements were observed mainly with light or moderate damage, while for stories lower than 5 approximately no damage was observed.

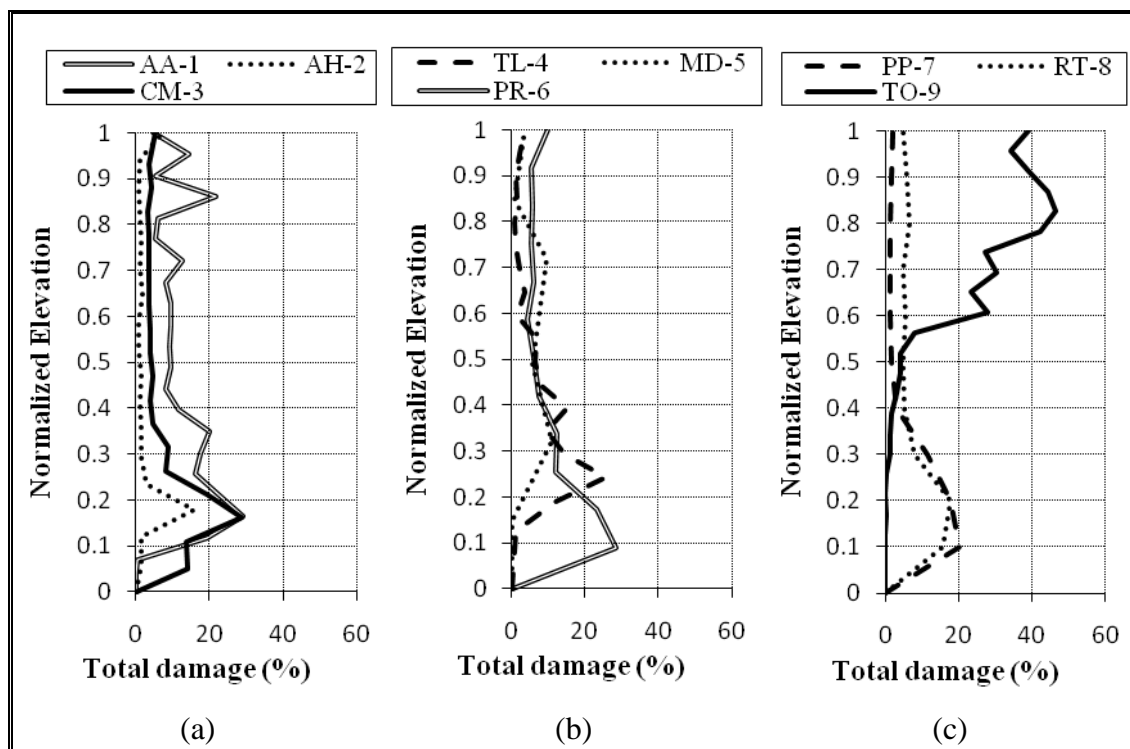
Figure 7-25: Total damage

Shown in Figure 7-25 is the damaged volume of elements (the sum of light, moderate and severe damage) as a percentage of total volume in each story versus the normalized height of the structure.

Consolidated damage is largest in Building AA-1 and TO-9 and reaches values of the order of 12%. Note that in TO-9 approximately 90% of damage observed is

severe. In PP-7 almost the 75% of damage in elements is light damage. Except for MD-5 (with particular column damage) and TO-9 (with partial collapse of story 12) all other buildings had their most damaged elements in lower stories. For most damaged high rise buildings (AA-1, CM-3, PR-6 and TO-9) code-analysis information will be presented further. It is apparent that only a small proportion of the structure in volume was compromised for the critical condition of the structure, which certainly shows the lack of efficiency of the building in terms of developing redundancy and energy dissipation. A second aspect that supports this observation is the lack of graduation of damage observed in these structures. For instance building TO-9 shows that most damage is severe, showing the incapacity of the structure to distribute its damage. It is also interesting to observe that damage is highly correlated with places where structural irregularities exist.

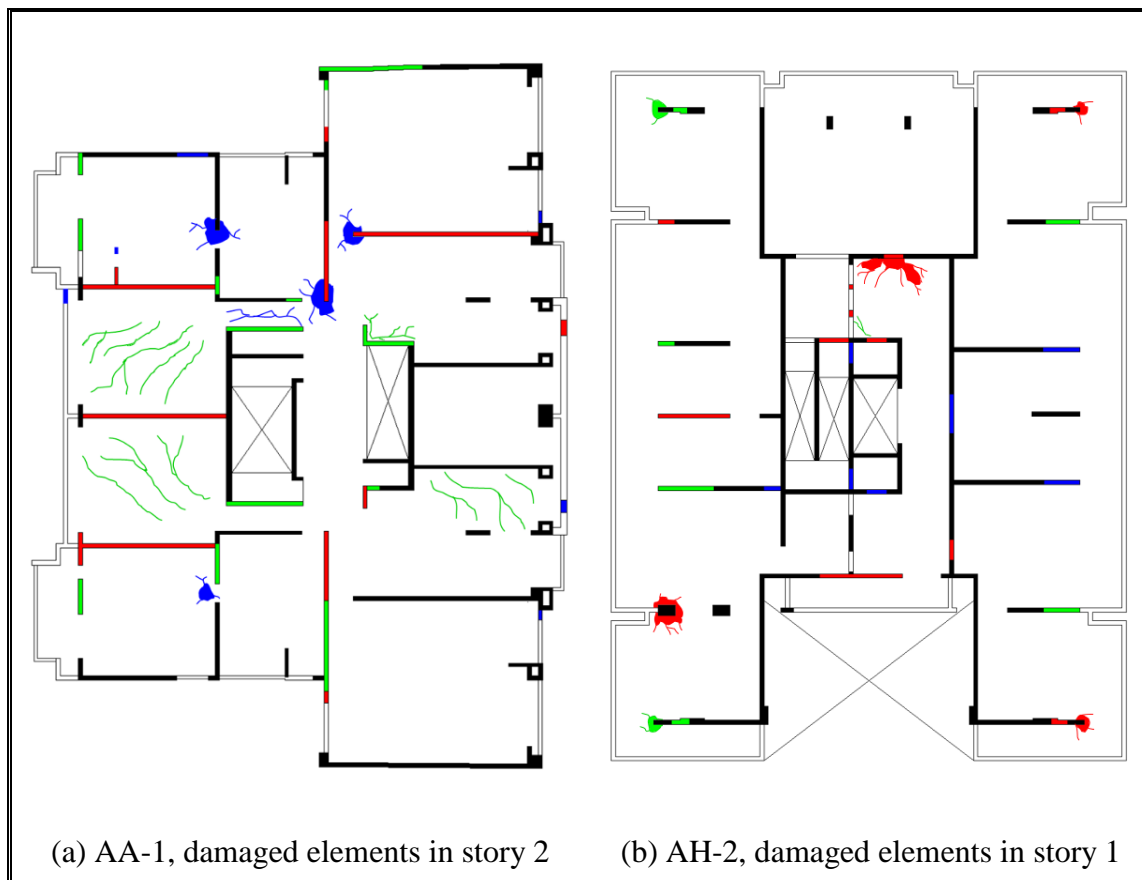
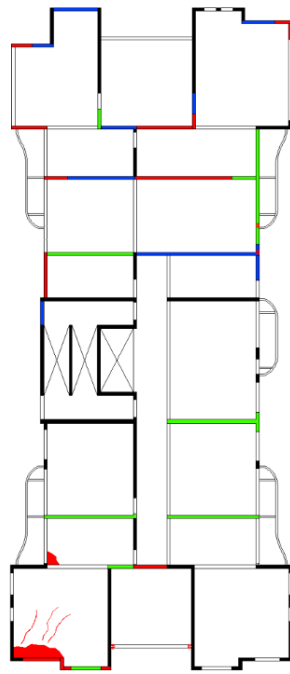
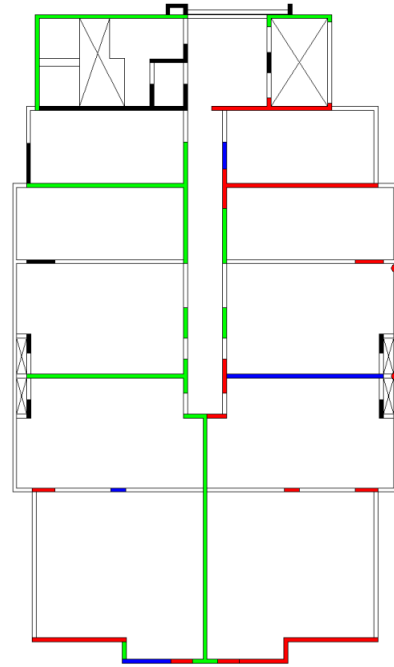
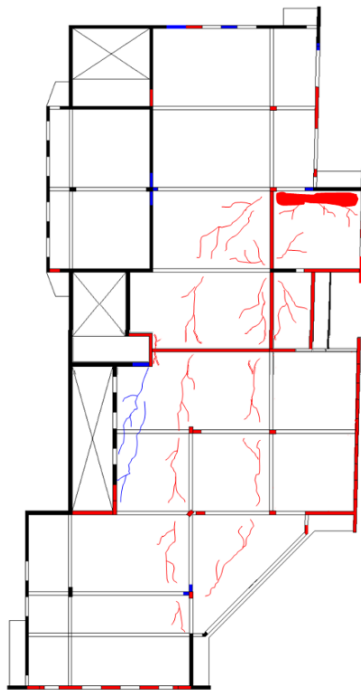
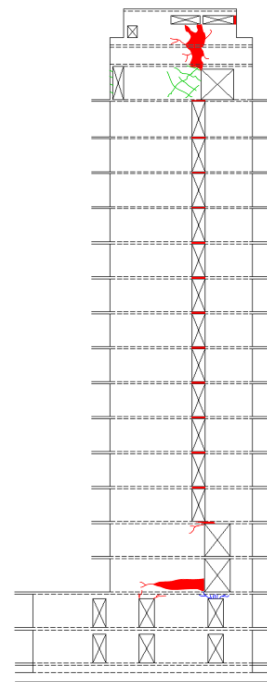
The convention in these drawings is: lightly damaged elements (green), moderately damaged elements (blue), and severely damaged elements (red). A schematic representation of the information available is presented in Figure 9-1. See Appendix A to view the most damaged story in each structure.

Figure 9-1: Example of damage observed in structural drawings

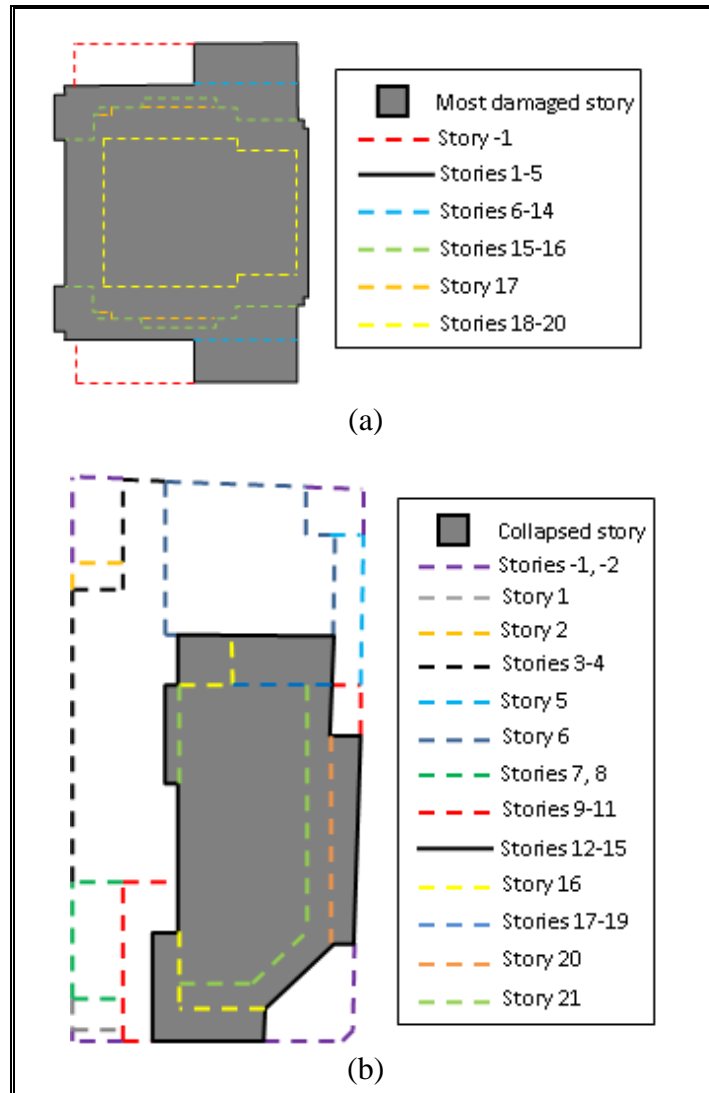
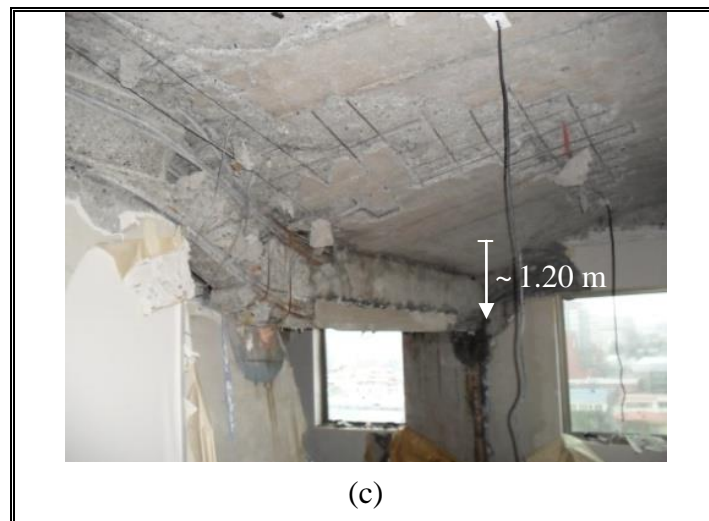
denominator present in most of the observed damage patterns (Arnold, 1990). Some dramatic configuration issues are found in buildings such as AA-1 and TO-9. To get an idea of these irregularities, shown in Figures 10-4a and 10-4b are schematic plan views of these buildings, respectively, indicating by different segmented traces how the plan changes in height. As an example, shown in Figure 10-4c is a beam at the 11th story of TO-9 which dropped about 1.2m, as a result of having an inverted wall in higher stories and leading to the observed damage.

Figure 10-4: Severe irregularities in buildings (a) AA-1, (b) TO-9, (c) inverted wall and damage at the 11th story of TO-9, axis 10

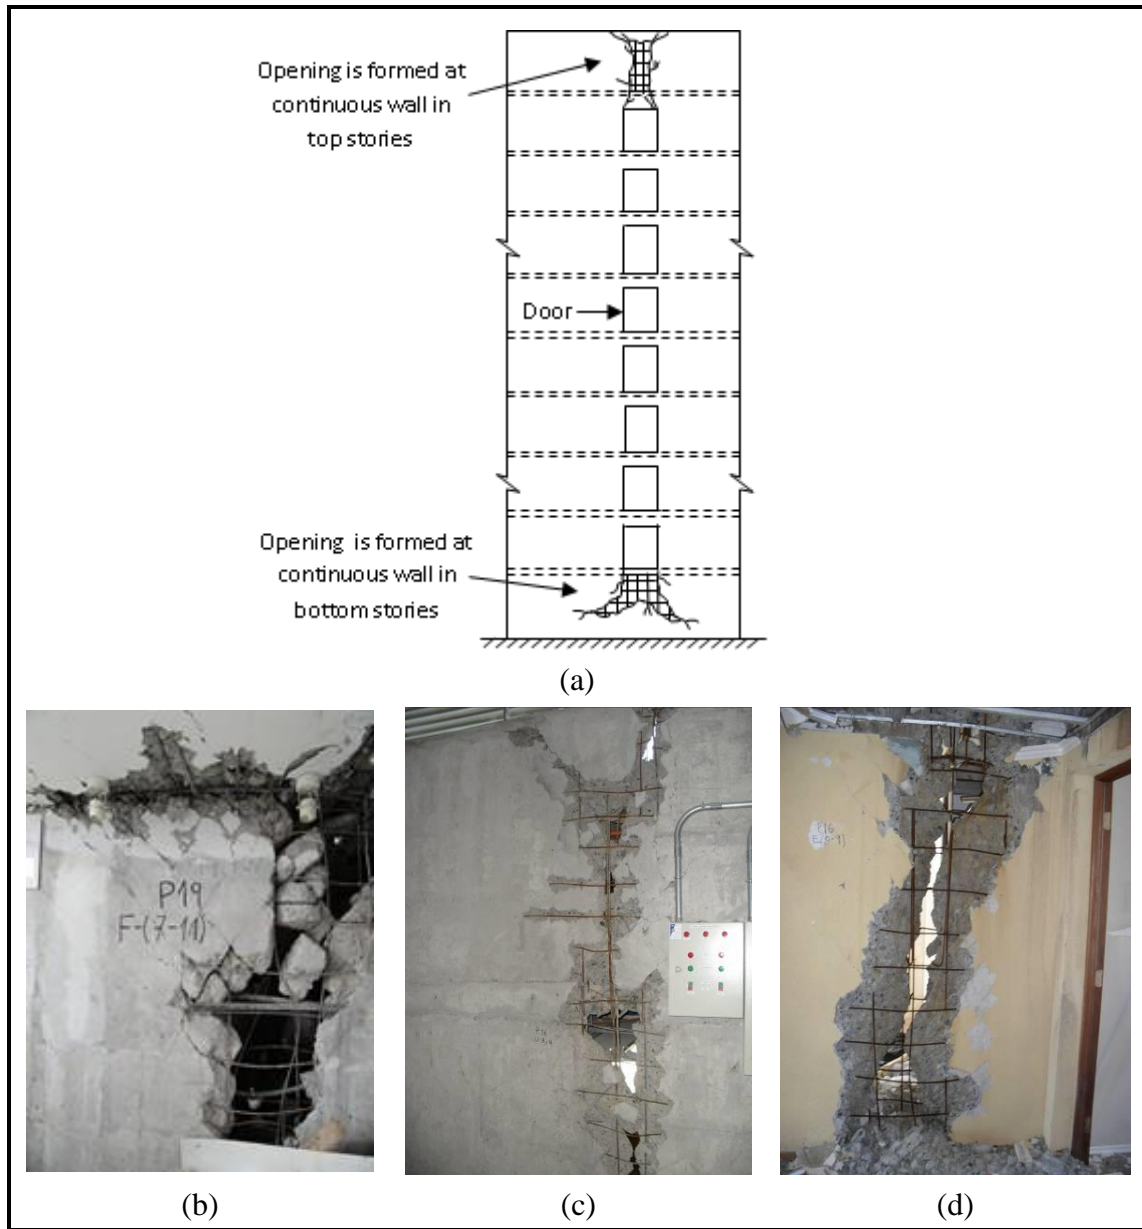
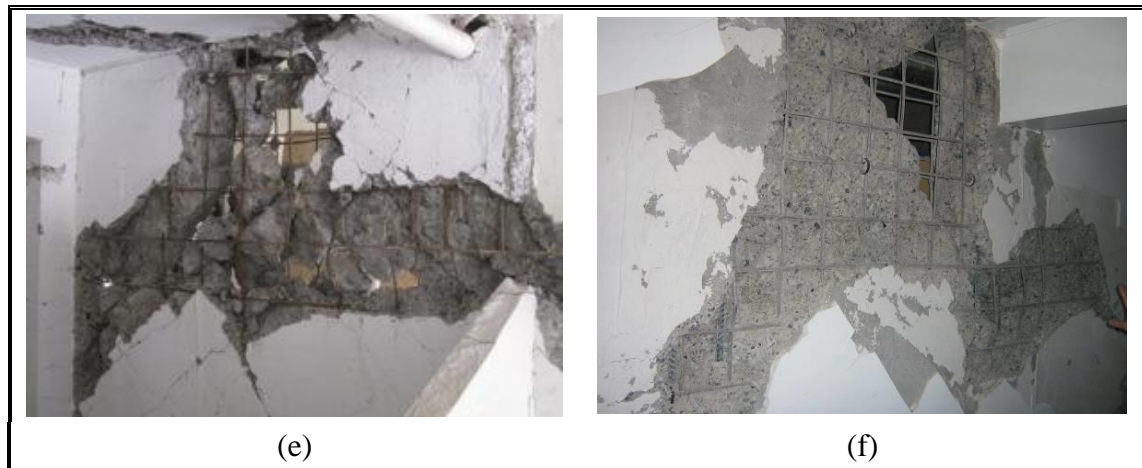
Another aspect of vertical irregularity that caused repetitive damage occurred where two different walls become coupled in upper and/or lower stories. This situation is common in the case of closing openings of coupled walls. A scheme and examples of this damage are shown in Figure 10-6. As both walls try to move independently, the coupling shear stresses between elements are very high, and tend to fracture the lintel and try to form the opening. In some cases such damage

may affect the vertical load carrying capacity of perpendicular gravitational elements causing serious problems.

Figure 10-6: (a) Opening formation at vertical irregularities; damage in upper stories of (b) AA-1, (c) AH-2, (d) CM-3; damage in lower stories of (e) CM-3, (f) building in Chillan

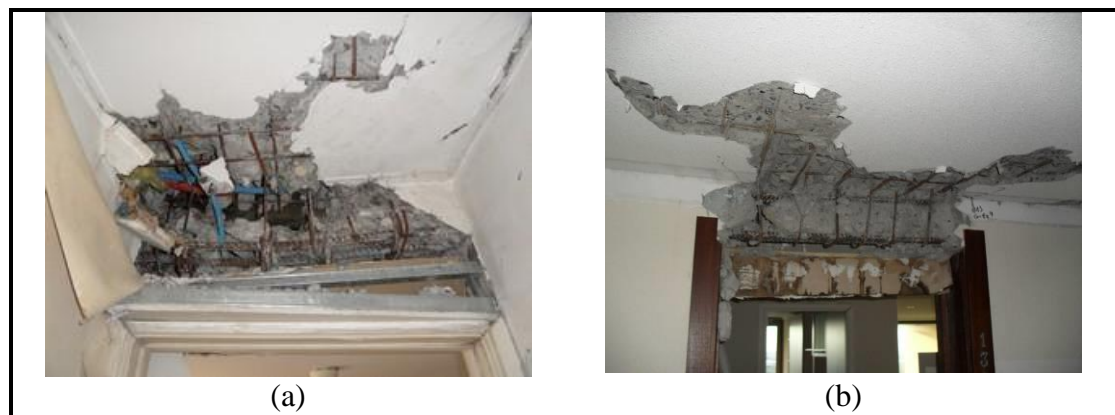
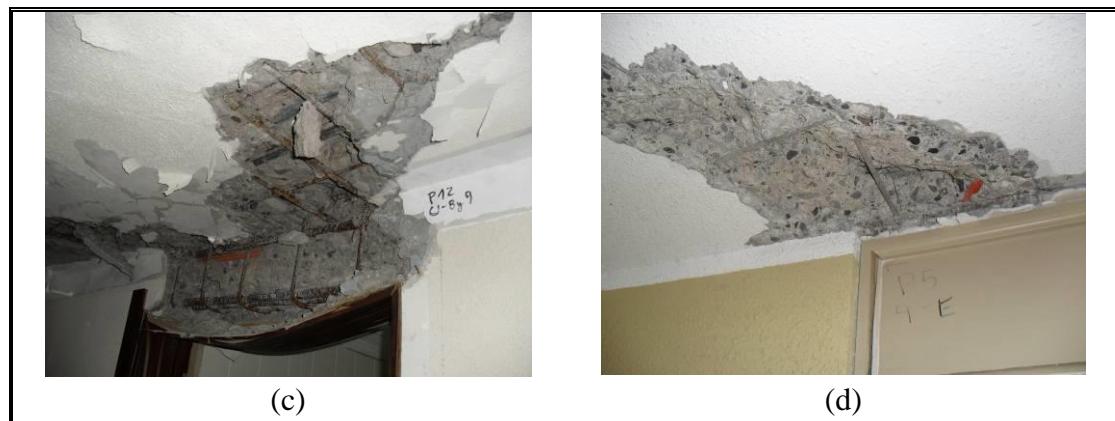
Figure 10-14: Slabs working as coupling beams in buildings (a) AA-1, (b), (c) AH-2 and (d) PP-7.

The absence of coupling beams makes non-structural components in a building to increase their role as energy dissipators. Indeed, in buildings PP-7 and RT-8, non-structural elements may justify the different intensities in the observed damage of these two identical structures. As mentioned elsewhere, RT-8 showed larger damage than PP-7, although they have the same nominal plans, same orientation, and are next to each other. Building PP-7 had very stiff partition elements made of plaster; RT-8 had very flexible partitions. While non-structural elements in PP-7 were practically shattered, in RT-8 were practically undamaged. Although it may be somewhat speculative, it seems that the energy dissipation coming from non-structural elements in PP-7 contributed to reduce structural damage as opposed to RT-8. This behavior shows some relevance since building PP-7 will be saved and RT-8 will be demolished.

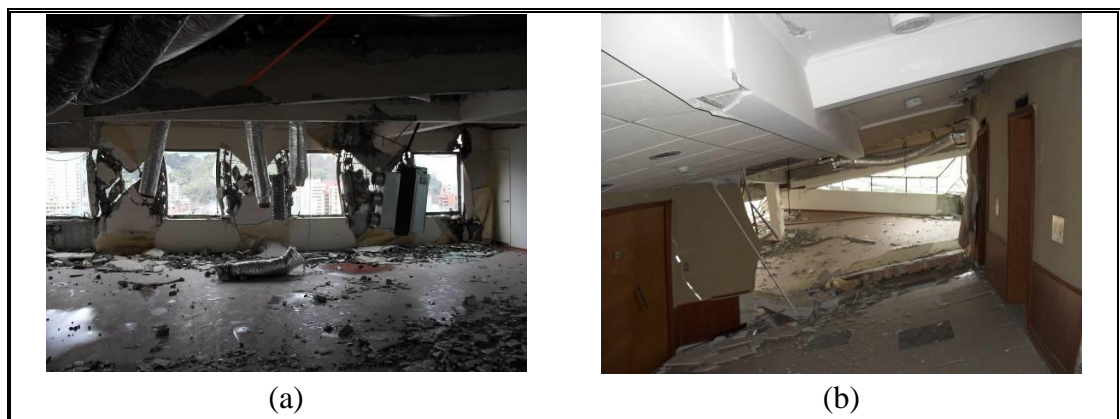
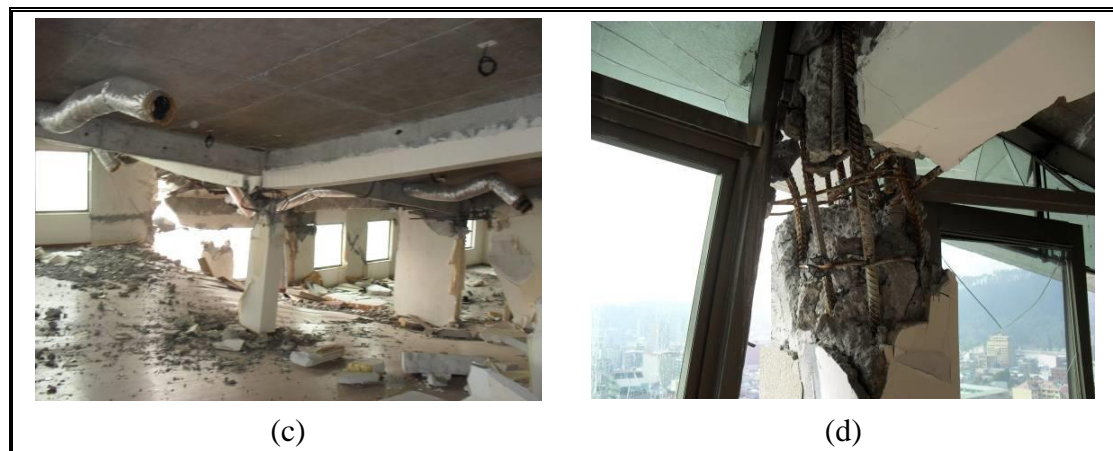
Damage in all internal building elements increases in height. A short summary is as follows: little to no damage was observed in stories -2 through 4; severe damage in a single wall is present in the 5th story; stories 6 through 11 show increasing damage in height; the main collapse at the 12th story augmented damage in every upper story, especially slabs and columns. As a reference, shown in Figure 11-3 is the inside condition of some stories.

Figure 11-3: Building TO-9. (a) Axis 1A at story 14, (b) slab deformation at story 16, (c) damage at 18th story, (d) severely damaged column at 21st story.

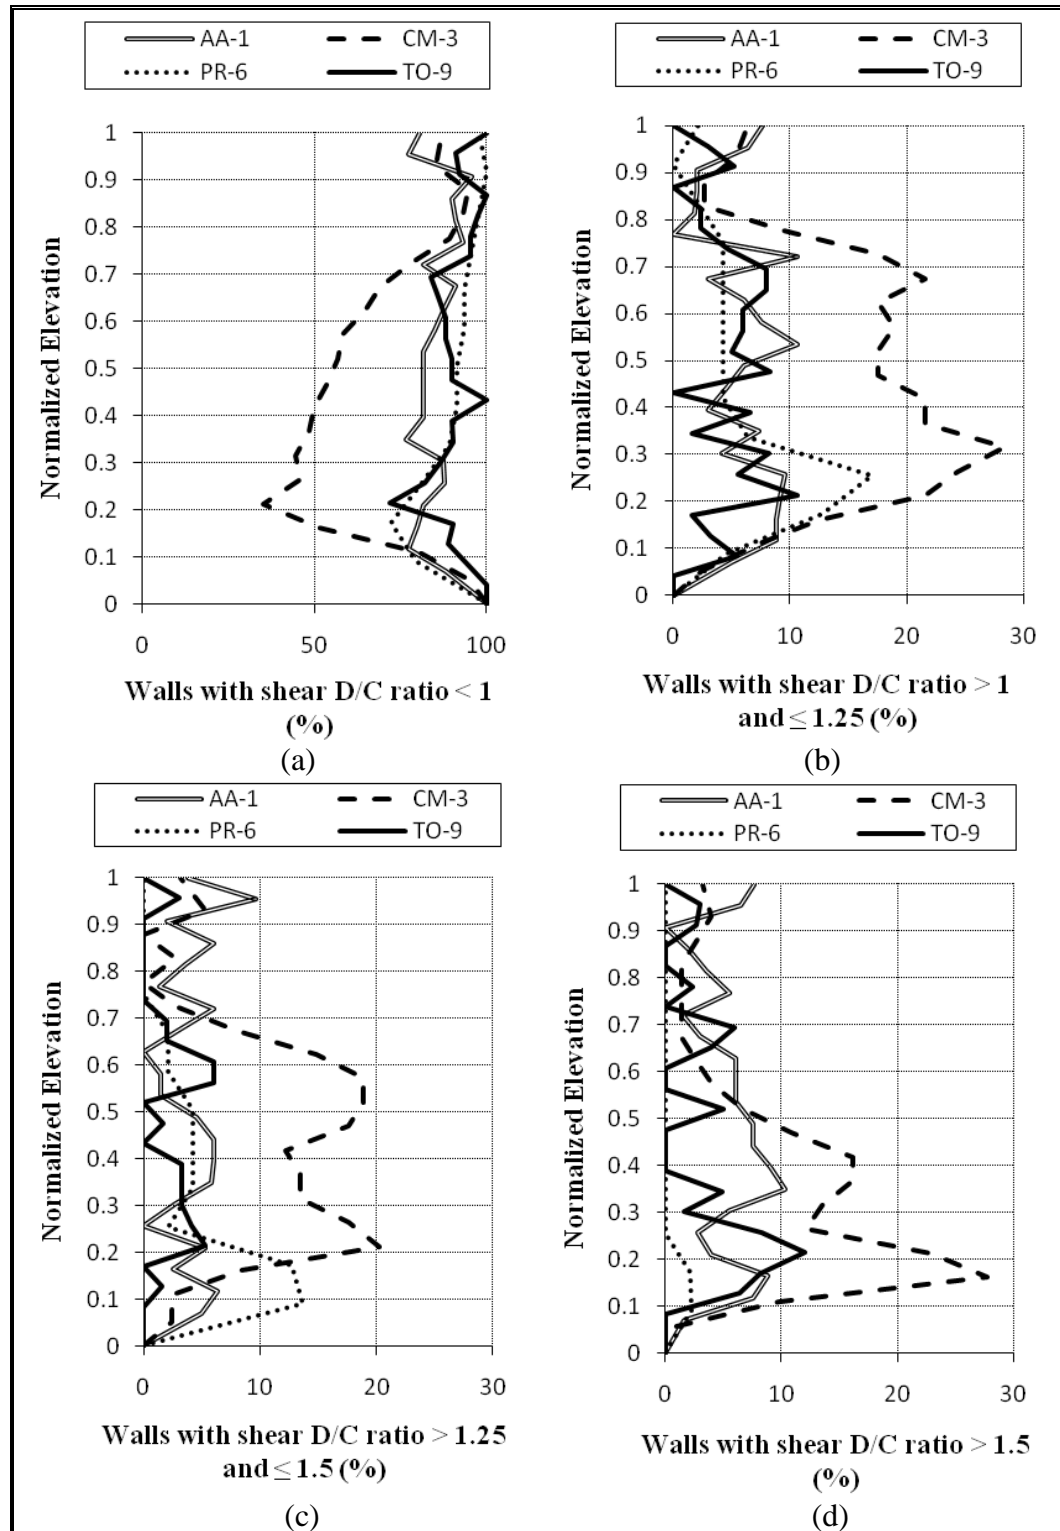
Figure 12-1: Percentage of analyzed walls with shear D/C ratios within each group

Buildings AA-1 and TO-9 show shear D/C ratios of every category well distributed among different stories. PR-6 shows higher D/C ratios in lower stories while CM-3 presents higher values at lower and intermediate levels. In building AA-1 walls with significant strength deficit were found on almost all stories (except on story 18), with higher percentages concentrated in stories 1, 2, 6, 7, 8 and 9. For CM-3 elements with significant strength deficit are focused on stories 2 and 3, reaching approximately 25% of analyzed walls on these stories. PR-6 shows maximum percentages for the most severe category in stories 1 and 2, which matches the observed damage, while TO-9 shows maximum code deficiencies on the 3rd story.
