PART I: RESPONSE OF REINFORCED CONCRETE BUILDINGS IN CONCEPCION DURING THE MAULE EARTHQUAKE

Thesis submitted to the Office of Research and Graduate Studies in partial fulfillment of the requirements for the Degree of Master of Science in Engineering

Santiago de Chile, (December, 2011)

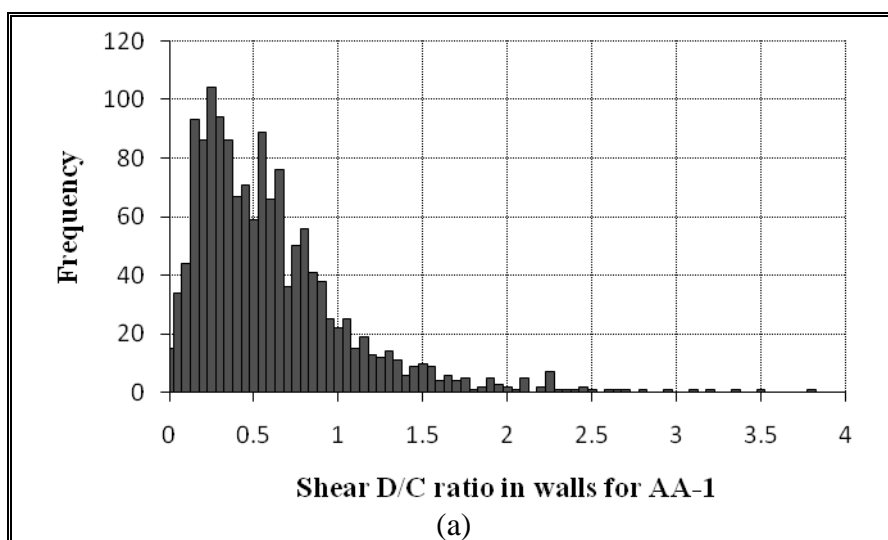
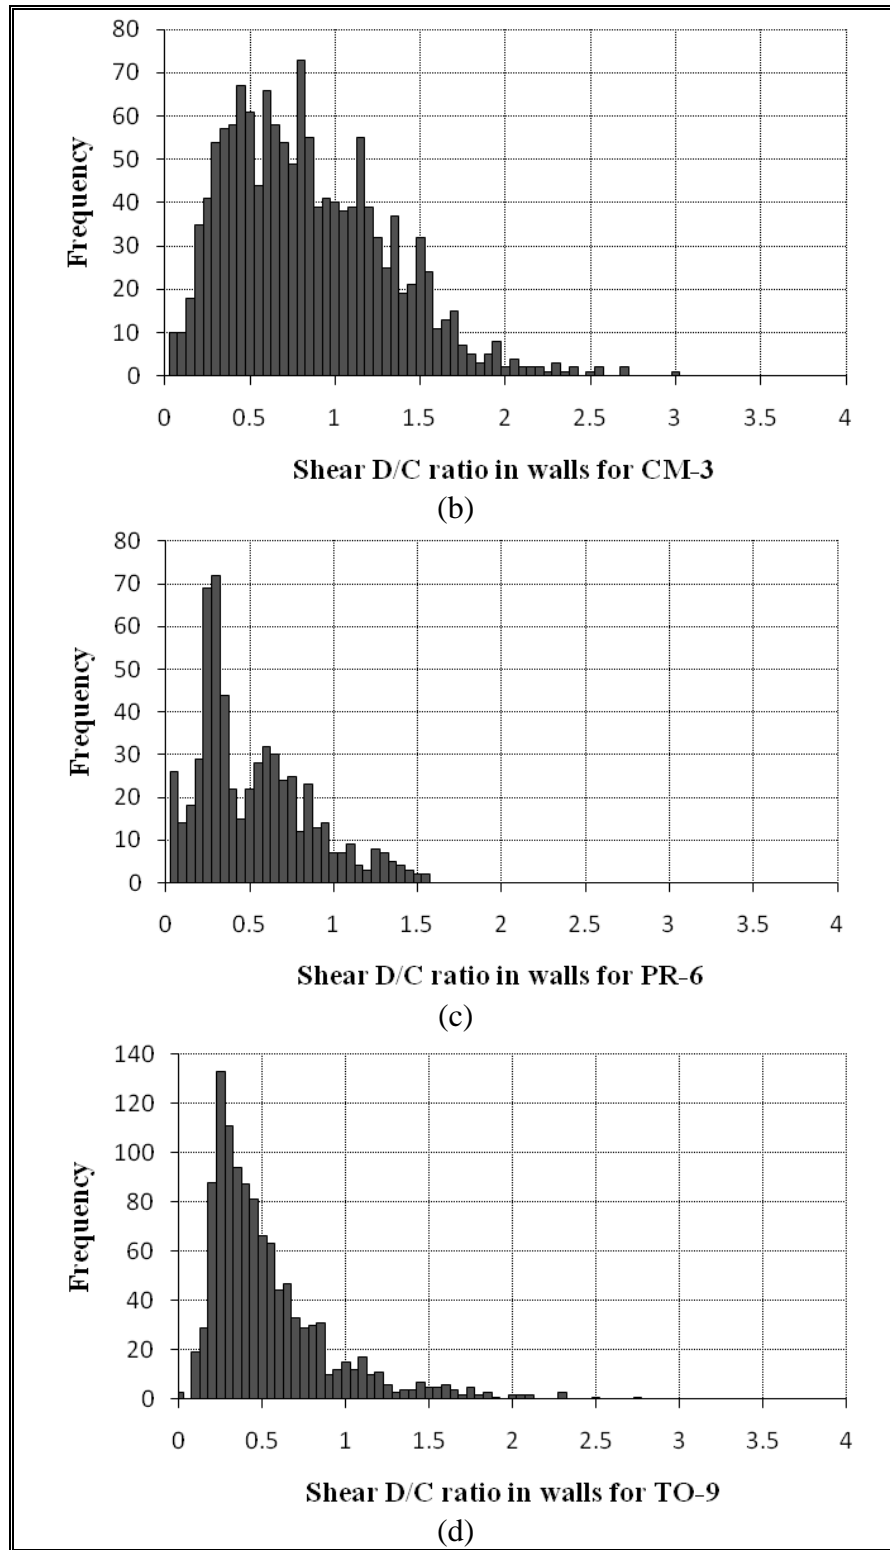
Figure 12-2: Shear D/C ratios in walls as histograms

All buildings show distributions with a clearly marked positive skew. Data in CM-3 is more scattered than in other buildings, having the worst designed walls in shear behavior (elements were designed to the limit of their capacities). Shown in Figure 12-3 is the shear D/C ratios in walls presented as a cumulative probability for every building analyzed.

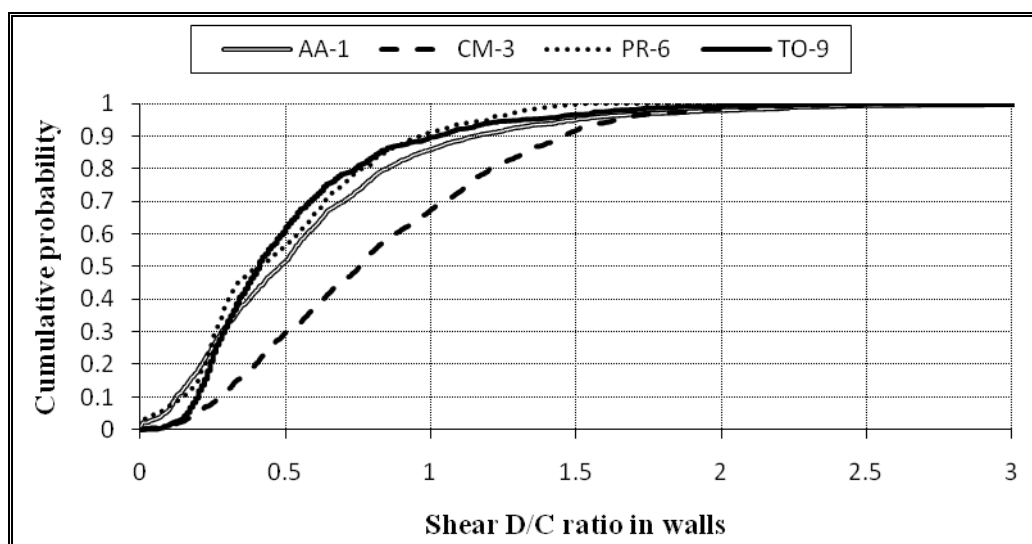
Figure 12-3: Shear D/C ratios in walls as cumulative probability

Although buildings AA-1, PR-6 and TO-9 show similar D/C distributions, the CM-3 curve is far below the others. Assuming that walls with higher D/C ratios were the ones that failed, limit values for these ratios will be proposed. 6.34 % of all walls in building AA-1 showed damage due to shear stress, which would account for walls with a D/C ratio limit of 1.39. On the other hand, 3.03 % of all walls in building CM-3 showed damage due to shear stress, which would match walls with a D/C ratio limit of 1.79. For PR-6, 10.28 % of all walls showed damage due to shear stress, which would mean walls having a D/C ratio limit of 0.95. Finally for TO-9, 3.55 % of all walls showed damage due to shear stress, which would account for a D/C ratio limit of 1.48. Note that in PR-6 the D/C limit is lower than one, which means that more walls were observed having shear

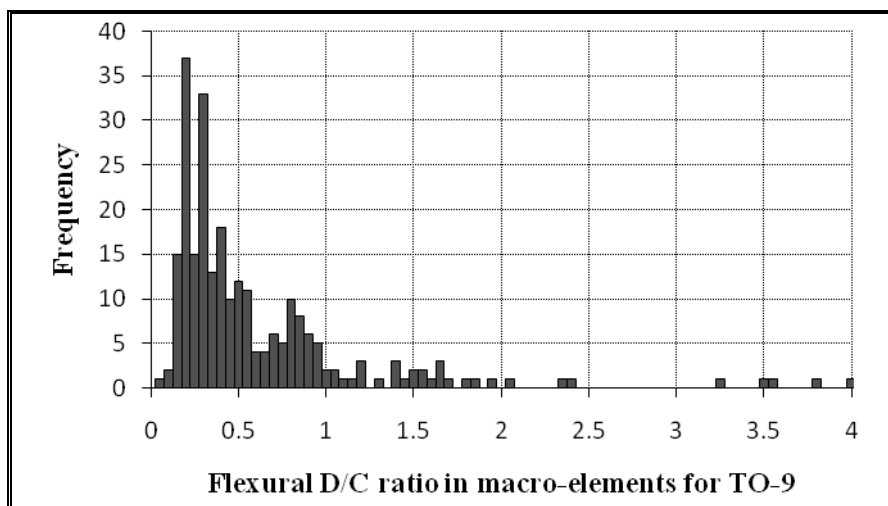
Figure 12-4: Flexural D/C ratios in walls as histogram for building TO-9

Note that in flexure, TO-9 also shows a distribution with a clearly marked positive skew. The mean value of D/C ratios for TO-9 is 0.44 with a standard deviation of 0.33, showing better designed walls for biaxial behavior than in shear. Shown in Figure 12-5 are the flexural D/C ratios in walls of building TO-9 presented as a cumulative probability.

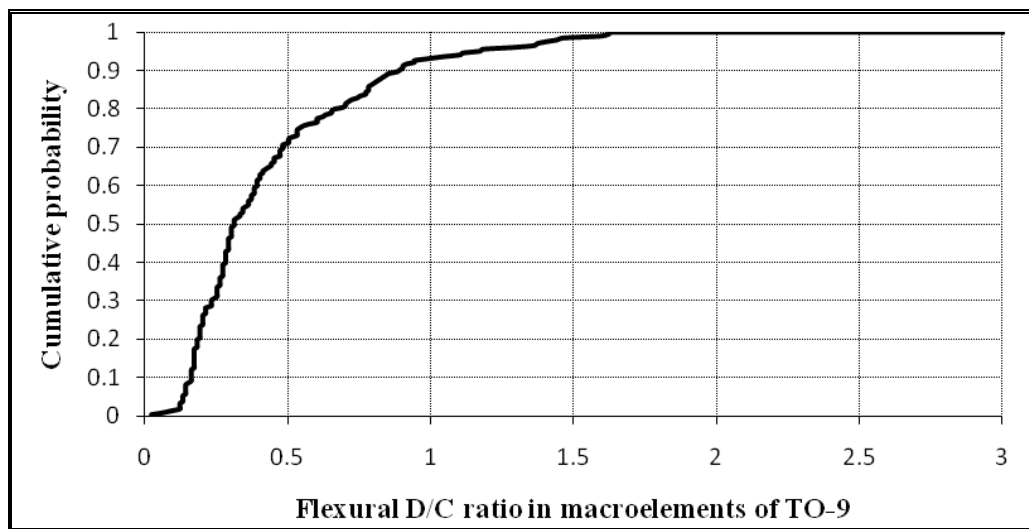
Figure 12-5: Flexural D/C ratios in walls of TO-9 as cumulative probability

Assuming that walls with higher D/C ratios were the ones that failed, limit values for these ratios will be proposed for TO-9. 1.15 % of all walls in building TO-9 showed damage due to flexure, which would account for walls with a D/C ratio limit of 1.53. In this case, the code was available to predict damage in walls, regarding that the D/C limit is greater than one.

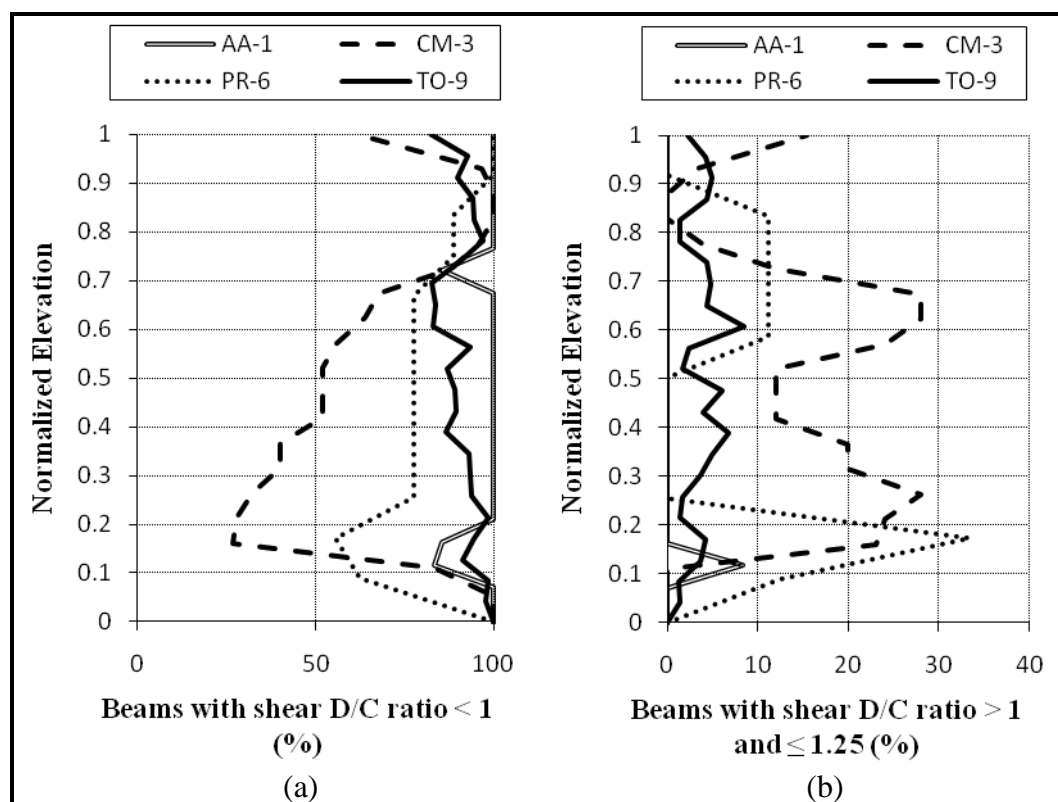
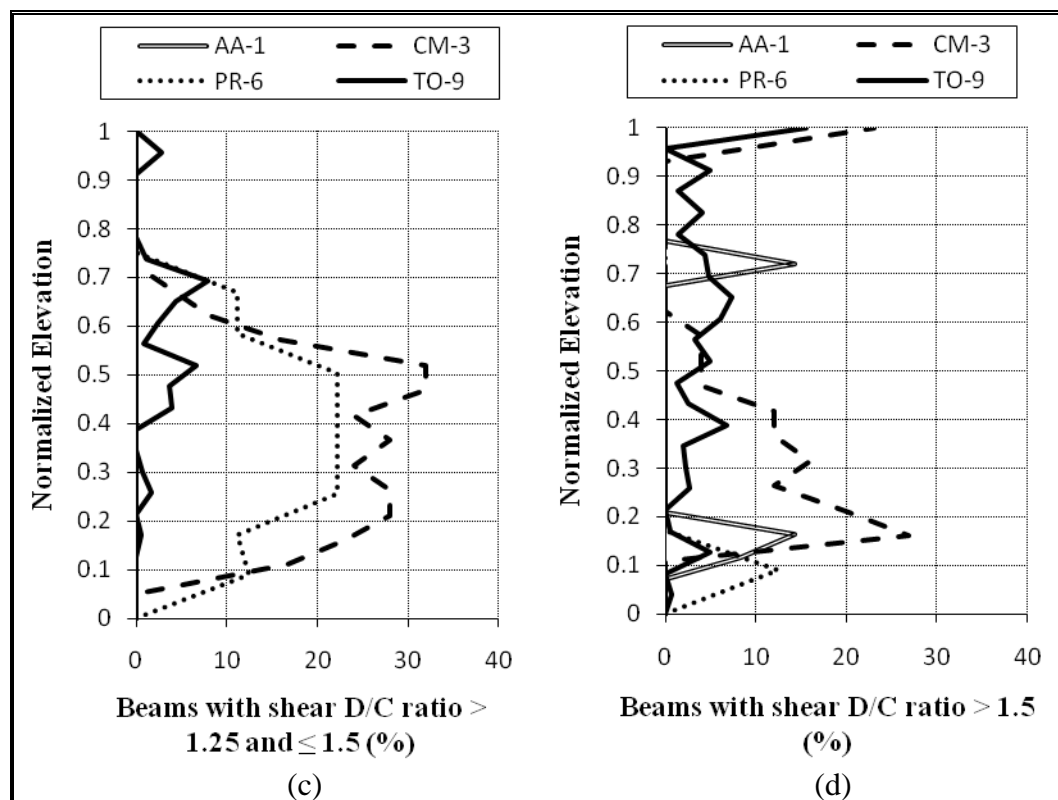
Figure 12-6: Percentage of analyzed beams with shear D/C ratios within each group

In building AA-1 beams with significant strength deficit were found in stories 1, 2, and 14. CM-3 and PR-6 show higher D/C ratios for intermediate and lower stories. For CM-3, elements with significant strength deficit are localized in stories 2, and 18, reaching approximately 25% of the analyzed beams in these stories. PR-6 shows beams with severe strength deficiencies on the 1st story. Building TO-9 shows shear D/C ratios in D/C category well distributed in height.

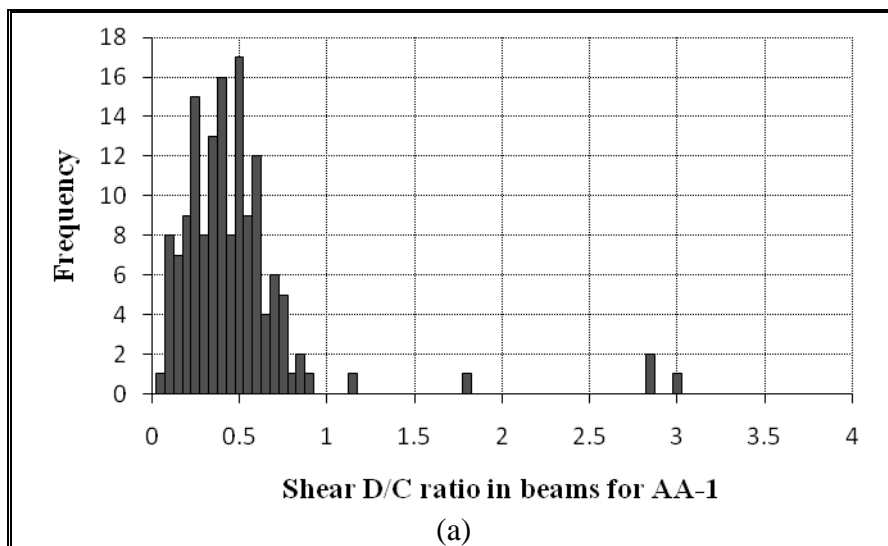
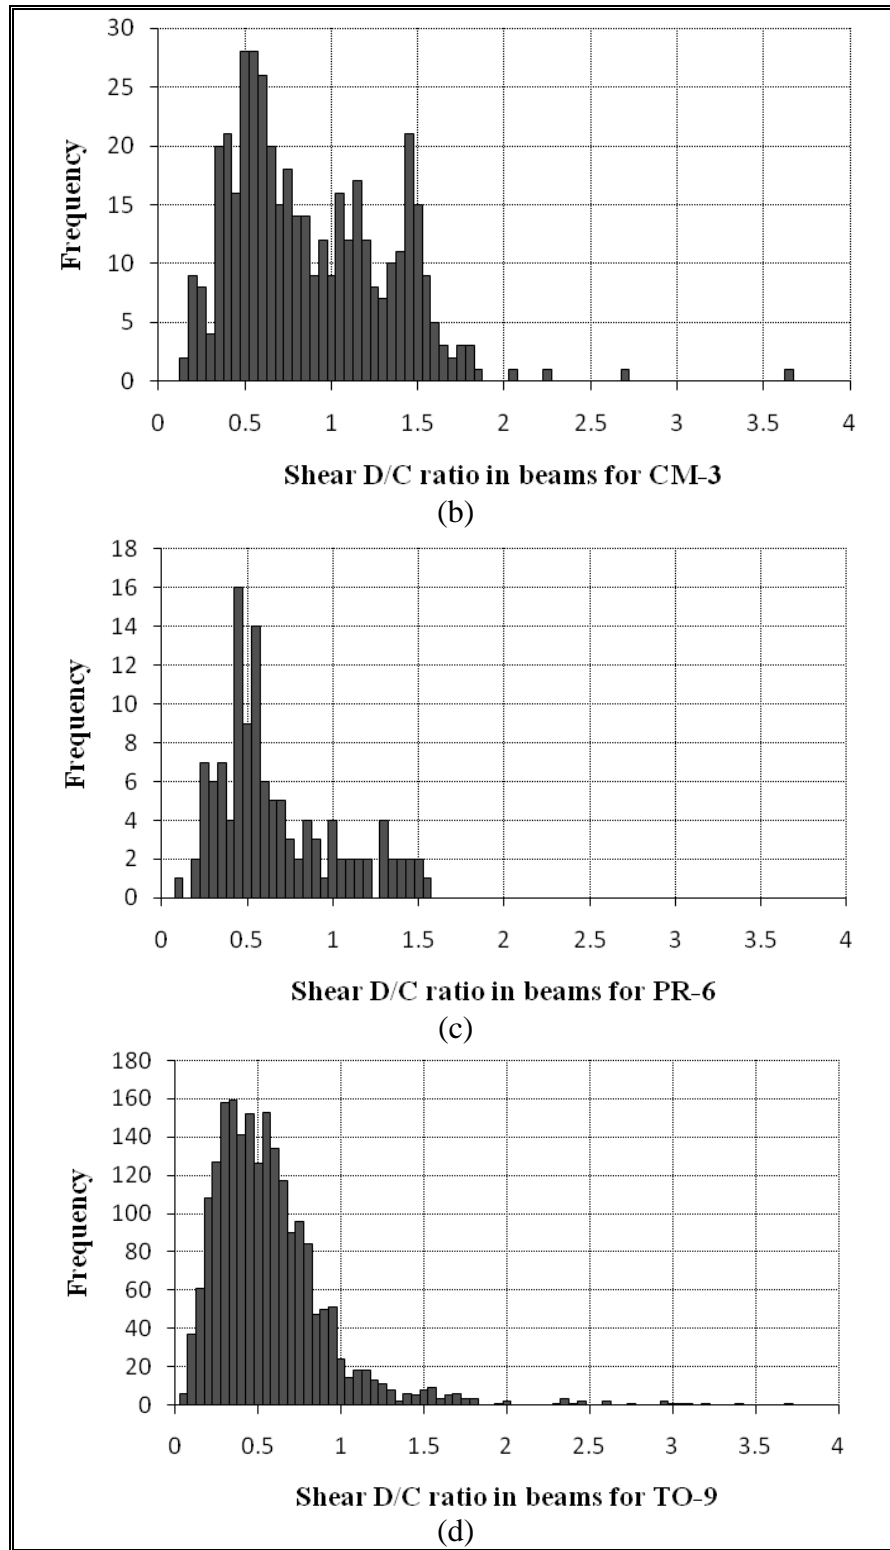
Figure 12-7: Shear D/C ratios in beams as histograms

Summarized in Table 12-4 is the distribution of D/C ratios, its mean, and standard deviation for the 4 buildings analyzed. Building CM-3 is the one that shows the highest percentage (63%) of beams with D/C shear ratios greater than 1. Mean values show the same, reaching for the CM-3 building a D/C shear ratio equal to 0.87. For building CM-3, beams with severe D/C ratios occur in axes A and O. In TO-9, axes 1A, 4 and 6 are the ones with the highest D/C ratios. Note that precisely in axis 1A, a large number of beams presented shear failures as viewed

All buildings show distributions with a clearly marked positive skew. Again, data in CM-3 is more scattered than in other buildings, having the worst designed beams in shear behavior (elements were designed to the limit of their capacities). Shown in Figure 12-8 are the shear D/C ratios in beams presented as a cumulative probability function for every building analyzed.

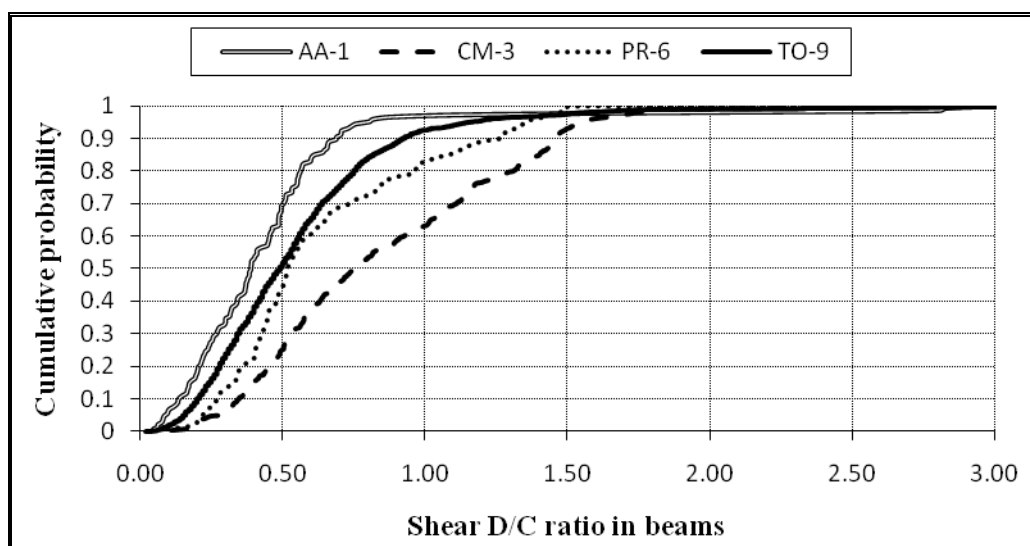
Figure 12-8: Shear D/C ratios in beams as cumulative probability

In shear behavior of beams, building AA-1 shows best designed elements while CM-3 again shows big deficiencies on D/C ratios. Assuming that beams with higher D/C ratios were the ones that failed, limit values for these ratios will be proposed for every building. 5.22 % of all beams in building AA-1 showed damage due to shear stress, which would account for beams with a D/C ratio limit of 0.79. On the other hand, 5.26 % of all beams in building CM-3 showed damage due to shear stress, which would match beams with a D/C ratio limit of 1.54. For PR-6, 11.93 % of all beams showed damage due to shear stress, which would mean beams having a D/C ratio limit of 1.17. Finally for TO-9, 4.62 % of all beams showed damage due to shear stress, which would account for a D/C ratio limit of 1.20. Note that in AA-1 the D/C limit is lower than one, which means that more beams were observed having shear damage than the ones the code could

prevent. Further analysis and future corrections of the code can be approached by checking behavior in AA-1.

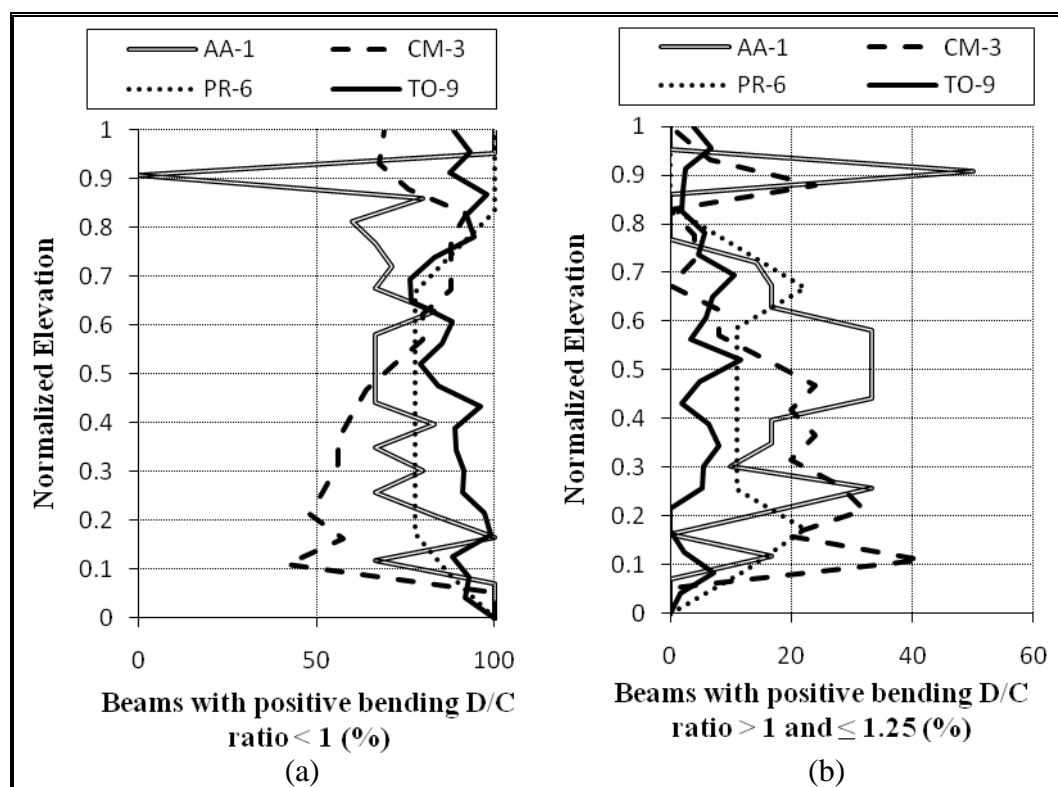
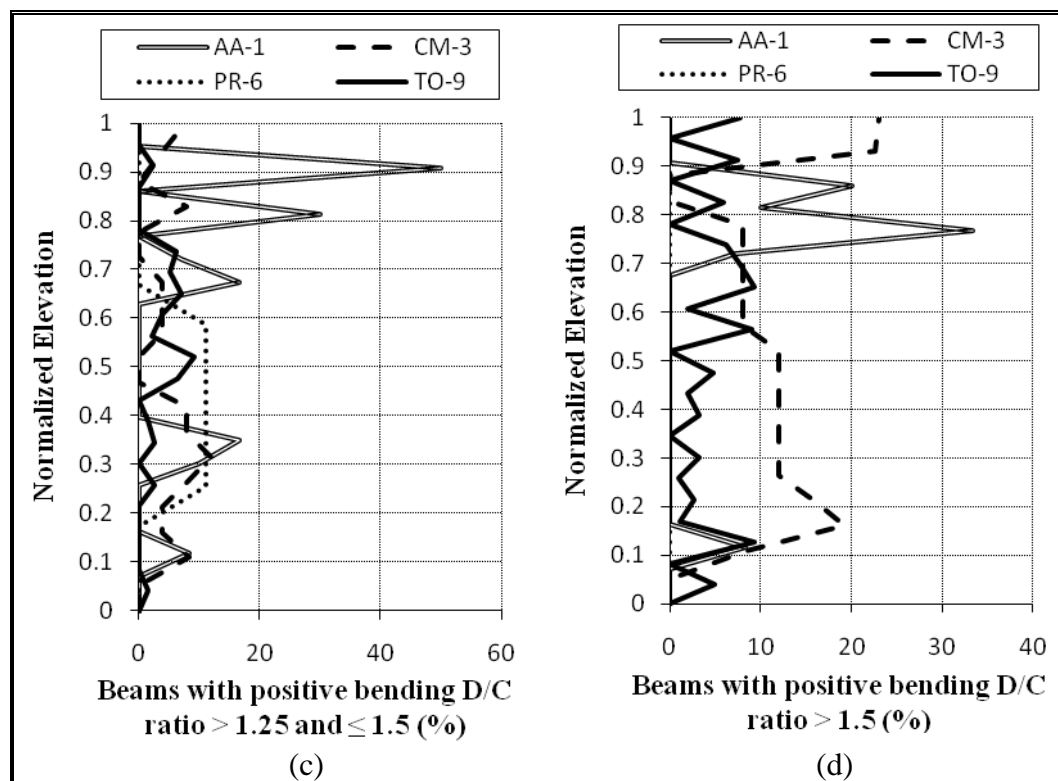
Figure 12-9: Percentage of analyzed beams with positive bending D/C ratios within each group

For positive bending, D/C ratio is defined as $M_u^+ / \phi M_n^+$. Results for the four groups defined in Table 12-1 are shown in Figure 12-9 as percentage of analyzed elements in each story. Building TO-9 shows positive bending D/C ratios of every category well distributed among different stories. AA-1 shows greater deficits in beams at high stories where setbacks exist. PR-6 shows bigger D/C ratios for intermediate stories while for CM-3 positive bending D/C ratios are bigger in lower and higher levels. PR-6 shows no beam with severe strength deficiencies. In building AA-1 beams with significant strength deficit were found in stories 1, 14, 15, 16 and 17, with higher percentages concentrated in upper stories. For CM-3 elements with significant strength deficit are focused on stories 2, 3, 17 and 18, reaching approximately 20 % of analyzed beams on these stories.

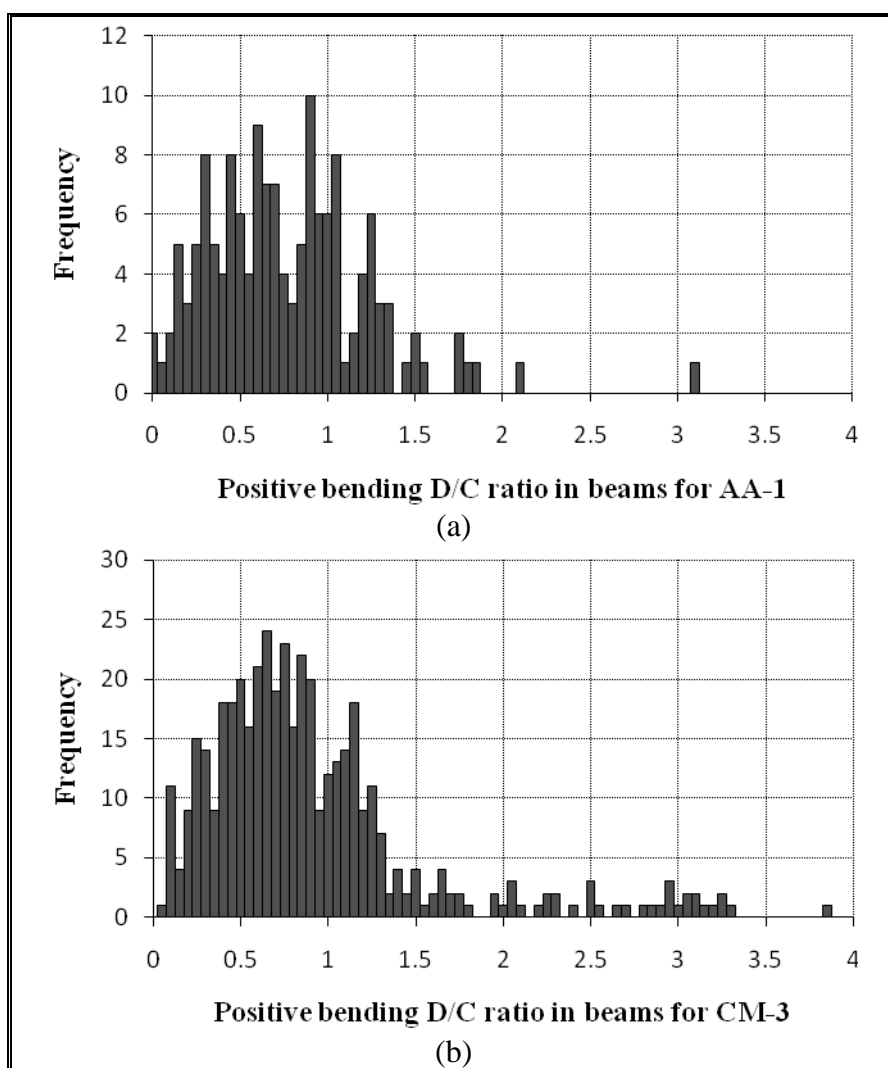
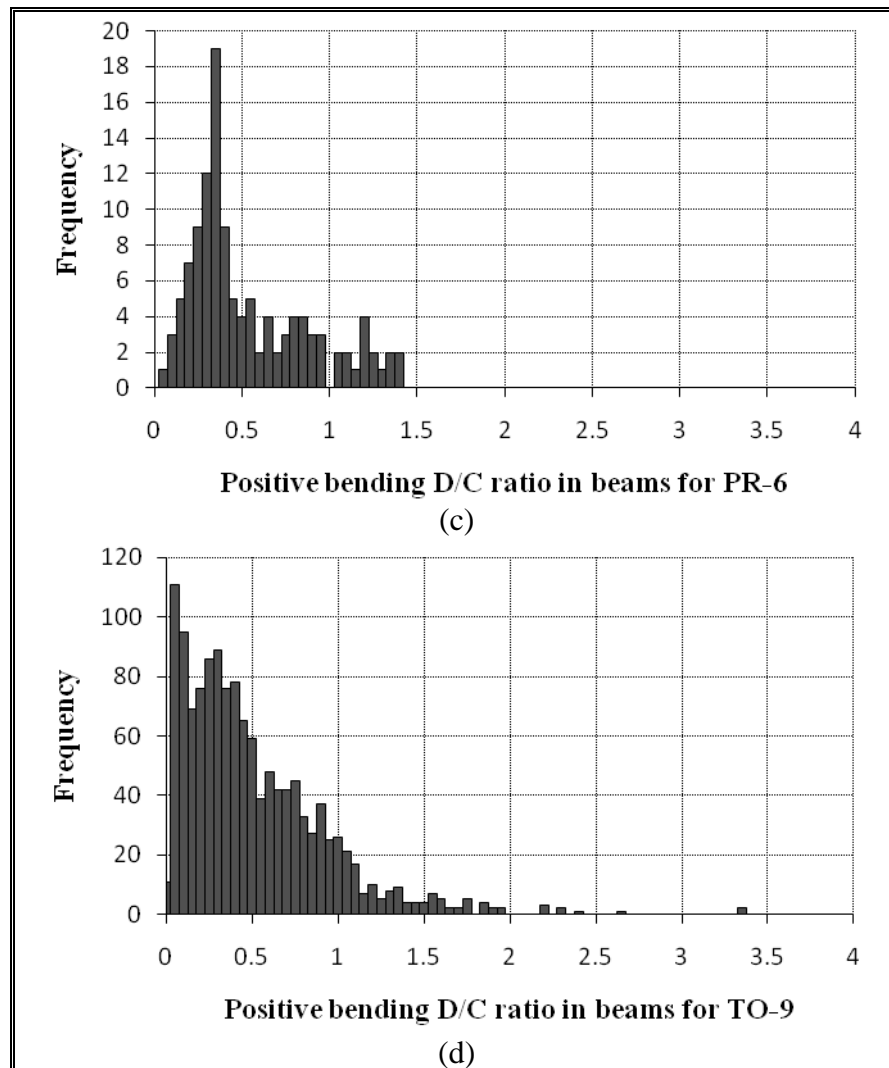
Figure 12-10: Positive bending D/C ratios in beams as histograms

Buildings AA-1 and CM-3 show the lowest percentages of beams properly designed (approximately 70% of analyzed elements against 90% of analyzed elements in other buildings). Mean values shows the same, reaching in AA-1 a

D/C ratio of 0.74 and in CM-3 a value of 0.89. Note that PR-6 has no beams with severe strength deficit in positive bending behavior while CM-3 has 11.09 % of the analyzed elements. For building CM-3, beams with severe strength deficit are focused in axes A and O. In TO-9, axis 1A is the one where most of the highest D/C ratios are found. Note that in axis 1A there is a big number of damaged beams. D/C ratios were organized in intervals of 0.05 and frequencies regarding each D/C ratio are shown in Figure 12-10 as histograms for every building.

As with shear, all buildings show distributions with a clearly marked positive skew, being stronger in TO-9. Data in AA-1 and CM-3 is more scattered than in other buildings, having the worst designed beams in positive bending behavior (elements were designed to the limit of their capacities). Shown in Figure 12-11 are the positive bending D/C ratios in beams presented as a cumulative probability function for every building analyzed.

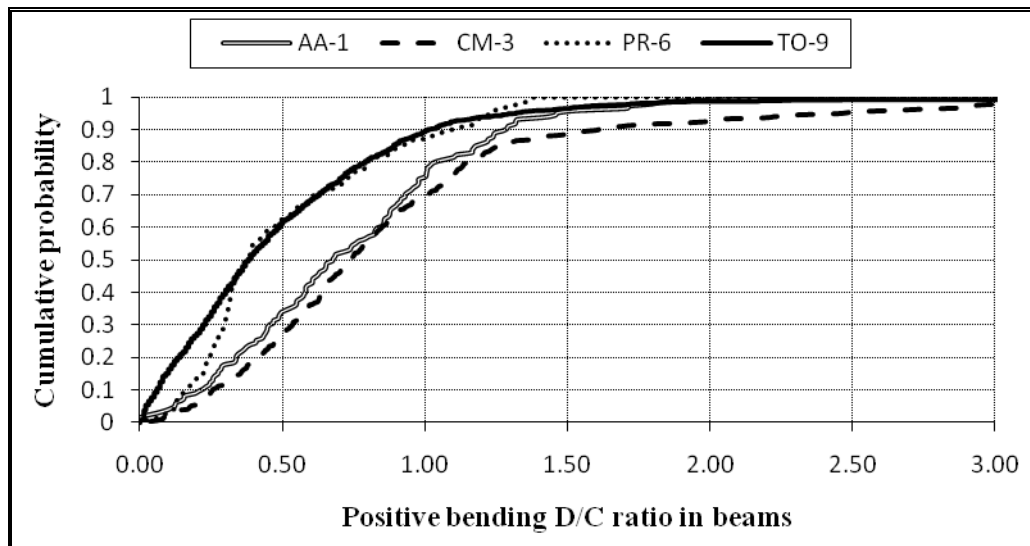
Figure 12-11: Positive bending D/C ratios in beams as cumulative probability

In positive bending of beams, building PR-6 and TO-9 shows the best behavior, while buildings AA-1 and CM-3 have poorly designed elements. Assuming that beams with higher D/C ratios were the ones that failed, limit values for these ratios will be proposed for every building. 9.19 % of all beams in building AA-1 showed evidence of damage due to flexural stress, which would account for beams with a D/C ratio limit of 1.29. On the other hand, 1.37 % of all beams in building CM-3 showed evidence of damage due to flexural stress, which would match beams with a D/C ratio limit of 3.08. For PR-6, 3.78 % of all beams showed evidence of damage due to flexural stress, which would mean beams having a D/C ratio limit of 1.18. Finally for TO-9, 10.87 % of all beams showed evidence of damage due to flexural stress, which would account for a D/C ratio limit of 0.85. Note that in TO-9 the D/C limit is lower than one, which means that more beams were observed having shear damage than the ones the code could prevent. Regarding that most of the beams in TO-9 that showed flexural evidence failed due to interaction with other elements (partial collapse takes big importance), no further code-analysis for positive bending in beams will be performed.

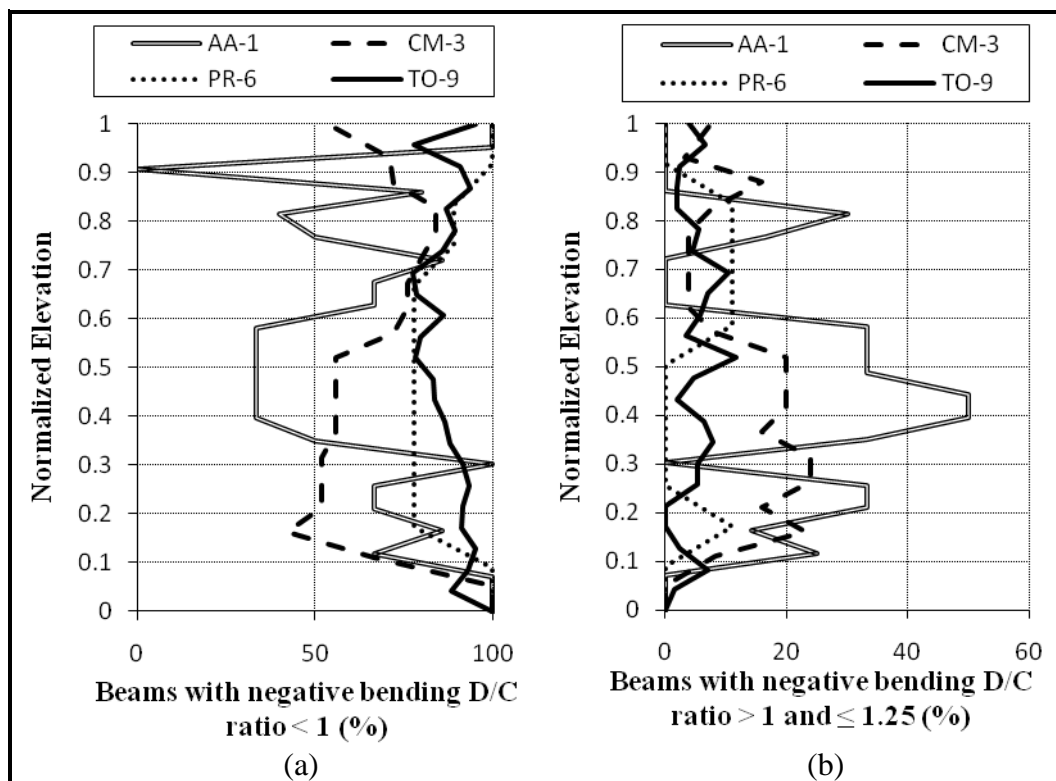
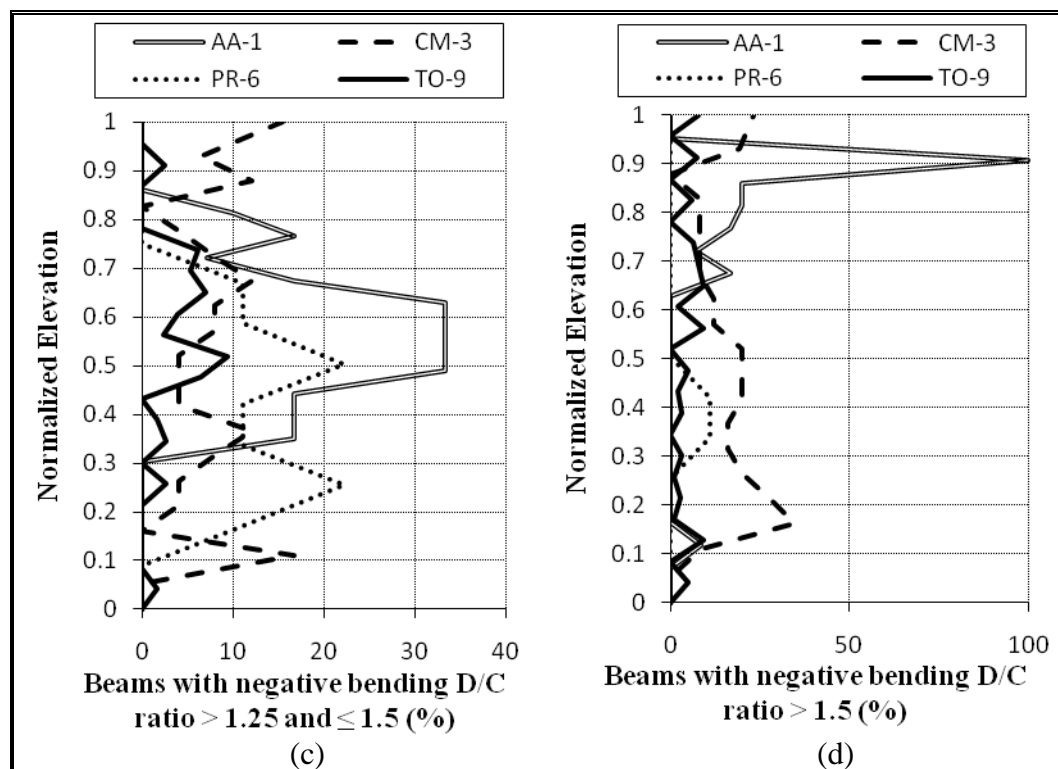
Figure 12-12: Percentage of analyzed beams with negative bending D/C ratios within each group

For negative bending, D/C ratio is defined as $M_u^-/\phi M_n^-$. Results for the four groups defined in Table 12-1 are shown in Figure 12-12 as percentage of analyzed elements in each story. Building TO-9 shows negative bending D/C ratios of every category well distributed among different stories. AA-1 shows greater deficits in beams at intermediate and higher stories where setbacks exist. PR-6 shows bigger D/C ratios for intermediate stories while for CM-3 negative bending D/C ratios are bigger in lower and intermediate levels. In building AA-1 beams with significant strength deficit were found in story 1 and stories 13 to 19, with higher percentages concentrated in upper stories. For CM-3 elements with significant strength deficit are focused on story 2, reaching approximately 35 % of analyzed beams on that story. PR-6 shows beams with severe strength deficiencies at stories 4 and 5.

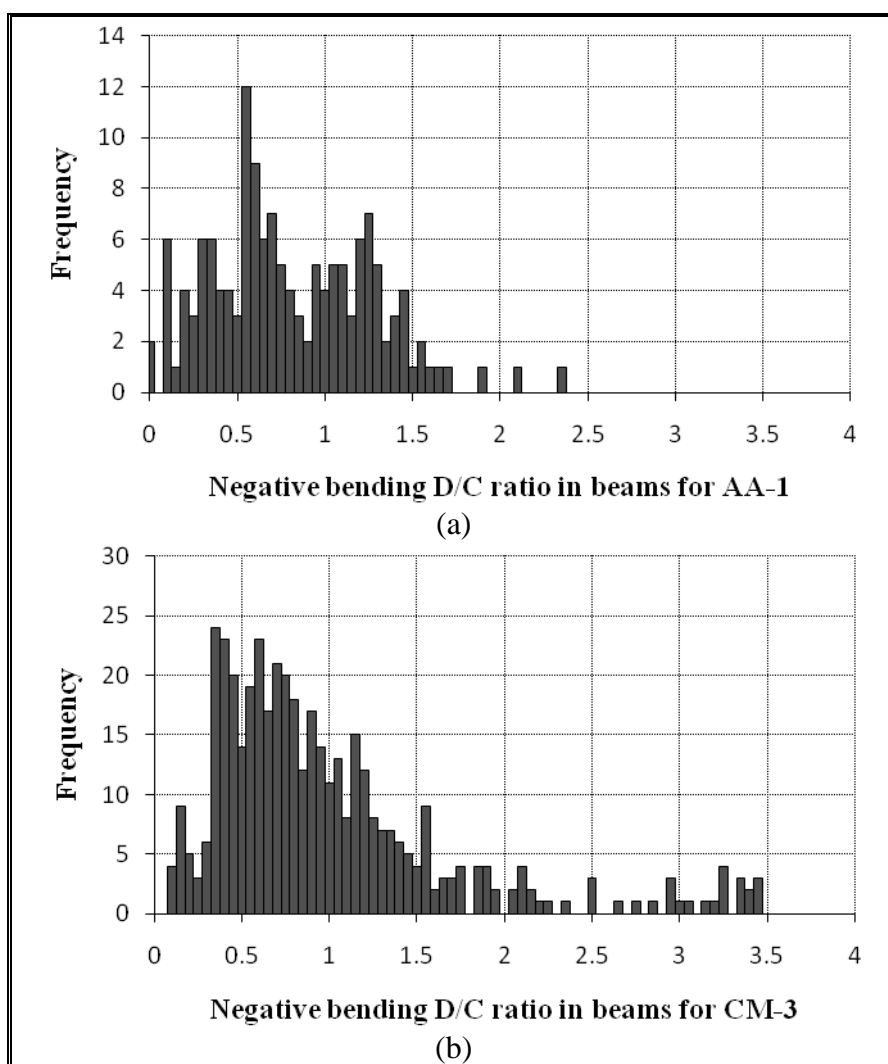
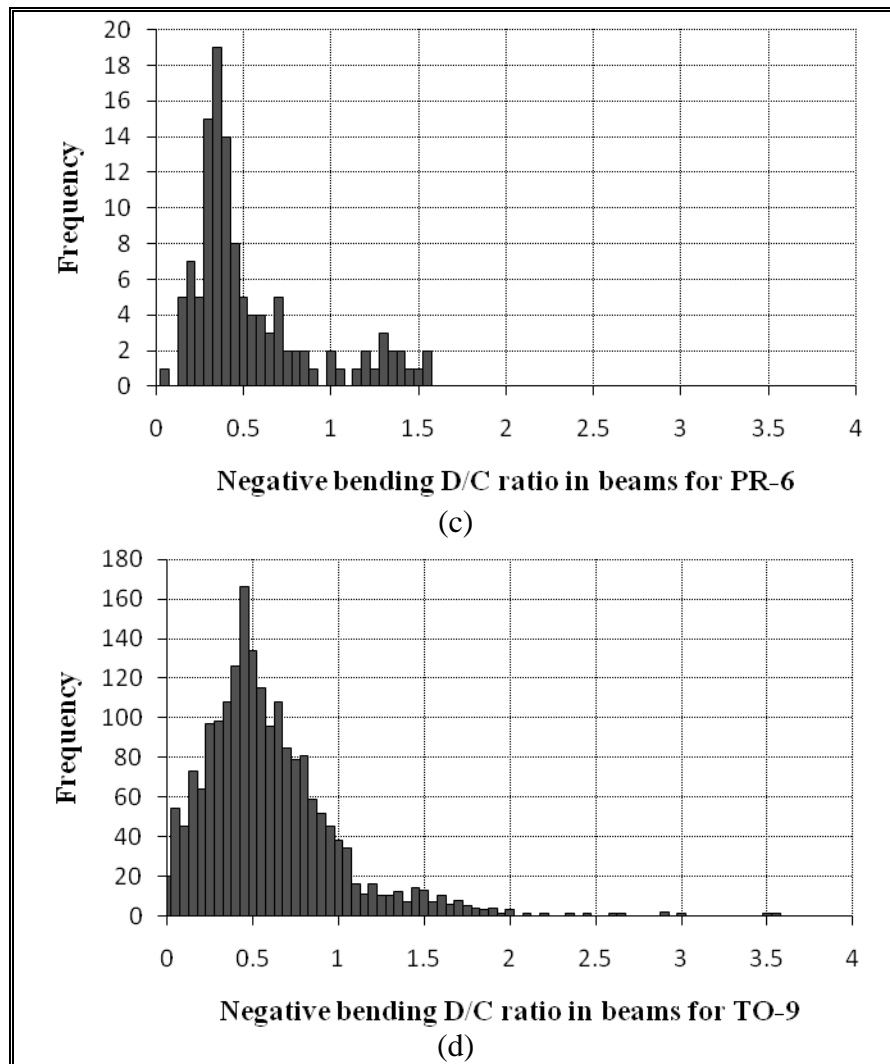
Figure 12-13: Negative bending D/C ratios in beams as histograms

Buildings AA-1 and CM-3 shows a significant lower percentage of beams properly designed than other buildings (approximately 65 % of analyzed elements against 90 % of analyzed elements in other buildings). Mean values shows the same, reaching in AA-1 a D/C ratio of 0.60 and in CM-3 a value of 0.72. Note that

PR-6 has a significant lower percentage of beams with severe strength deficit in negative bending behavior (lower than 2 % of analyzed beams), while building CM-3 shows the biggest percentage (15.70 % of analyzed elements). For building CM-3, beams with severe strength deficit are focused in axes A and O. In TO-9, axes G, I and 7 are the ones where most of the highest D/C ratios are found. These ratios were organized in intervals of 0.05 and frequencies regarding each D/C ratio are shown in Figure 12-13 as histograms for every building.

As with positive bending, all buildings show distributions with a clearly marked positive skew. Again, data in AA-1 and CM-3 is more scattered than in other buildings, having the worst designed beams in negative bending behavior (elements were designed to the limit of their capacities). Shown in Figure 12-14 are the negative bending D/C ratios in beams presented as a cumulative probability function for every building analyzed.

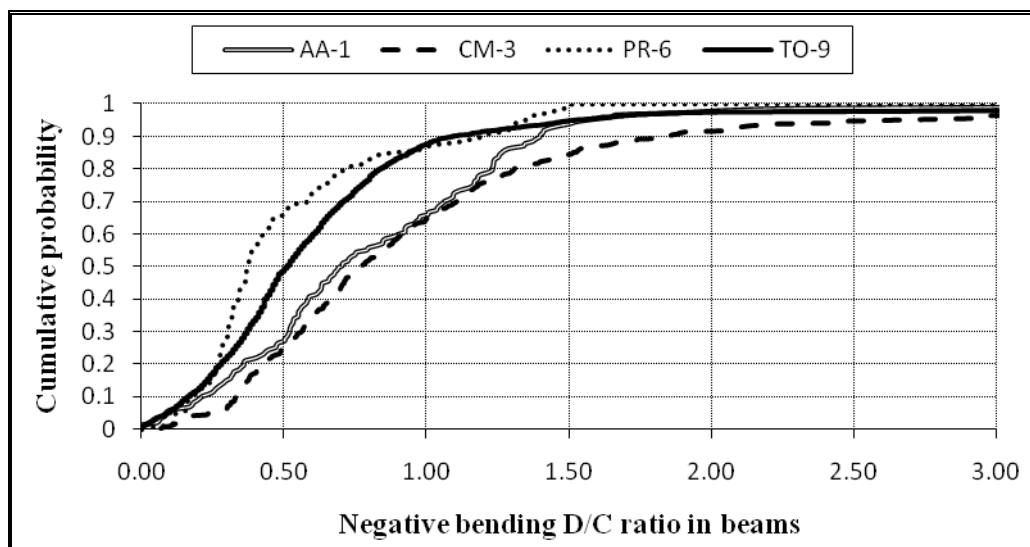
Figure 12-14: Negative bending D/C ratios in beams as cumulative probability

In negative bending of beams, building PR-6 and TO-9 shows best behavior, while buildings AA-1 and CM-3 shows poorly designed elements. Assuming that beams with higher D/C ratios were the ones that failed, limit values for these ratios will be proposed for every building. Percentages of damaged beams showing flexural evidence in every building were presented previously in the positive bending section. Limits for D/C ratios are 1.40 for AA-1, 3.34 for CM-3, 1.37 for PR-6 and 1.02 for TO-9. In this case, the code was available to predict damage in beams, regarding that all D/C limits are bigger than one.

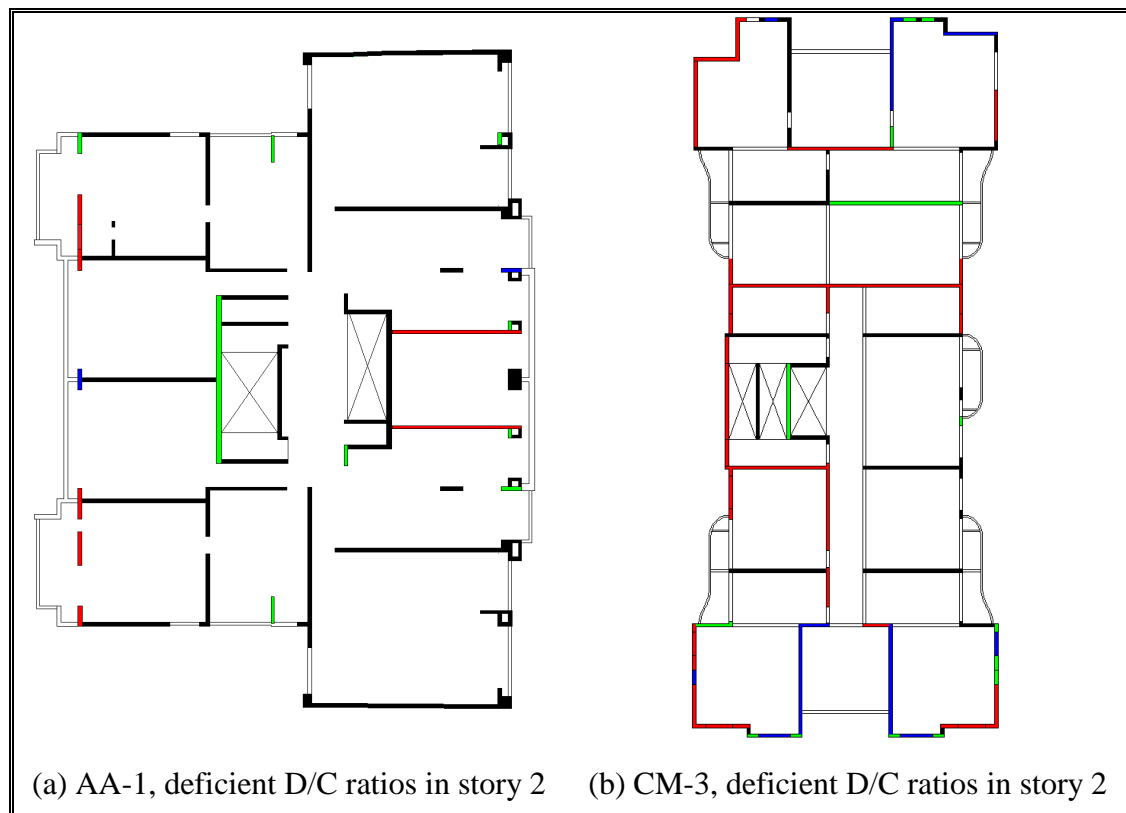
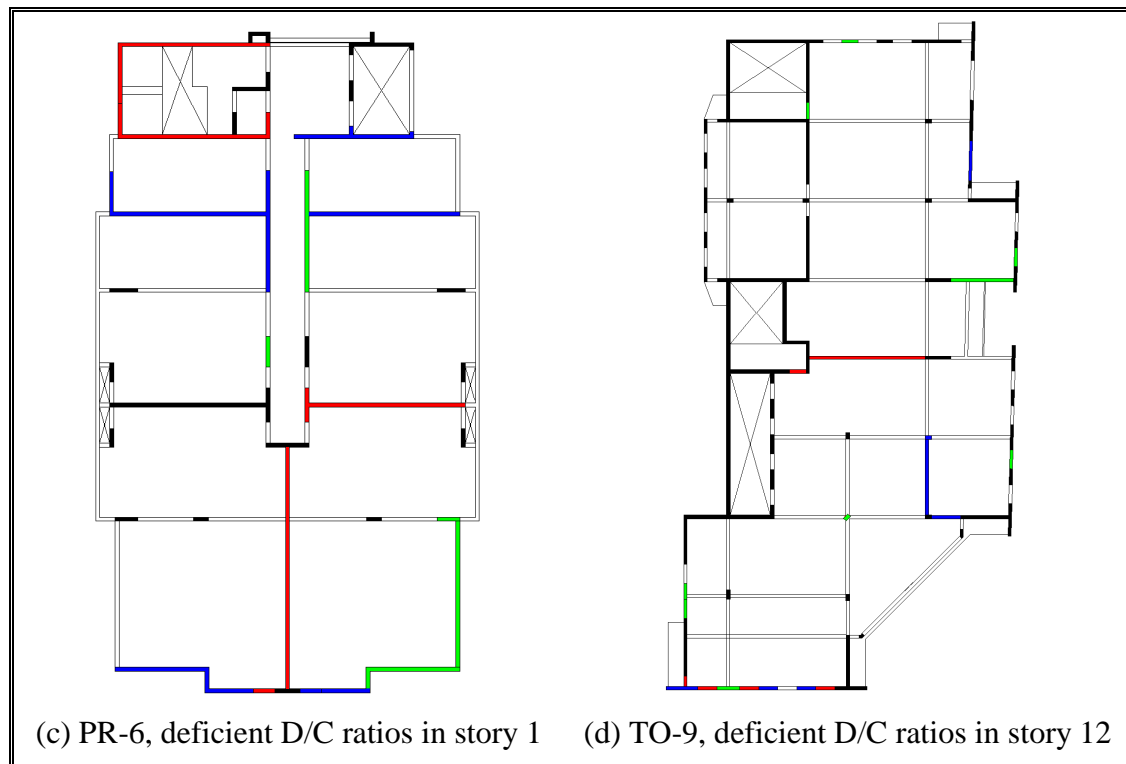
Figure 12-15: Example of deficient D/C ratios in structural drawings

In this section a comparison between the observed damage with some of the code analysis results will be performed. With that idea in mind, structural drawings showing D/C ratios were created for all four buildings. For D/C drawings, elements with D/C ratios between 1 and 1.25 are associated with green, between

1.25 and 1.5 with blue, and larger than 1.5 with red. These drawings can be compared with the ones mentioned in chapter 9 of this thesis which shows the observed damage in every analyzed building (Figure 9-1). A schematic representation of the information available is presented in Figure 12-15. See Appendix B to view the most damaged story in each structure with code analysis revision.

It is apparent that there are cases where D/C ratios and design deficit match the damaged elements; there are also cases where damage cannot be explained by high D/C ratios. Such is the case mainly because of load transfer between elements when the first element collapse occurs, and load gets distributed within the structure. There is evidence of significant redistributions of loads in these buildings; otherwise, it is difficult to explain why they did not collapse.

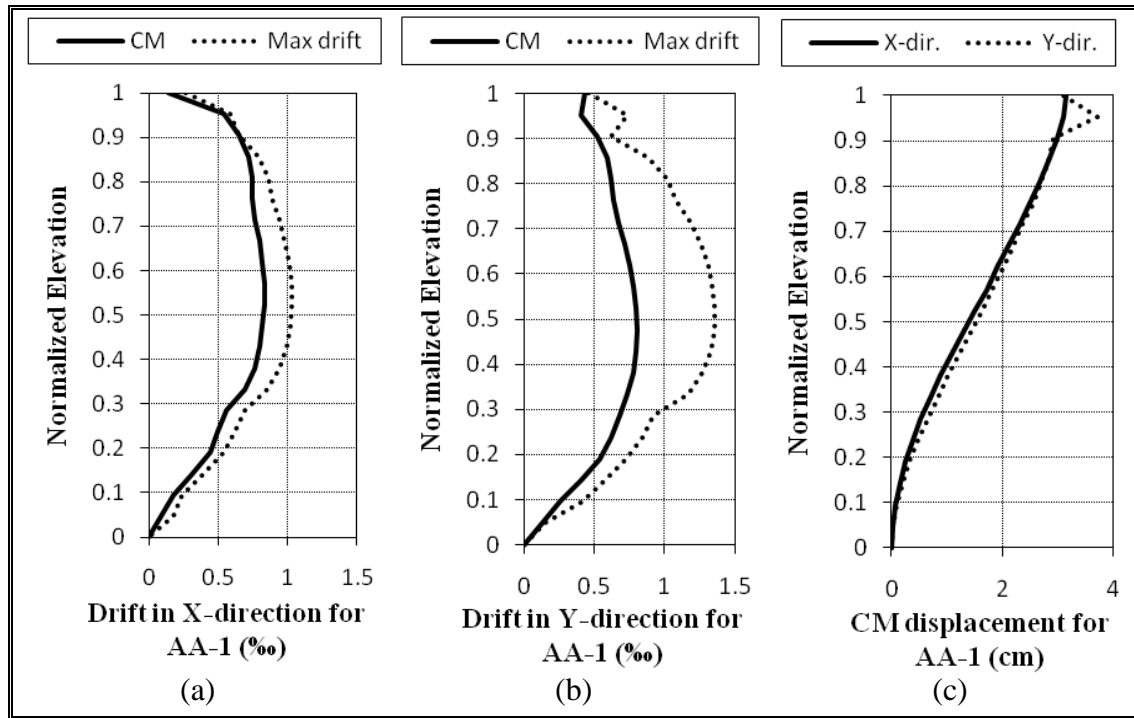
Figure 12-16: Drifts and displacements for building AA-1

Figure 12-16 shows drifts of center of mass, maximum story drifts, and center of mass displacements for each direction in normalized elevation for building AA-1. Note that seismic deformations are quite similar in both directions, implying similar stiffness in the center of mass for both directions. Maximum drifts in Y-direction are considerably higher than drifts in the center of mass, probably because there is torsion involved due to plan asymmetry. Discontinuities can be observed where setbacks exist. All limits given by the code are met; expected behavior for very rigid structures.
