PART I: RESPONSE OF REINFORCED CONCRETE BUILDINGS IN CONCEPCION DURING THE MAULE EARTHQUAKE

Thesis submitted to the Office of Research and Graduate Studies in partial fulfillment of the requirements for the Degree of Master of Science in Engineering

Santiago de Chile, (December, 2011)

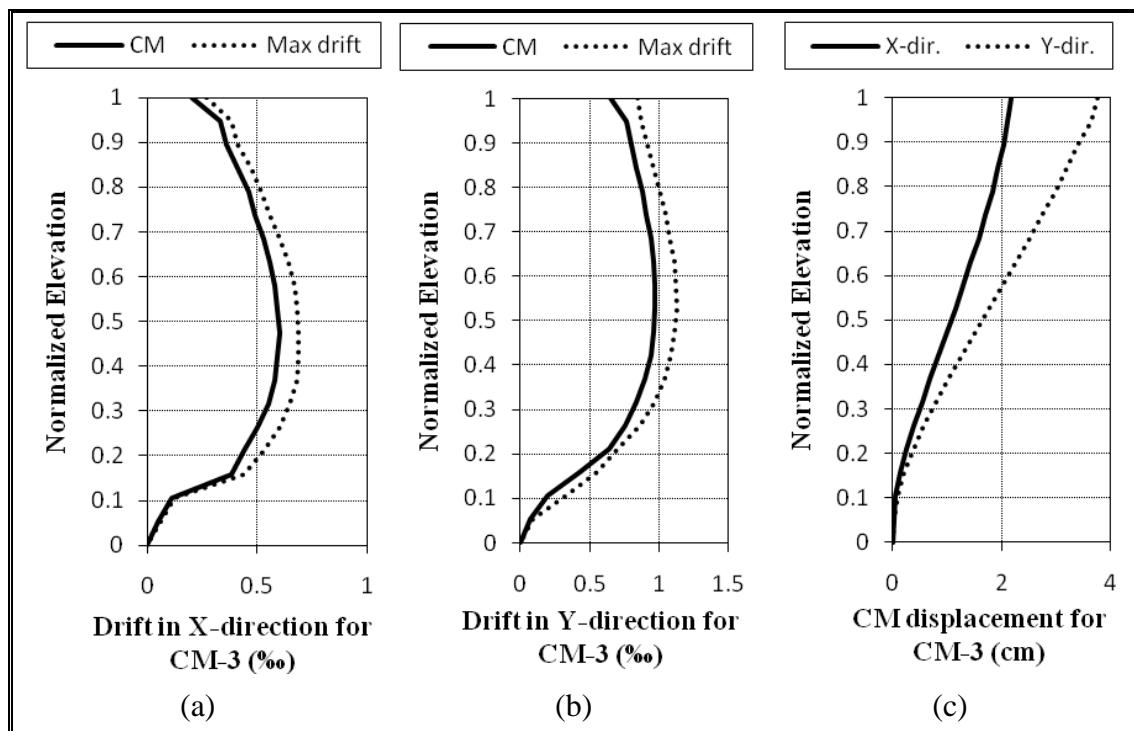
Figure 12-17: Drifts and displacements for building CM-3

Figure 12-17 shows drifts of center of mass, maximum story drifts, and center of mass displacements for each direction in normalized elevation for building CM-3. Note that seismic deformations are very different in both directions (regarding magnitude rather than shape), expected behavior due to the narrow plan. Maximum drifts in Y-direction are quite similar than drifts in the center of mass, implying no significant torsion occurred. Again, all limits given by the code are met.

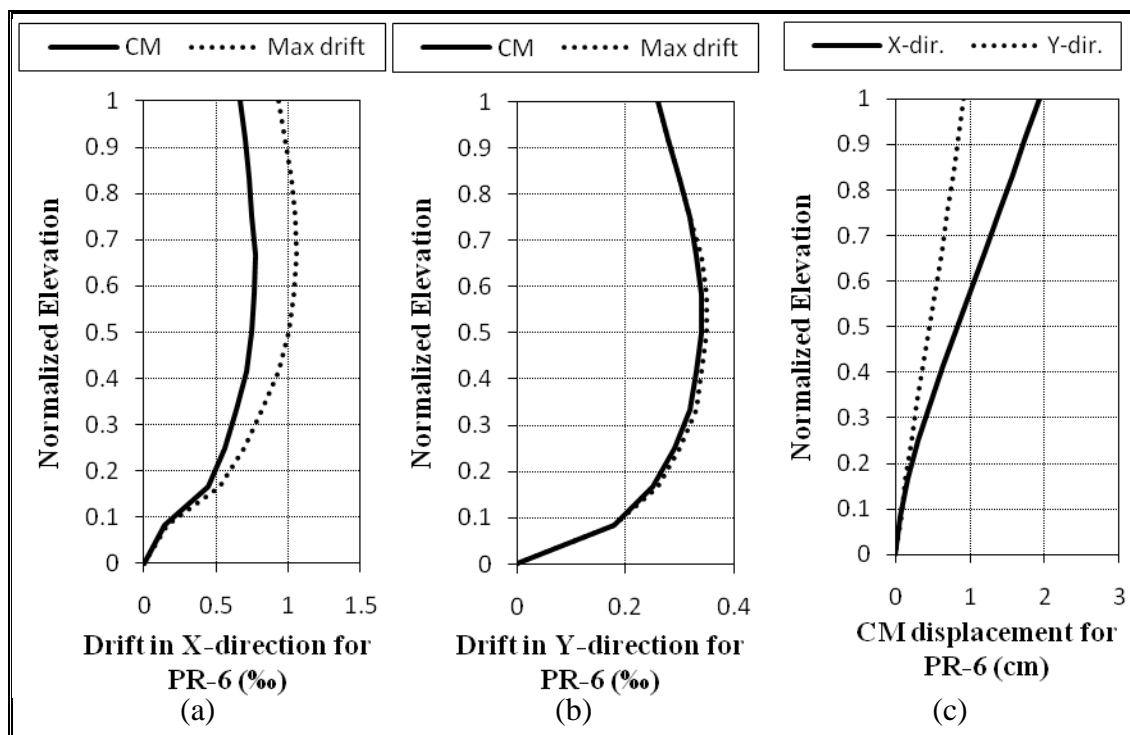
Figure 12-18: Drifts and displacements for building PR-6

Again, seismic deformations are very different in both directions (regarding magnitude rather than shape), expected behavior due to the narrow plan. Maximum drifts in X-direction are very different than drifts in the center of mass, implying significant torsion occurred in X-direction. Axes V and W are the ones with maximum drifts, which differs approximately in a 30% with drifts in the center of mass. Again, all limits given by the code are met.

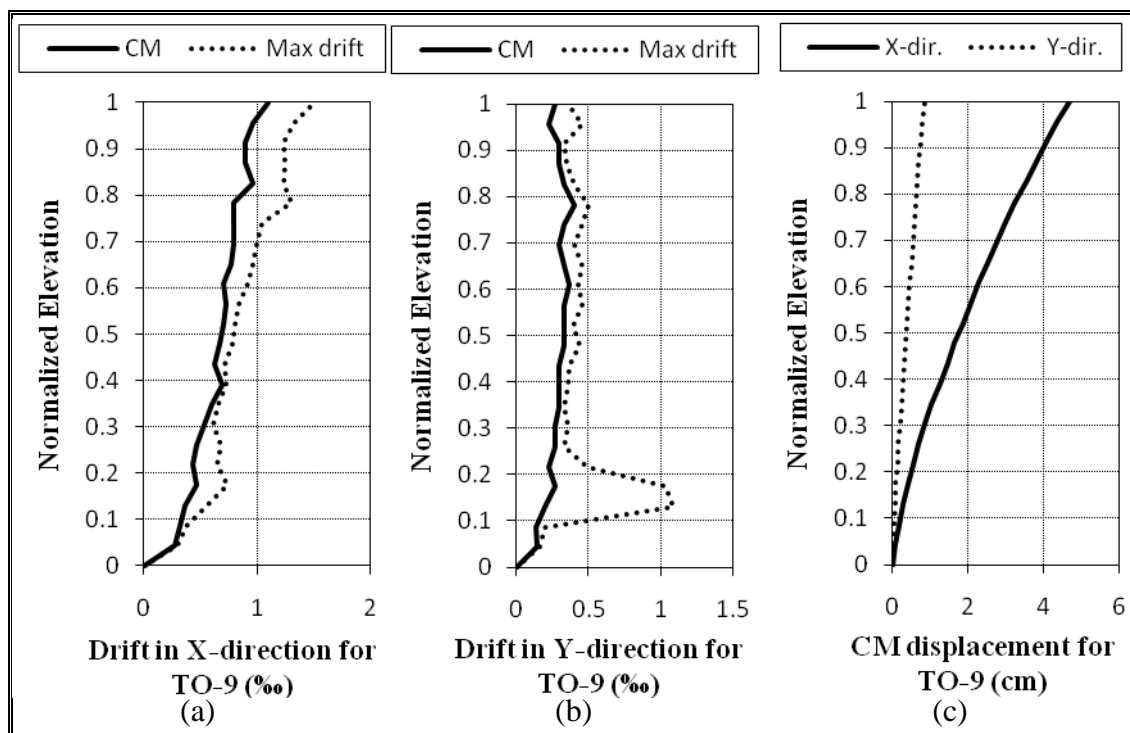
Figure 12-19: Drifts and displacements for building TO-9

TO-9 shows an important difference in seismic deformations for both directions. Center of mass displacements at story 21 reaches 4.69 cm in X-direction and 0.84 cm for Y-direction. Note the discontinuities on drift behavior, given by a capricious configuration. Maximum drifts in Y-direction shows a great difference with center of mass drifts in lower stories, mainly due to the double height columns present at these stories. At higher stories, X-direction shows a greater difference between maximum and center of mass drifts, implying more torsion at this direction in higher levels. Again, all limits given by the code are met.

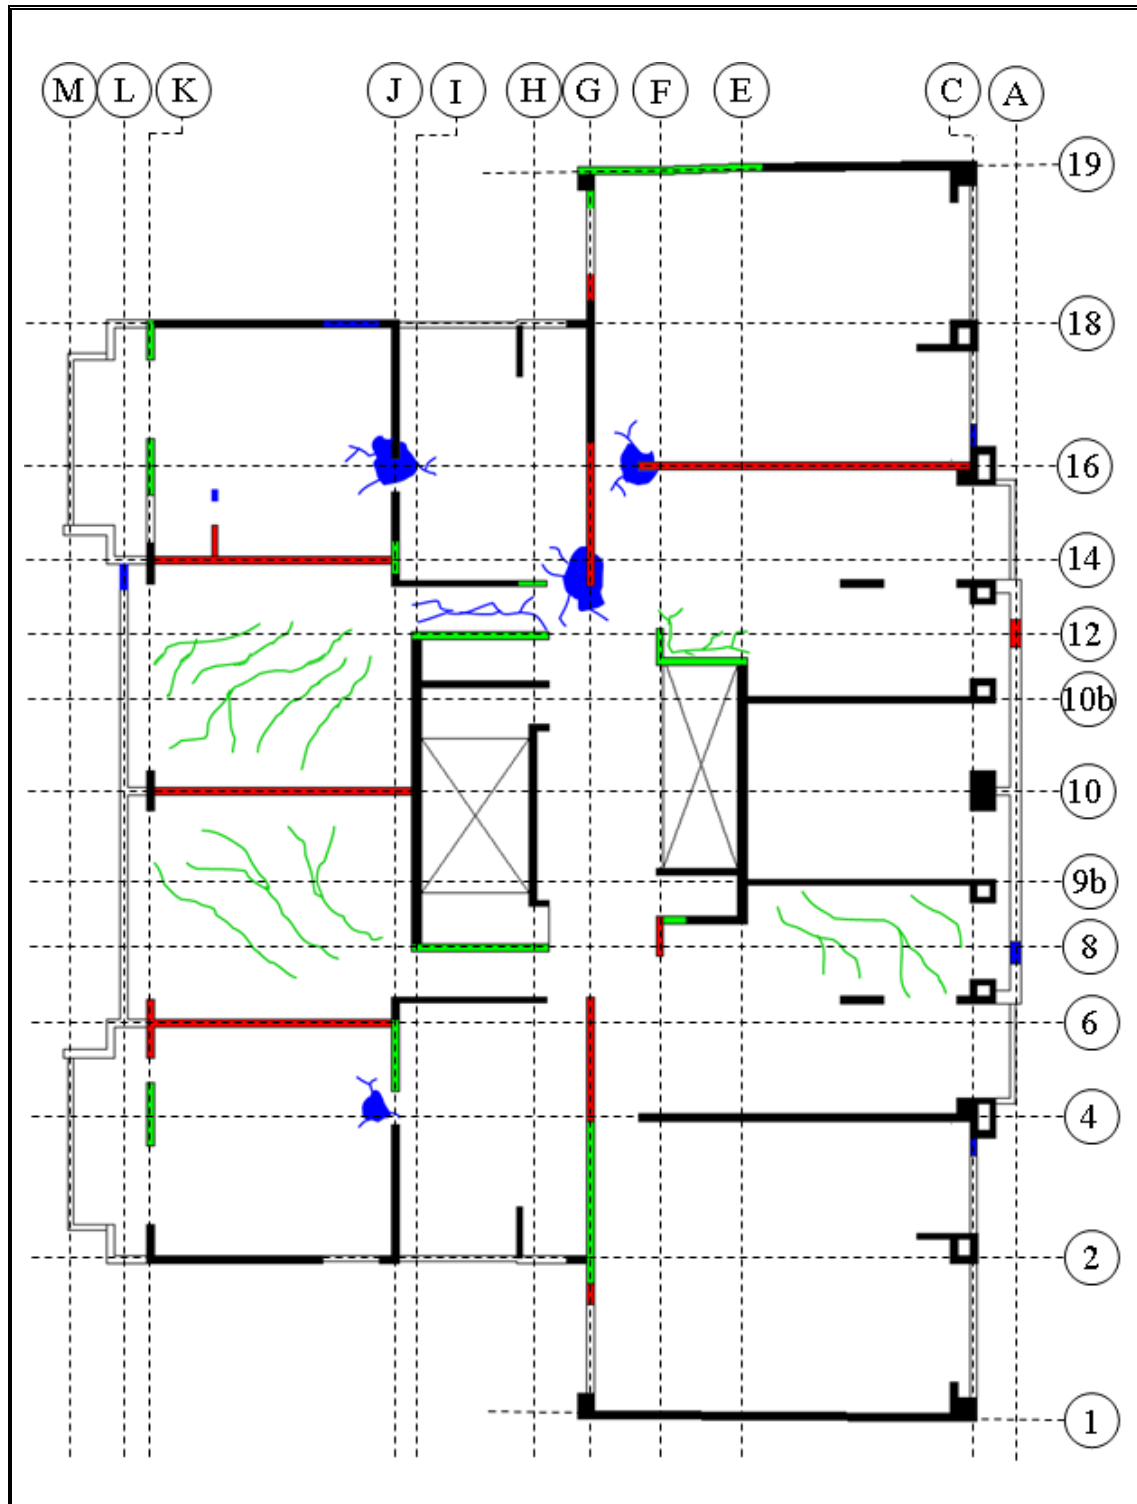
Figure A-1: Damaged elements in story 2 of building AA-1

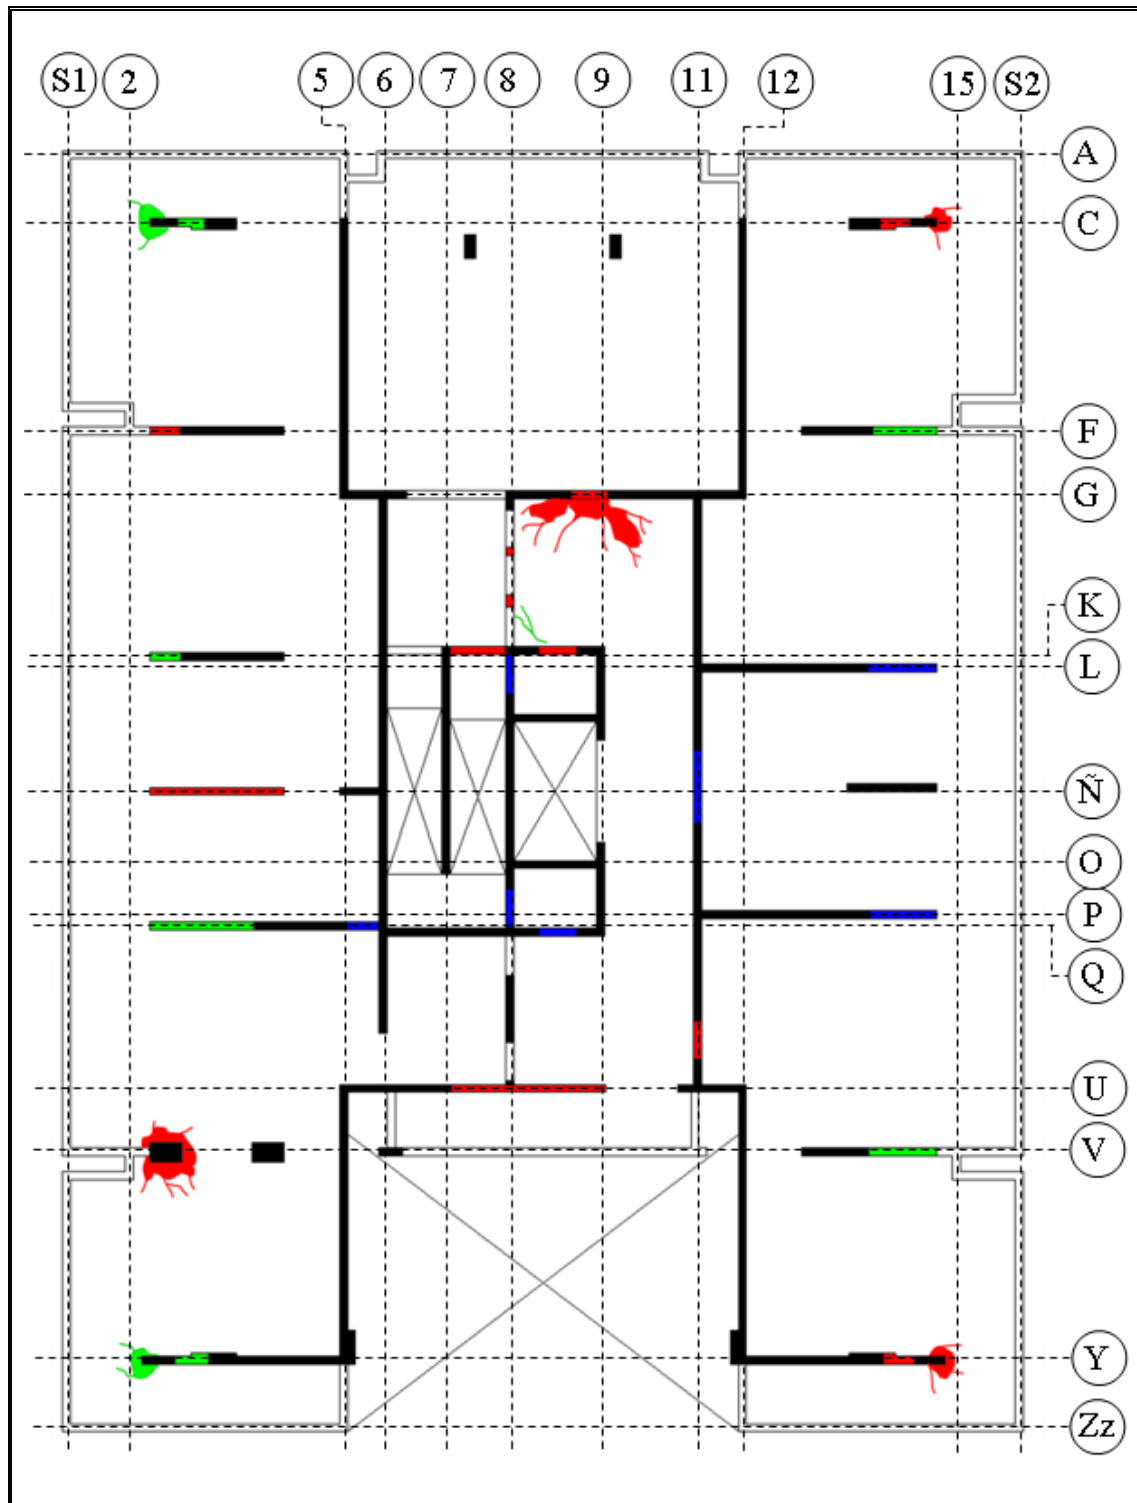
Figure A-2: Damaged elements in story 1 of building AH-2

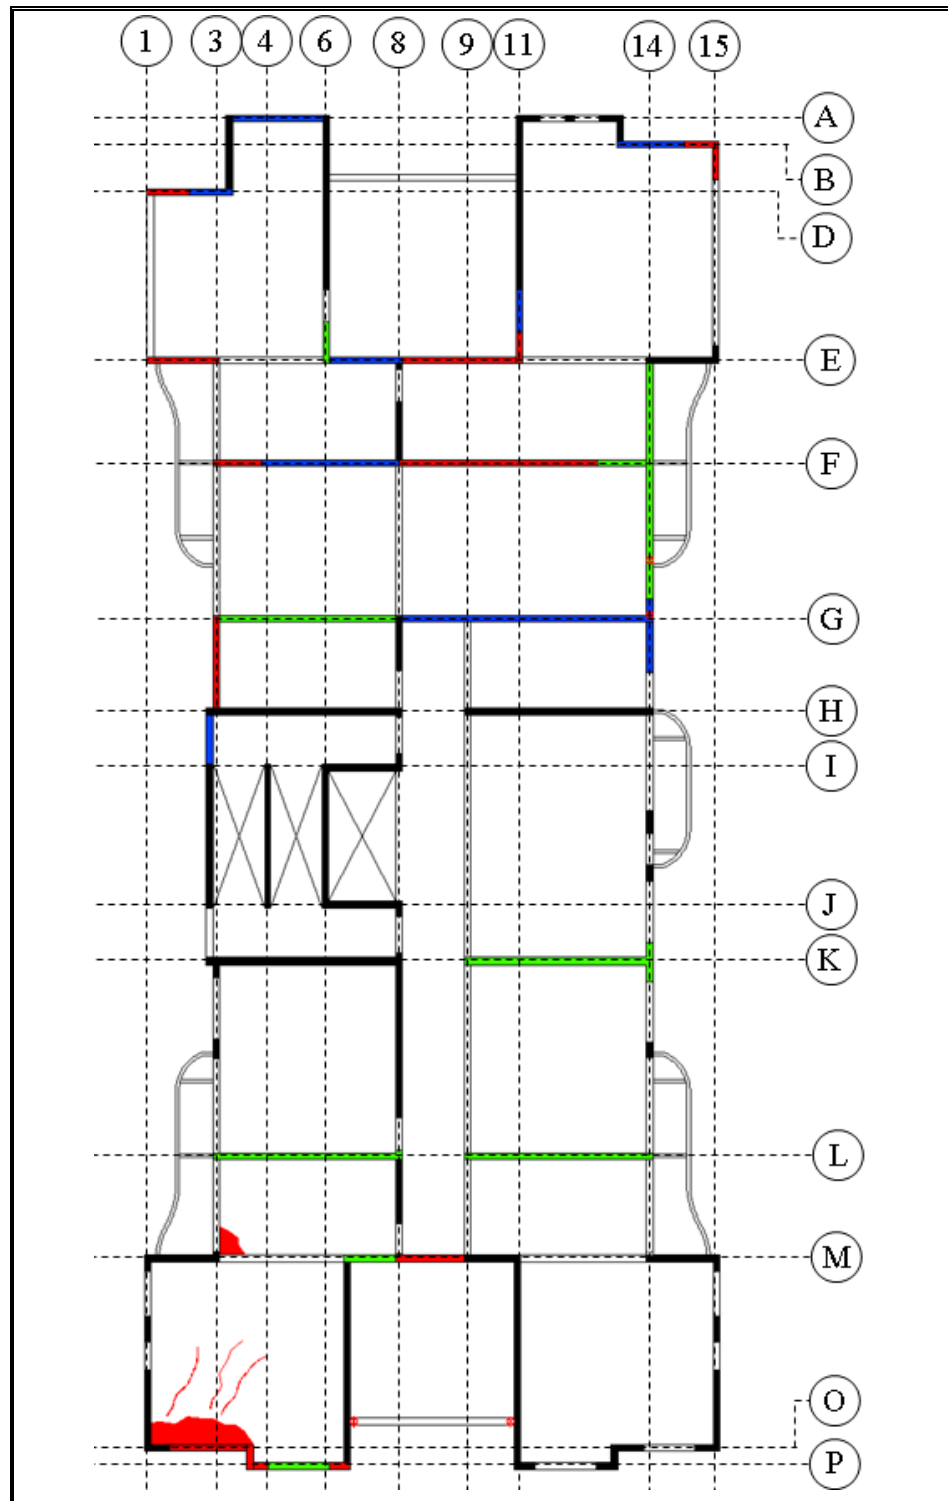
Figure A-3: Damaged elements in story 2 of building CM-3

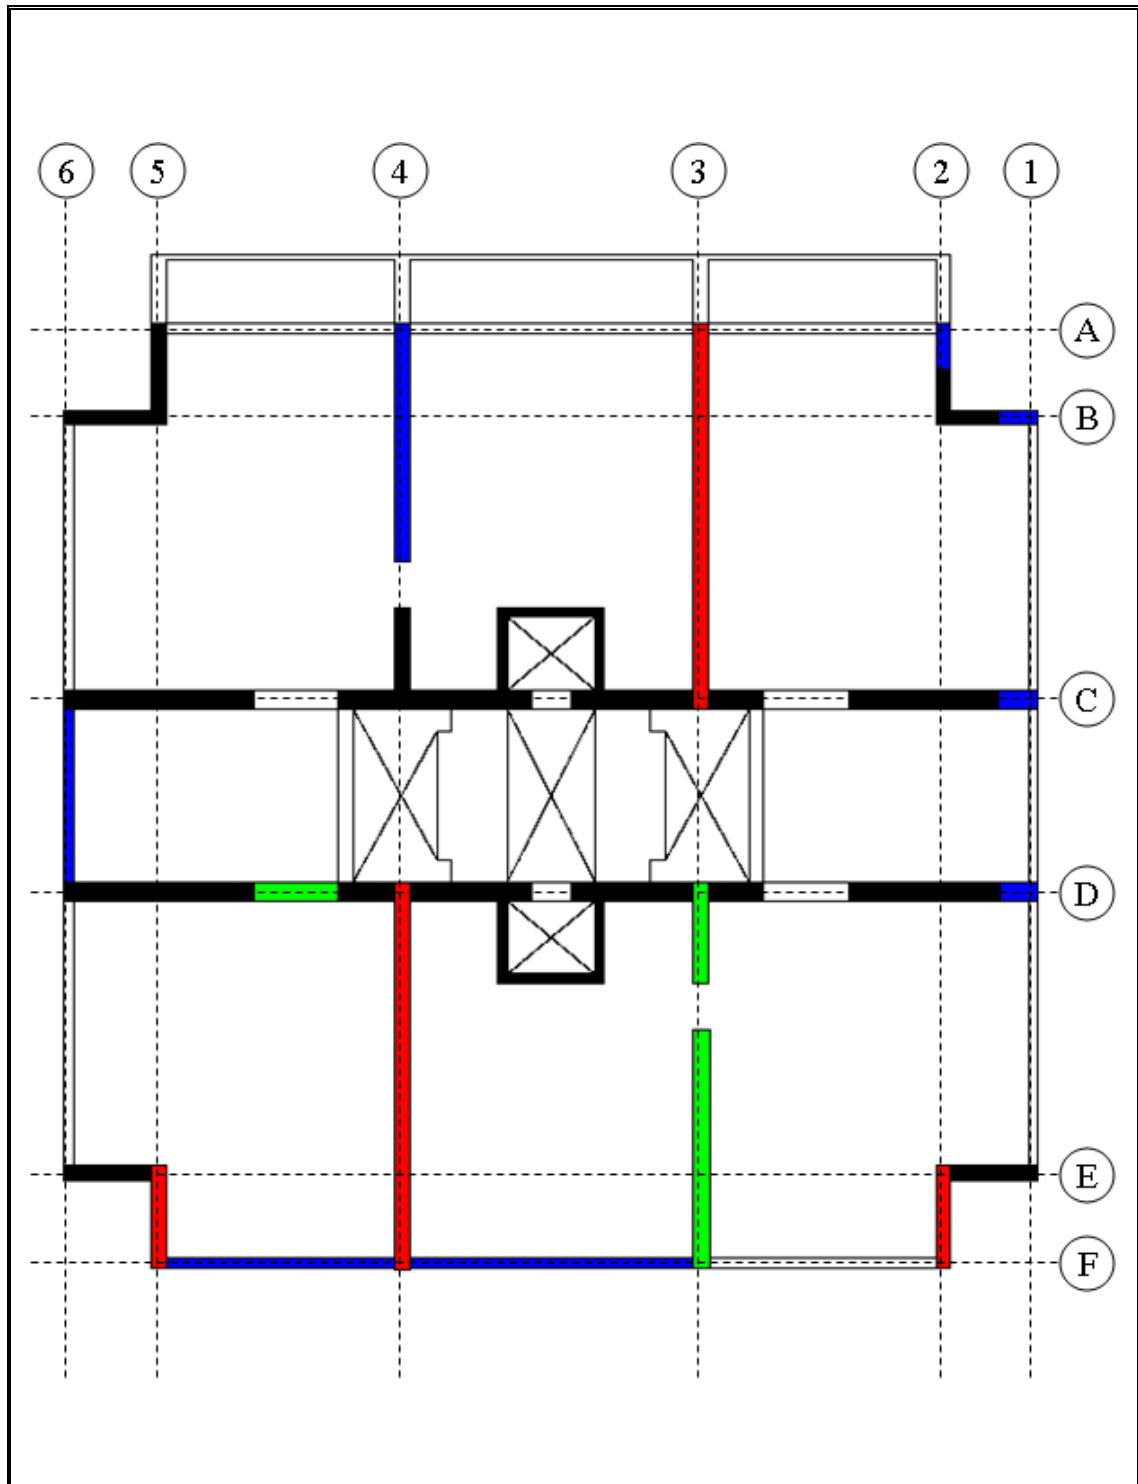
Figure A-4: Damaged elements in story 2 of building TL-4

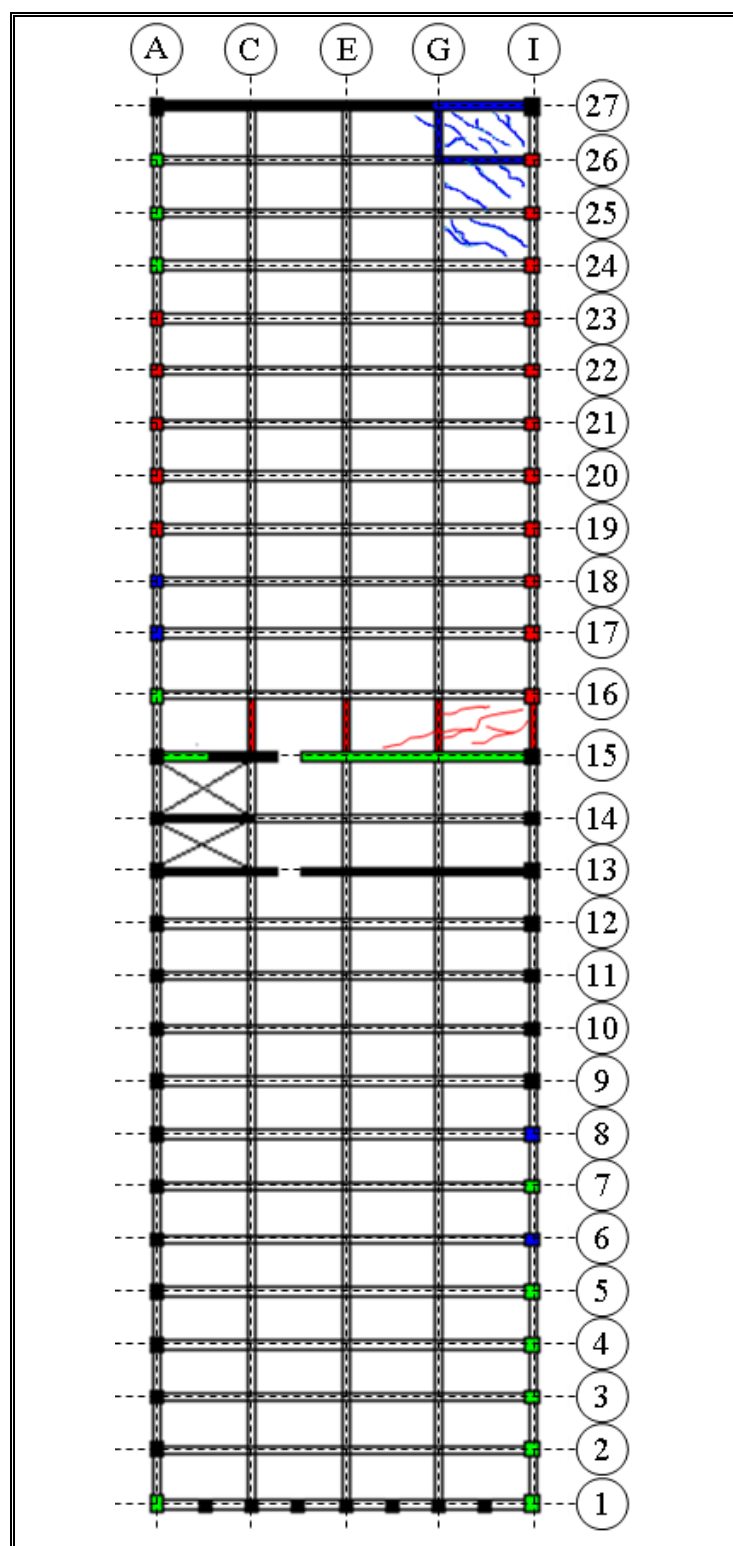
Figure A-5: Damaged elements in story 3 of building MD-5

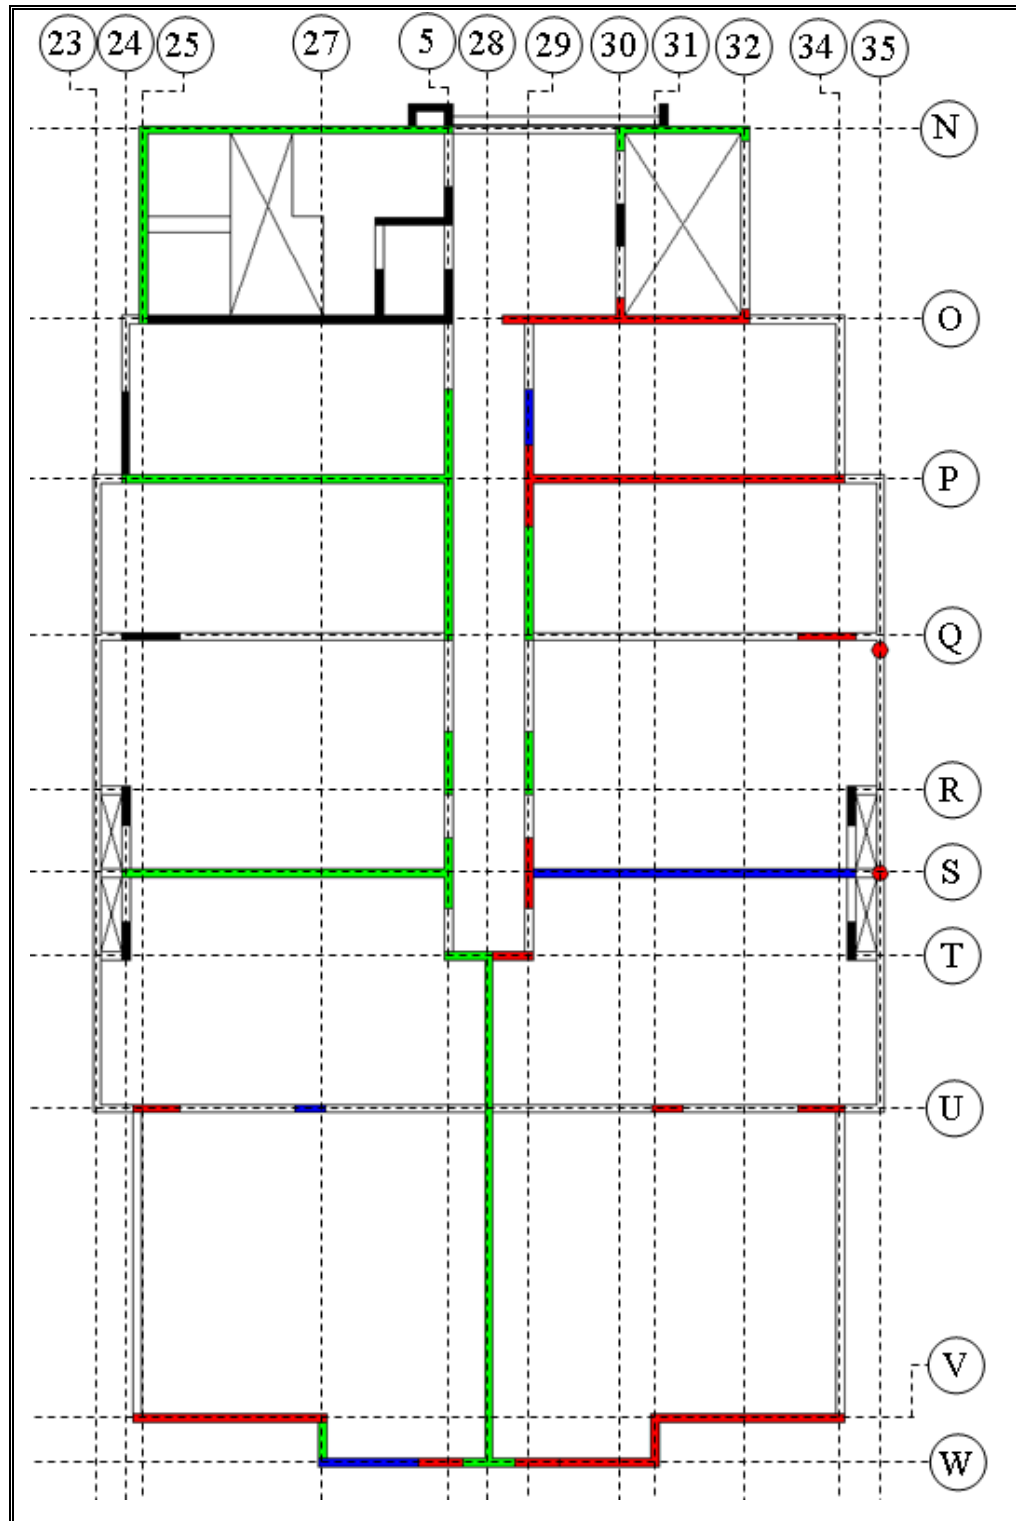
Figure A-6: Damaged elements in story 1 of building PR-6

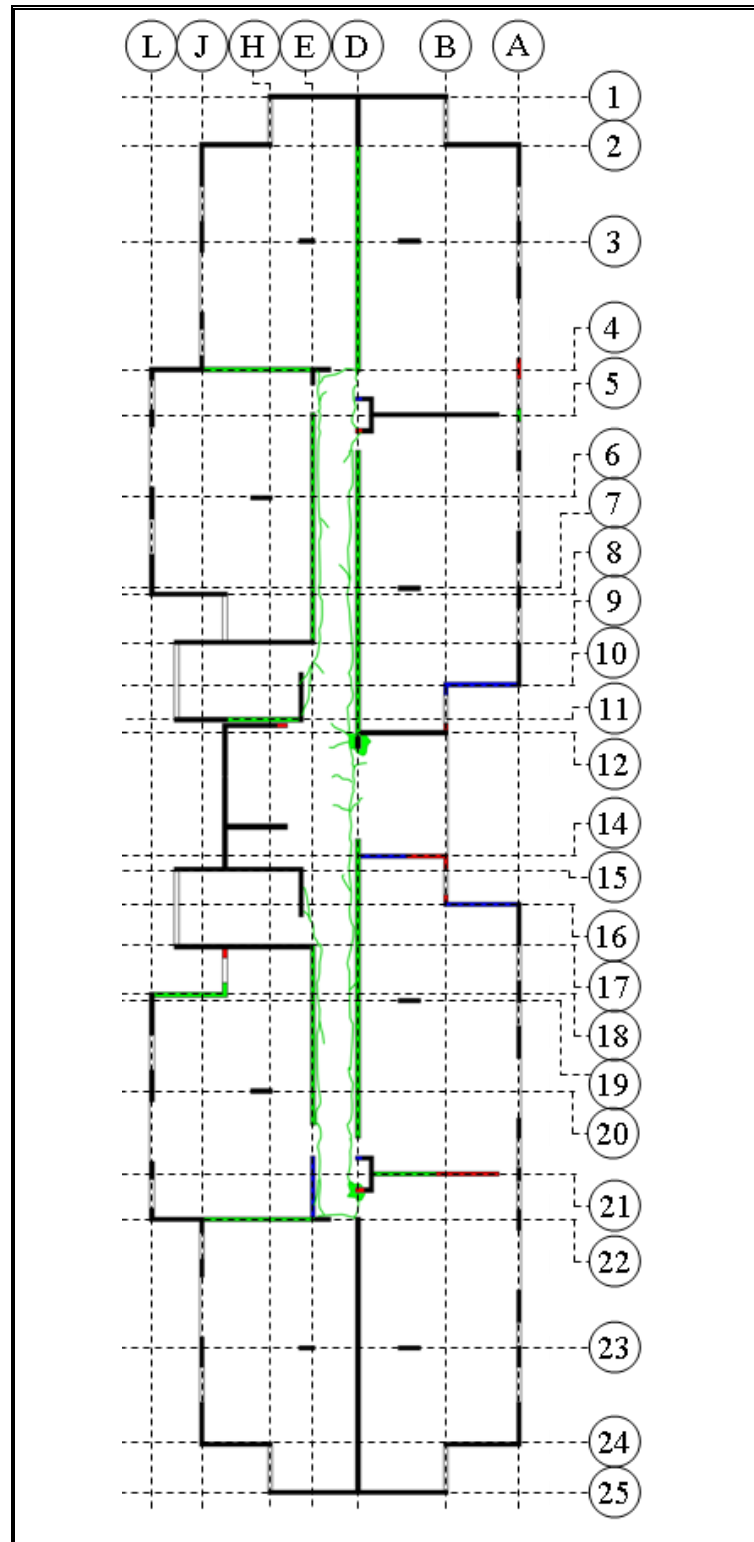
Figure A-7: Damaged elements in story 1 of building PP-7

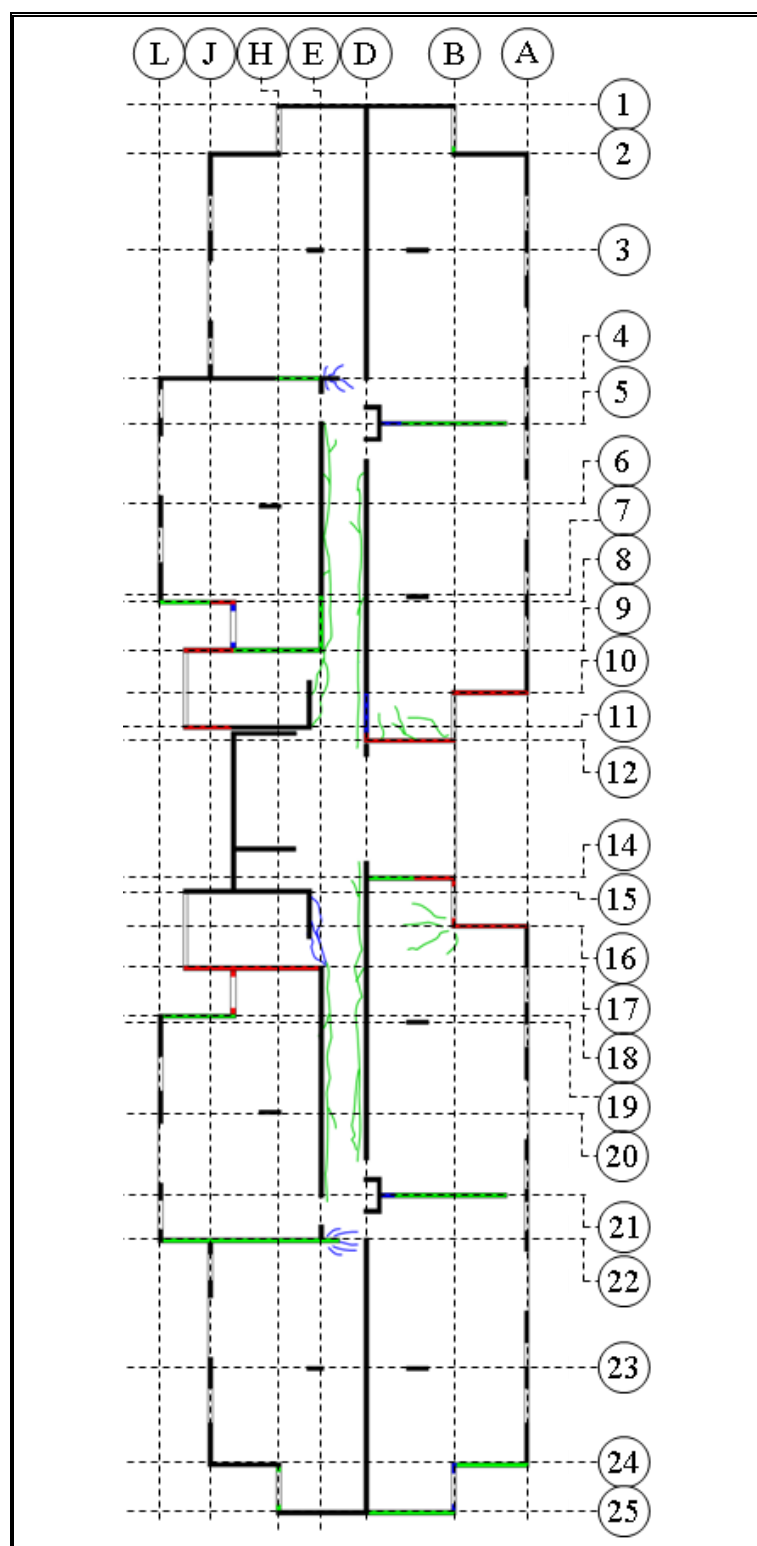
Figure A-8: Damaged elements in story 2 of building RT-8

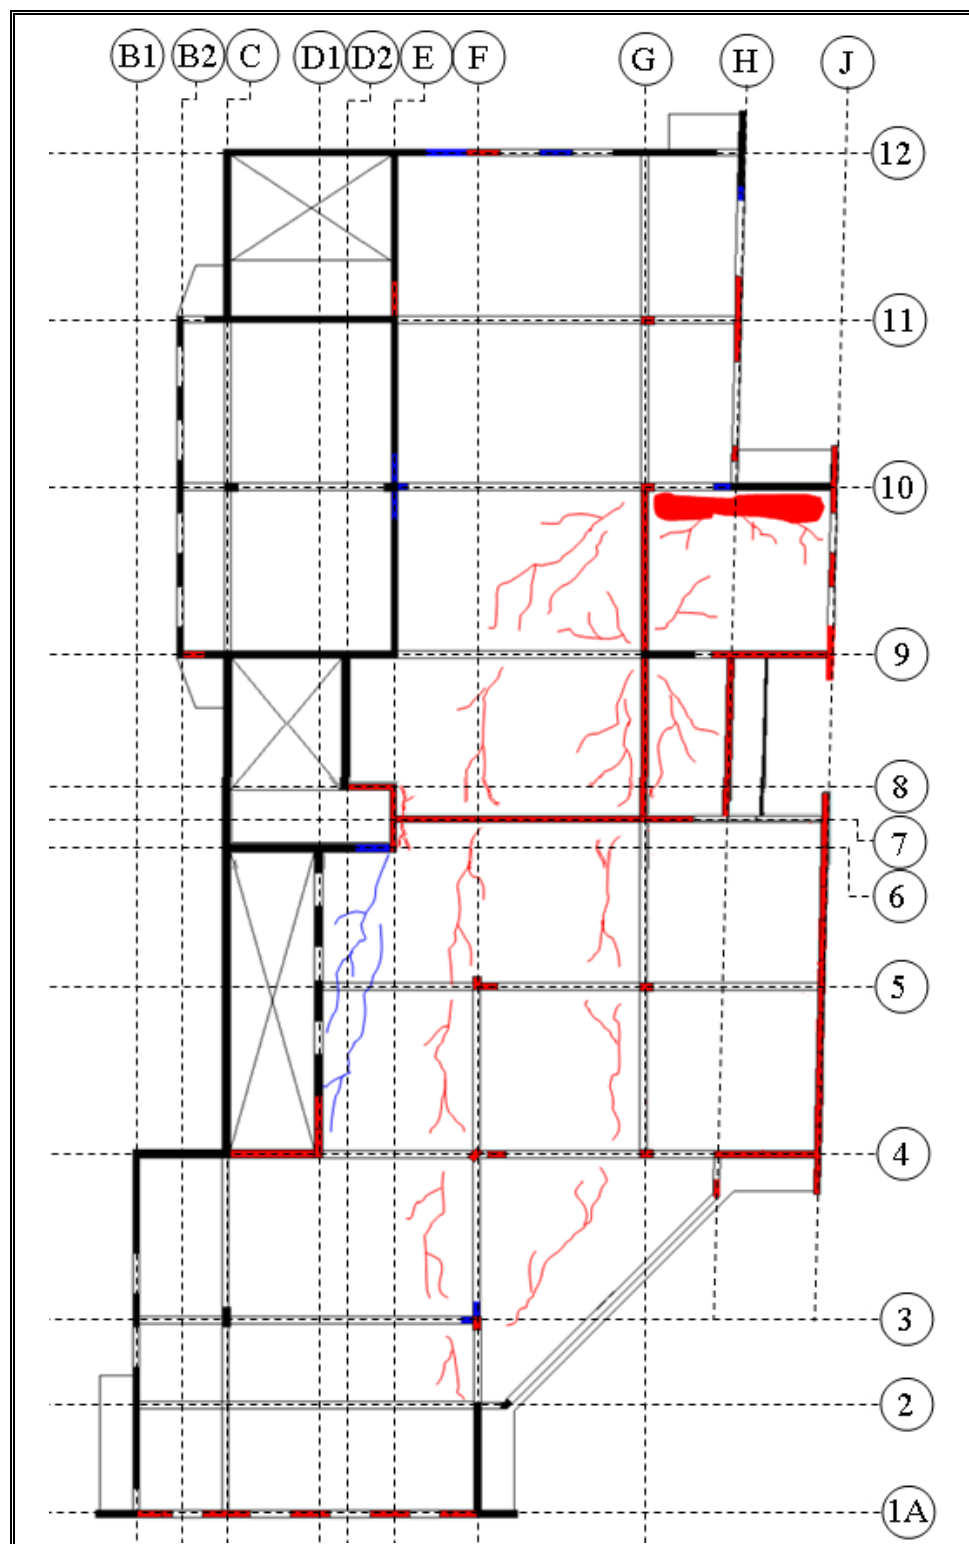
Figure A-9: Damaged elements in story 12 of building TO-9

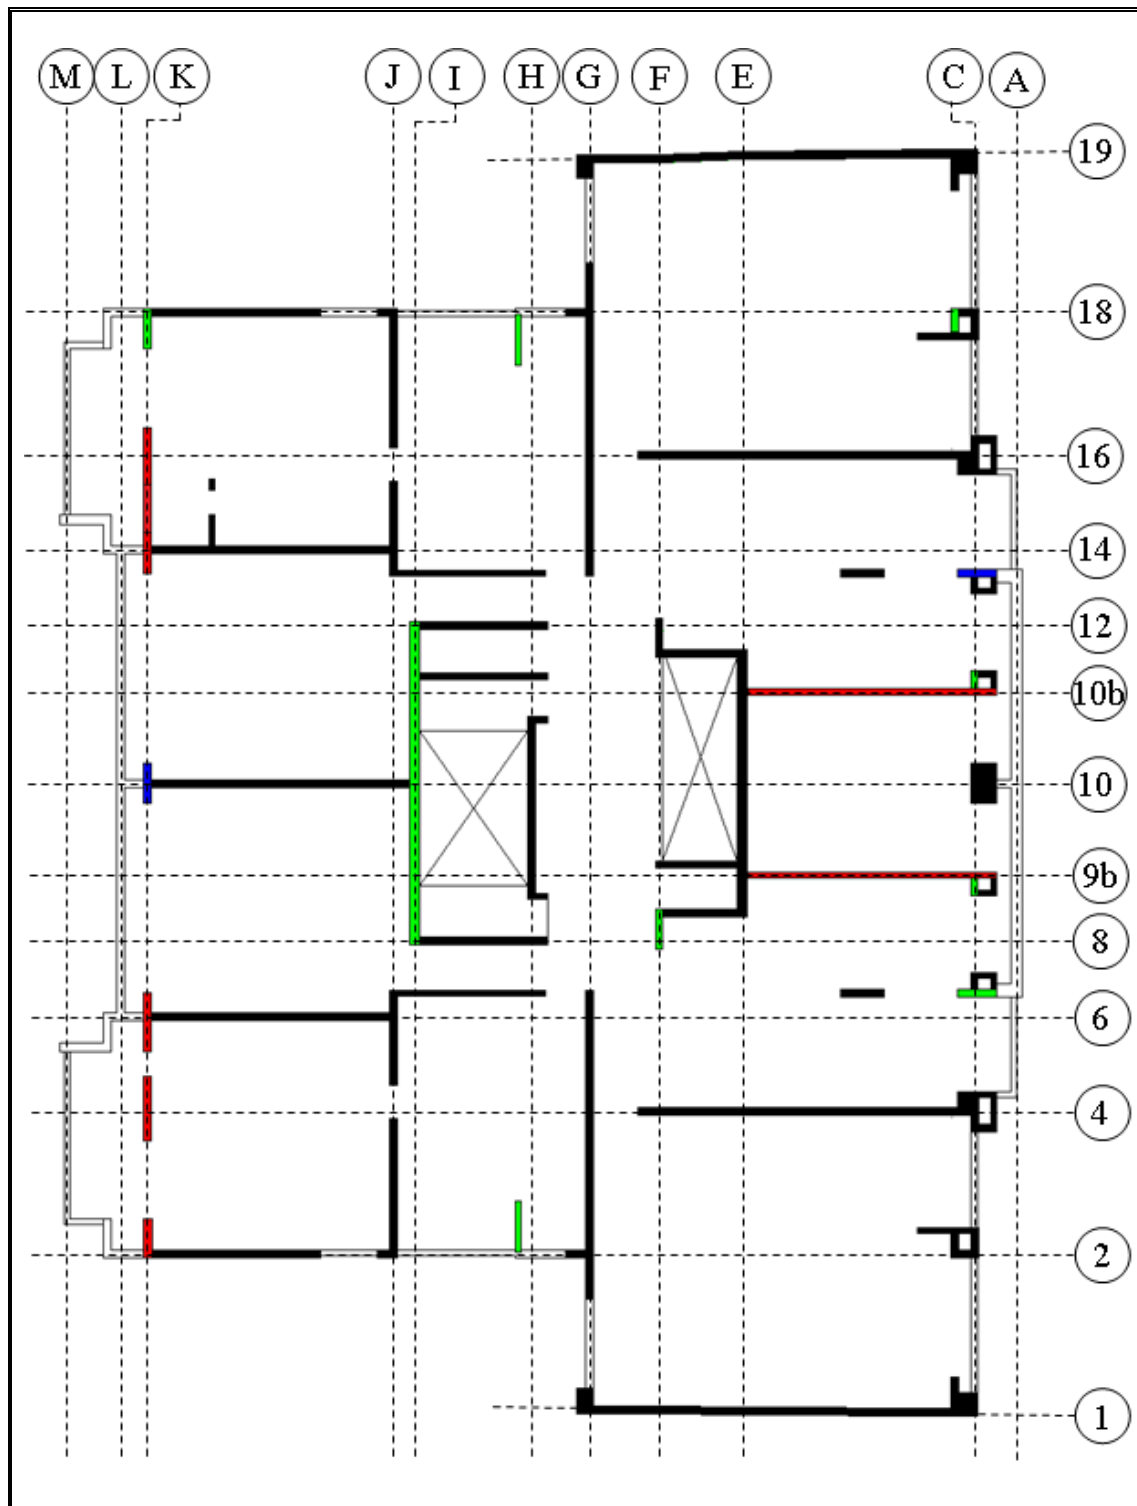
Figure B-1: D/C ratios in story 2 of building AA-1

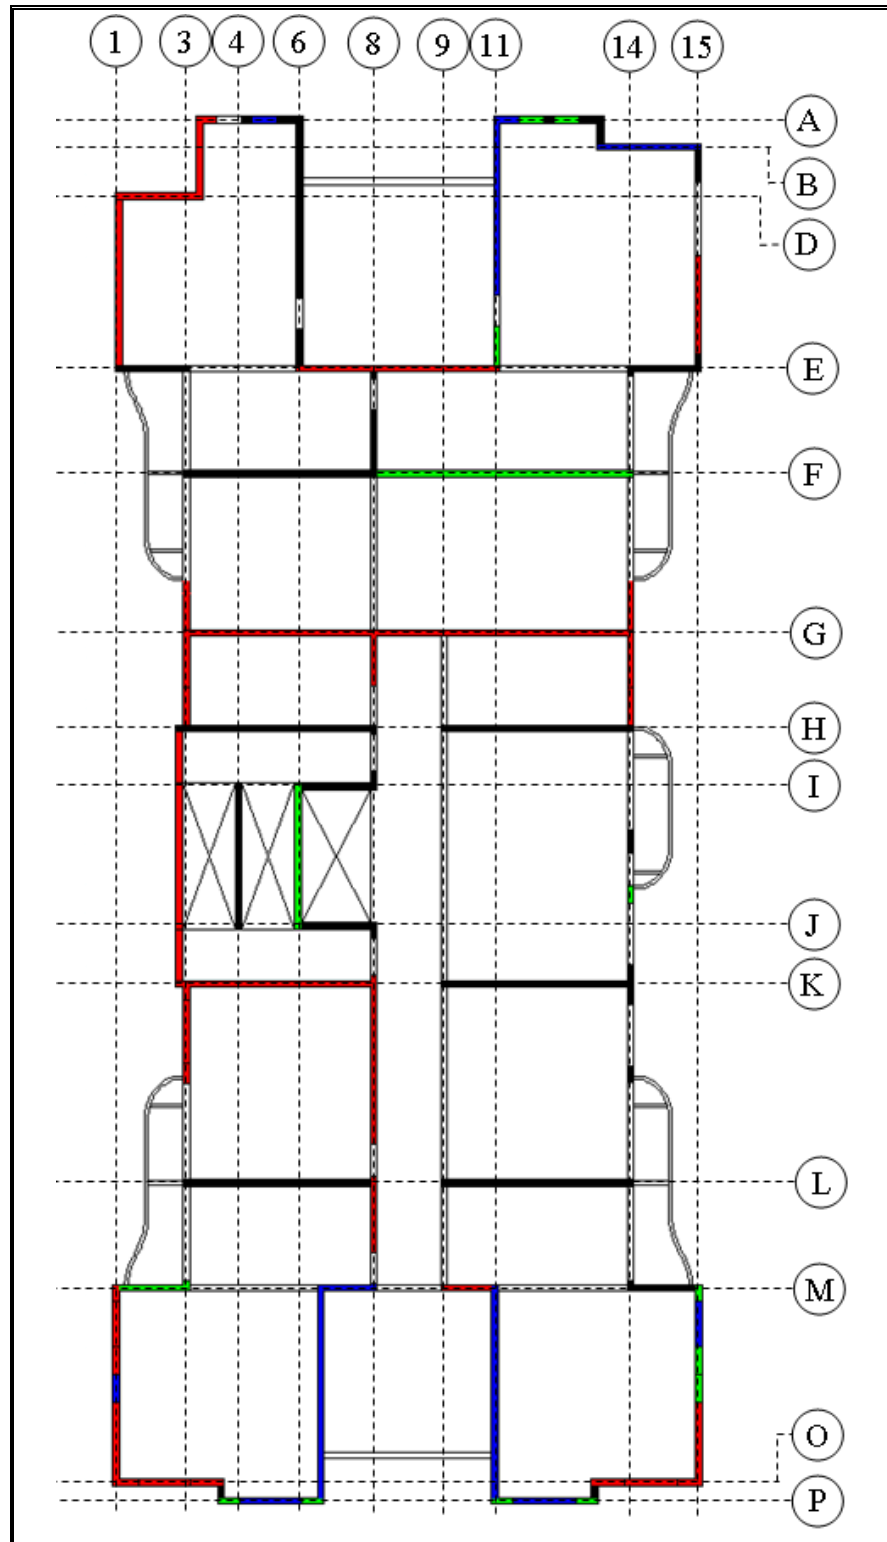
Figure B-2: D/C ratios in story 2 of building CM-3

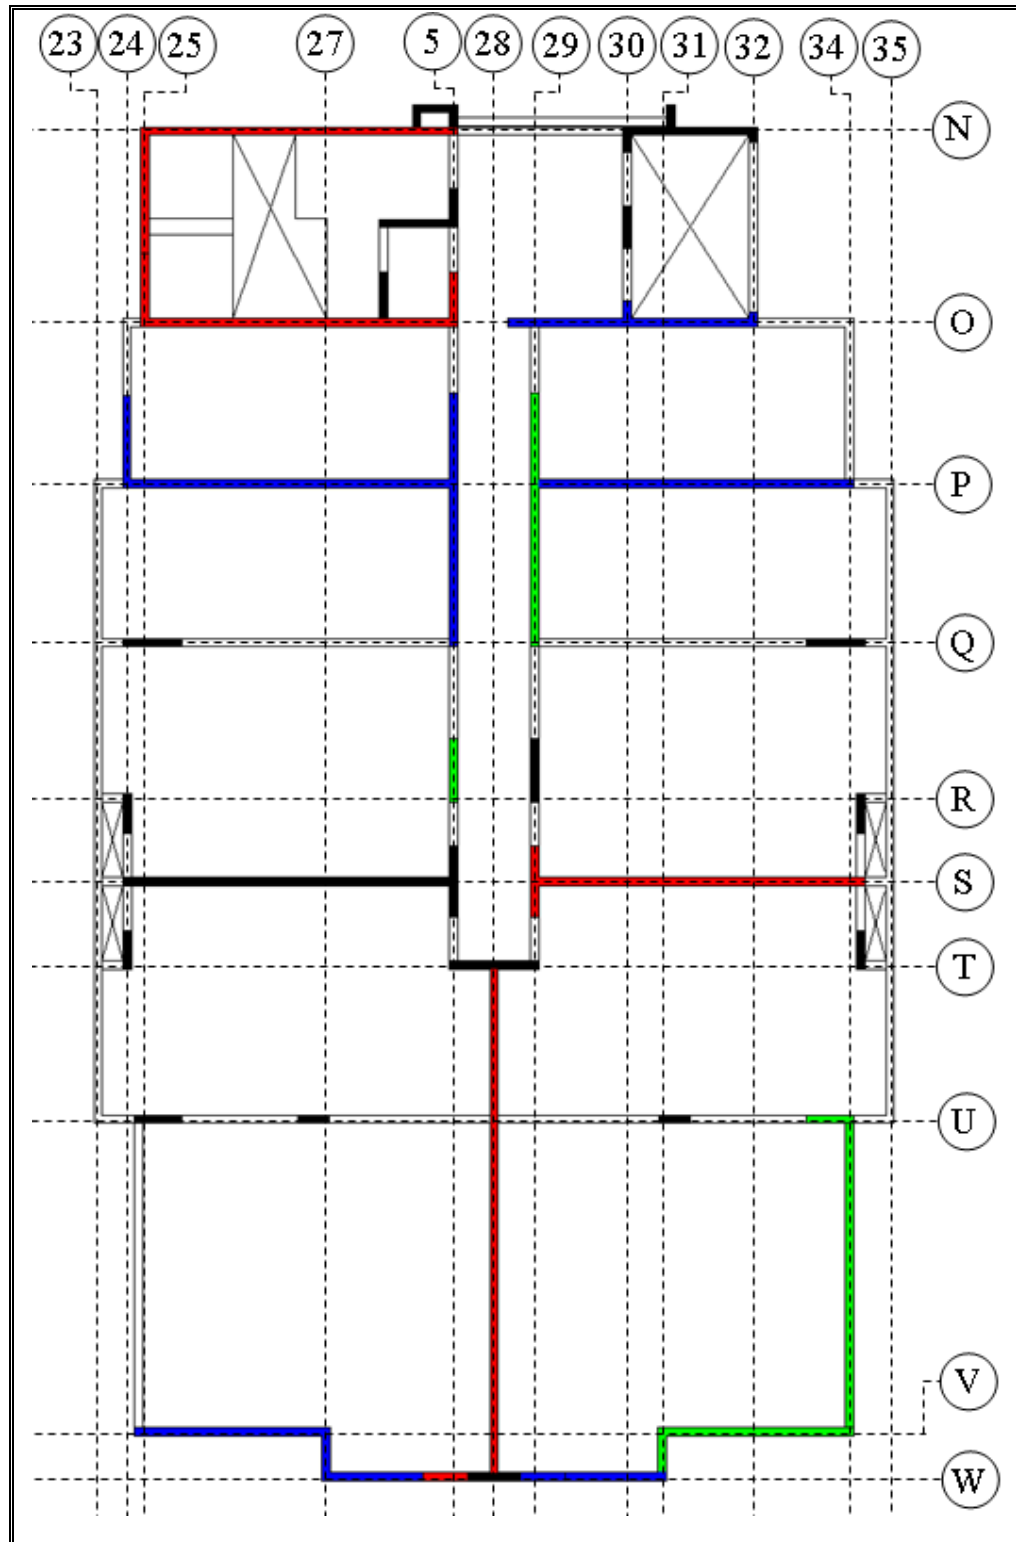
Figure B-3: D/C ratios in story 1 of building PR-6

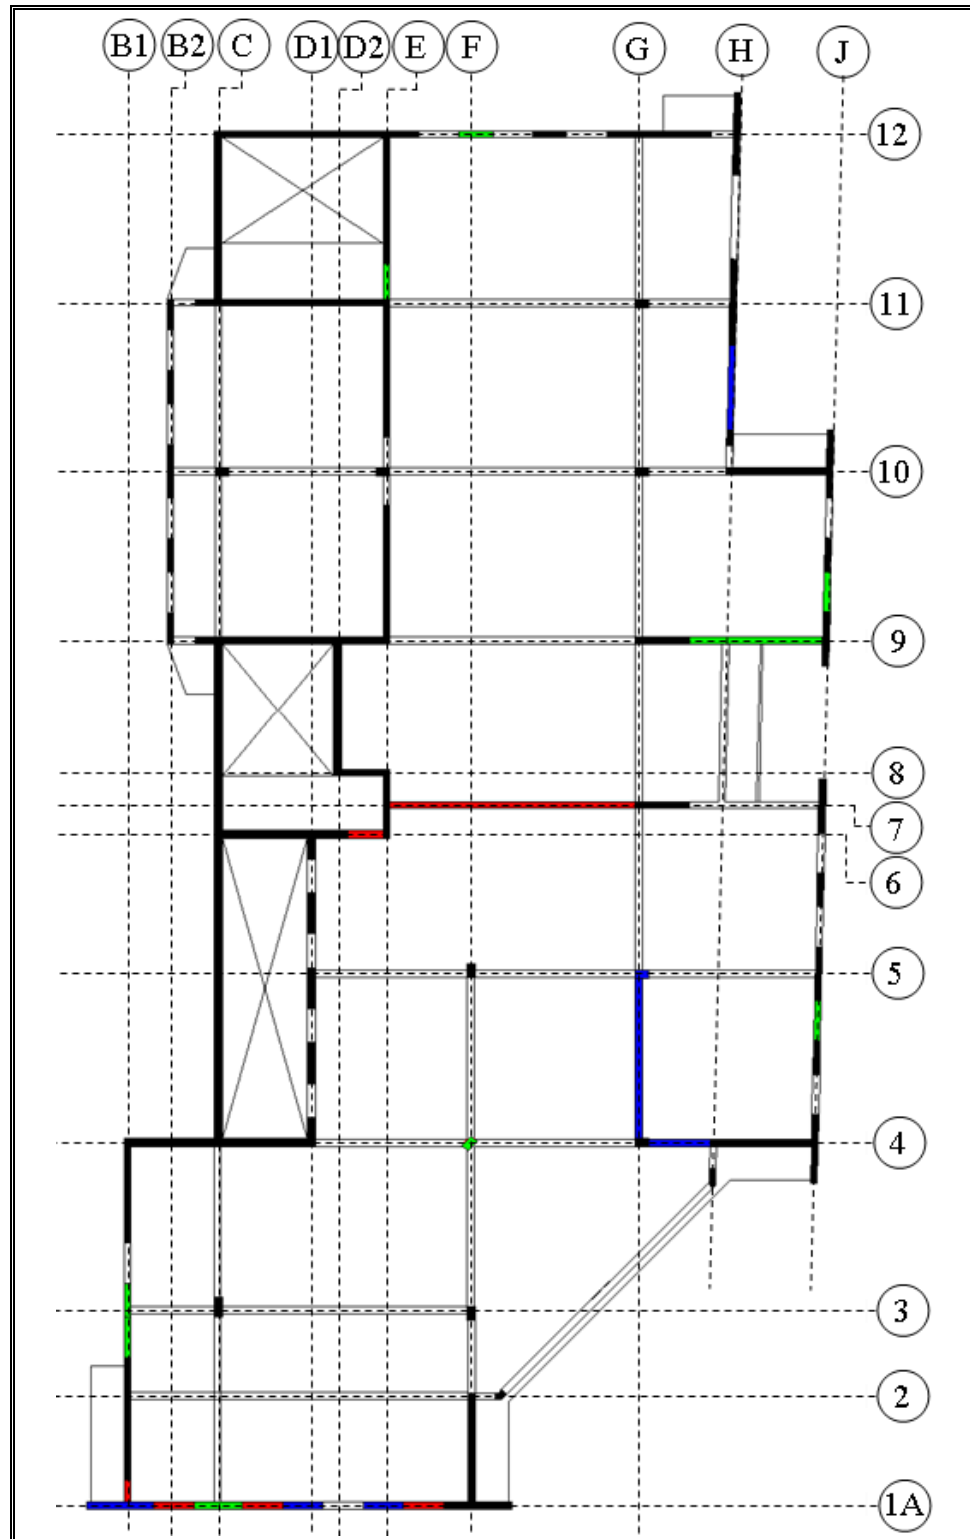
Figure B-4: D/C ratios in story 12 of building TO-9
